COMPARISON OF HYDROLOGIC CHARACTERISTICS FROM TWO DIFFERENTLY RECLAIMED TAILINGS PONDS; GRAVES MOUNTAIN, LINCOLNTON, GA¹

Abstract: This study compares and evaluates the hydrologic characteristics between two kyanite ore process tailings ponds that were reclaimed with different reclamation strategies; one reclaimed with an impermeable membrane and the other with an open, surface reconfiguration methodology. During the extraction and processing of kyanite ore from the Graves Mountain mine, Lincoln County, Georgia, fine grained tailings were produced. The tailings were transported by slurry pipeline to various tailings ponds which were created by the construction of dams using on-site materials. The first study site, referred to as the Pyrite Pond (PP), was constructed and filled during the 1960's and early 1970's. In early 1992, the PP was capped with an impermeable membrane, covered with a thin soil veneer and vegetated and in 1998 the upslope reclamation was completed. The second tailings pond, referred to as the East Tailings Pond (ETP), was constructed and filled in the 1970's and early 1980's and was reclaimed in 1995-96 by surface reconfiguration and the addition of soil amend

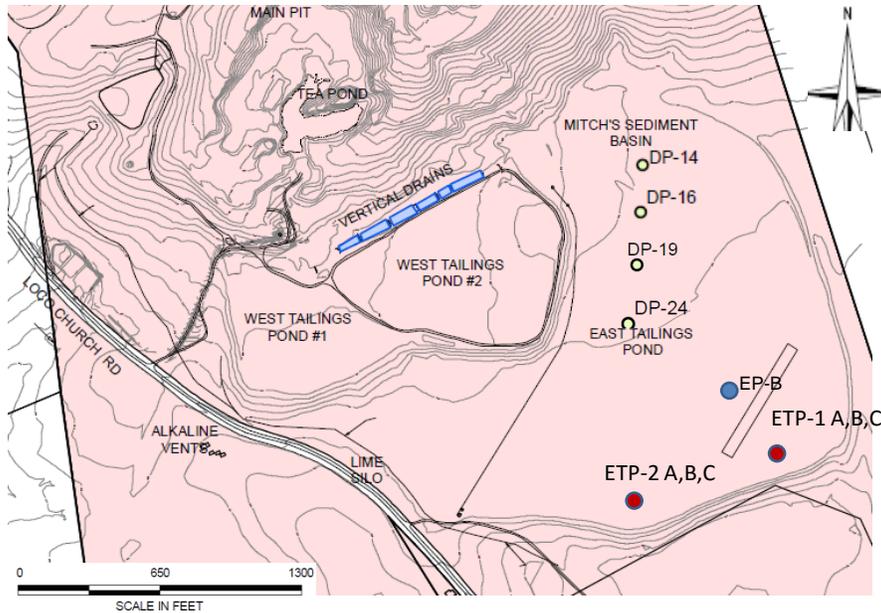
Figure 1. Location of ETP wells (red) and EP peizometers (blue) in East Tailings Pond. (DP locations, used to determine depth of tailings and water level only, were bored by direct push methods)

screened, B was installed approximately one-half the depth from the surface to the base of the tailings with the bottom 1.6m (5ft) screened and the third (C), was installed about one-half the depth between B and the surface with the bottom 1.6m (5ft) screened. The configuration of the well locations as well as a cross section of the tailings pond showing the maximum depth of the tailings are shown in Figs. 1 and 2.

At approximately the same time as the installation of well clusters ETP-1 and ETP-2, seventeen borings were completed in the northern half and in western portion of the ETP. These borings were installed by direct push (DP) technology and were used to identify the depth of the interface between the tailings and the clay layer below the tailings. These borings are labeled as “DP-##” in Fig. 1.

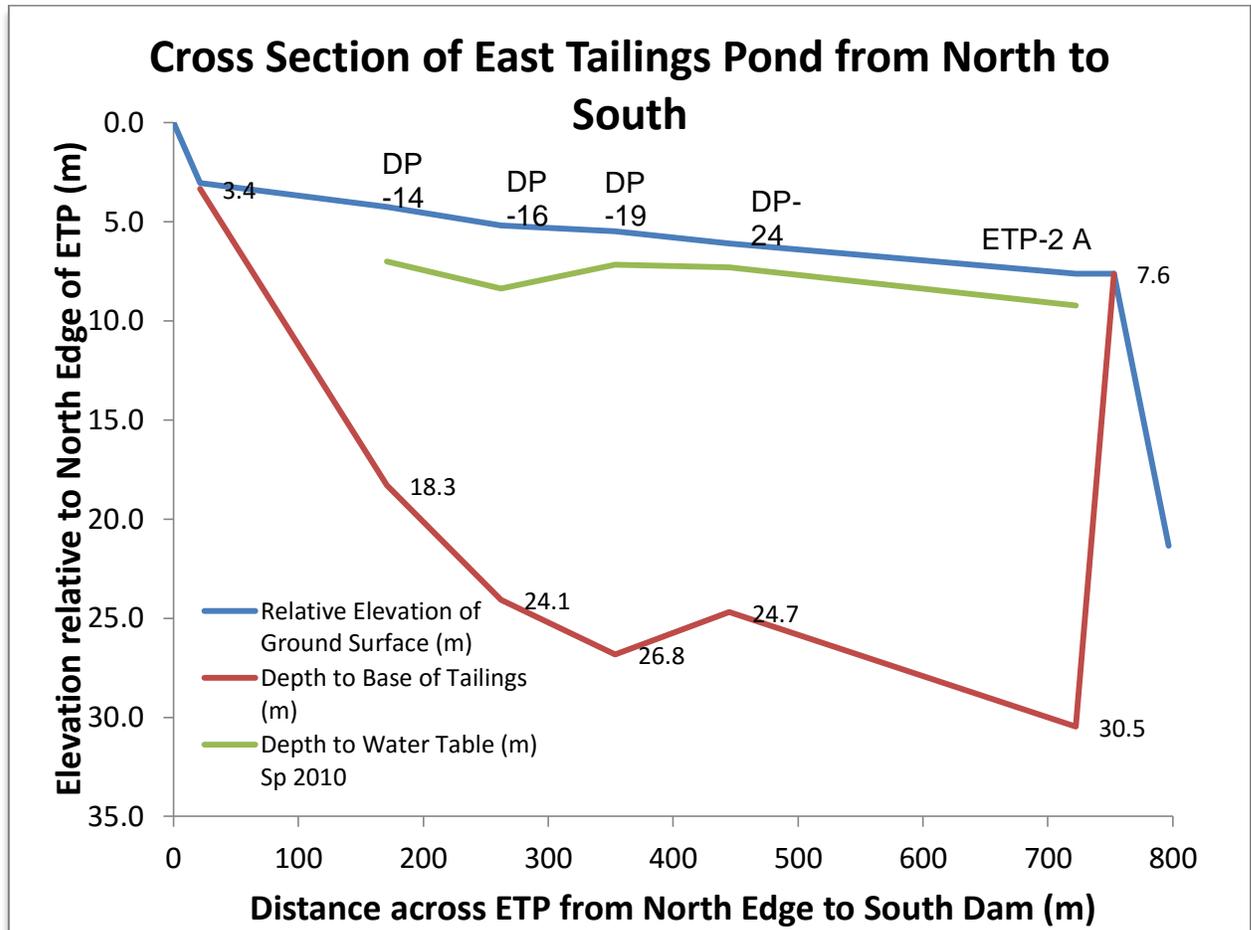
Figure 2. Cross section of East Tailings Pond showing depth of tailings, water level and surface elevation.

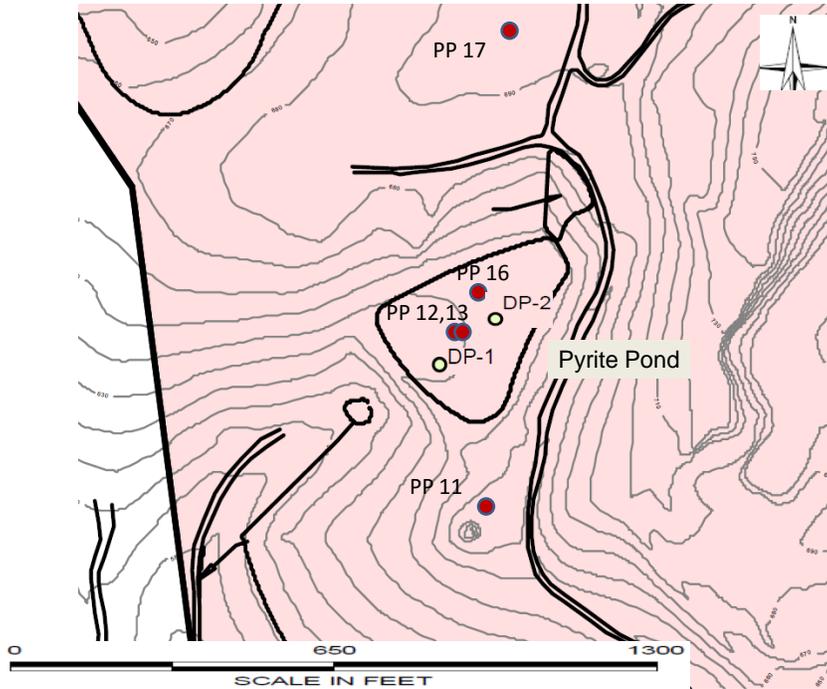
Figure 3. Topographic map of Pyrite Pond tailings pond and locations of wells and borings.

In the Spring of 2010, two additional borings (DP-1 and -2) were completed in the tailings pond to provide additional data on the depth of the tailings within the pond and depths to saturation. The locations of the wells and borings are shown in Fig. 3 and cross sections of the PP are shown in Fig. 4A and 4B. Figure 4A represents the data from the southeastern side and the most shallow borings while 4B shows both the deeper wells as well as the shallow borings.

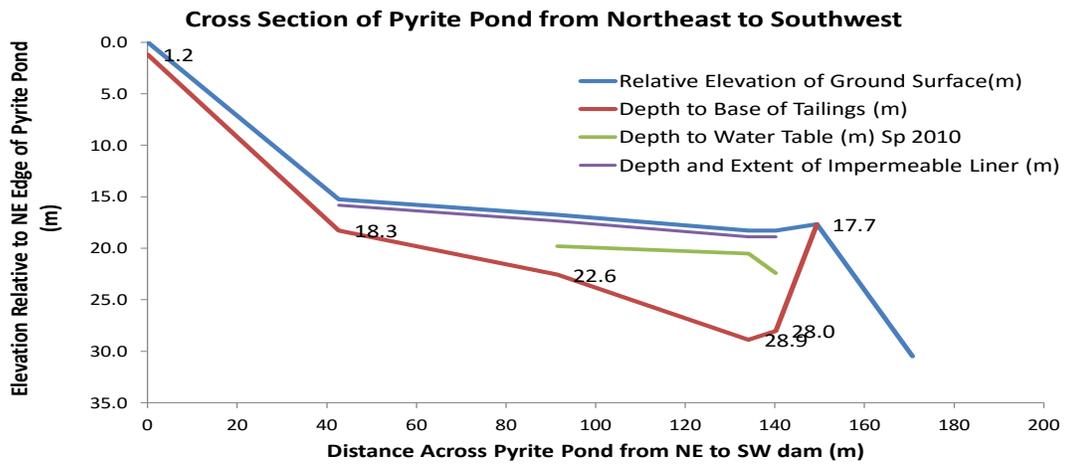
Figure 4A. Cross section of Pyrite Pond from NE to below dam to SW, based on DP-1, DP-2, and PP-12 through the eastern side of the tailings pond.

As depicted in Fig. 4A and 4B, the impermeable liner may allow some seepage of surface water and ground water, especially from the upslope direction. Even with the liner covered on the edge with a trench 0.6m (2ft) deep, this may not prevent water flowing at the interface of the tailings and the base slope from entering beneath the liner and continuing to feed the tailings. The amount of direct precipitation infiltration over the 0.8 ha (2a), however, may have been substantially diminished.

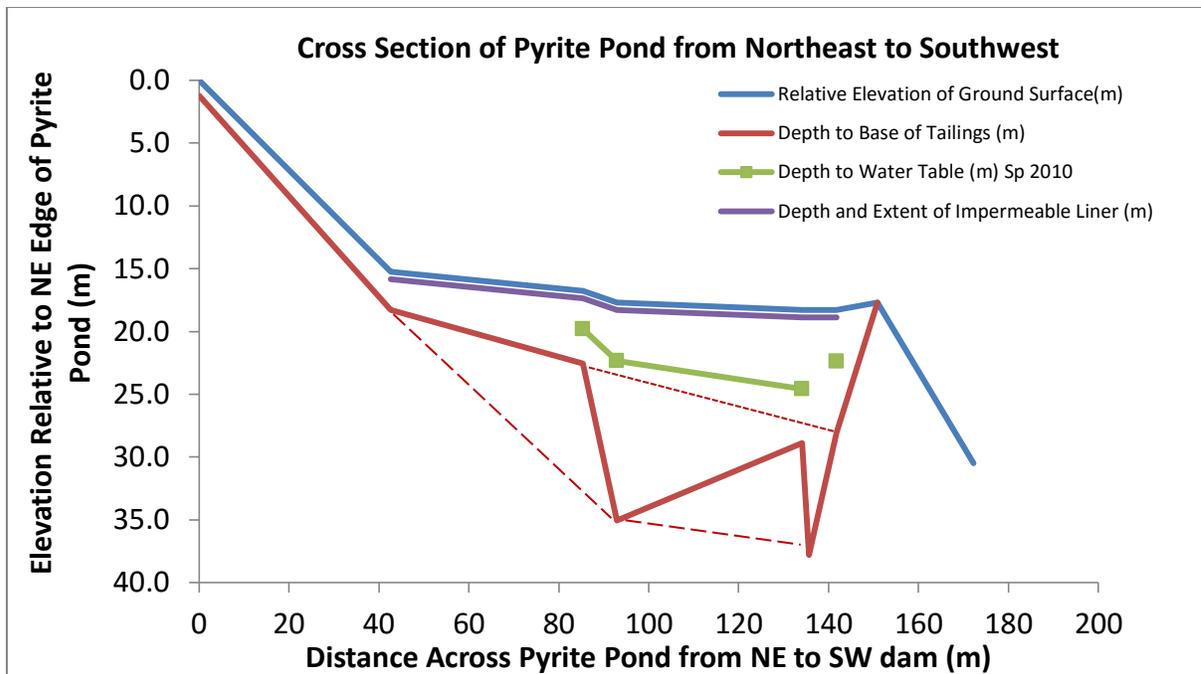
Figure 4B. Cross section of Pyrite Pond. (dotted lines are data from southeastern side of pond and dashed line represents data from center of pond)

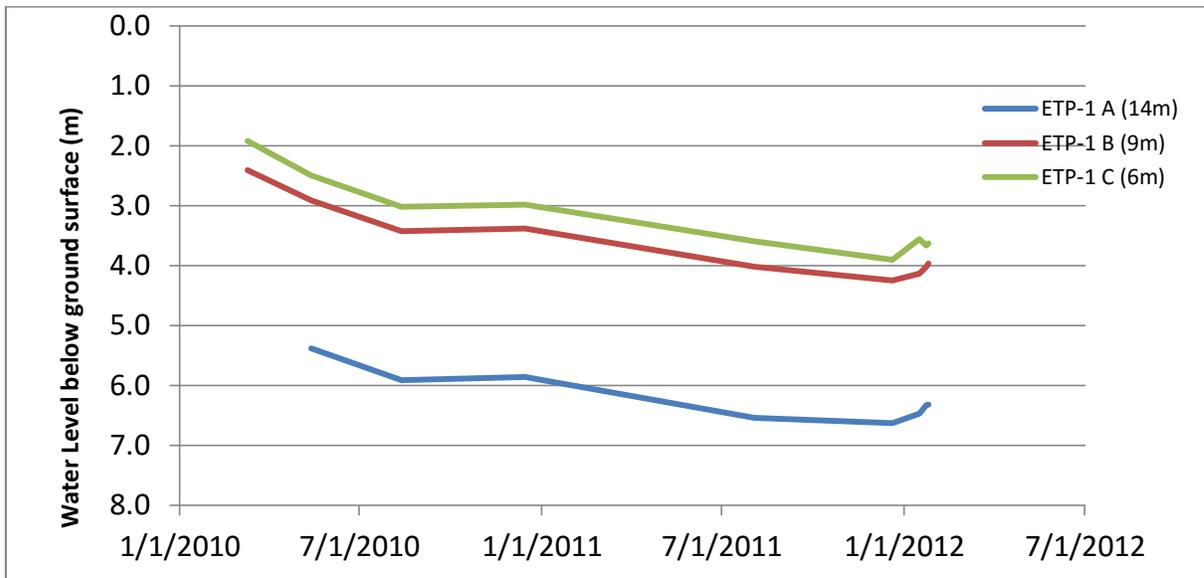
Figure 5. Depth to water level (bgs (m)) in ETP-1 A, B, and C.

C (to depths of 14, 9 and 6m) was sampled intermittently between 2010 and 2012. The variations in water elevations are presented in Fig. 5.

Because these wells were screened and completed at 3m and 1.6m intervals from the base of the hole, the variation in water level elevation is a reflection of the potentiometric surface at that location. Therefore, while each of the wells has a very similar trend ($R^2 > 0.95$ between each set of values), the levels reflect the water pressure at that point. Given the relatively shallow nature of the tailings (14 to 6m) the differences suggest that the tailing deposition process and the fine nature of the tailings allow for stratification and that a number of perched layers may exist within the tailings. Well ETP-1 C, completed and screened from 4.5 to 6 m and, therefore, closest to the surface, most likely reflects the water table.

The water level variations were compared to rainfall during a similar time period and it appears that a delay exists between rainfall events and increases in water level, even in the shallower (ETP-1 C) well. Based on the late 2010 data and Dec 2011/Jan 2012 data, the delay may be on the order of 3 to 4 months. Figure 6 provides rainfall data during this time period. Specifically, the beginning increases in water levels in late December 2011 and January 2012 most likely relate to higher rainfall during October 2011. This delay is most likely attributed to the infiltration through soil moisture and to the water table, however, given the location of the

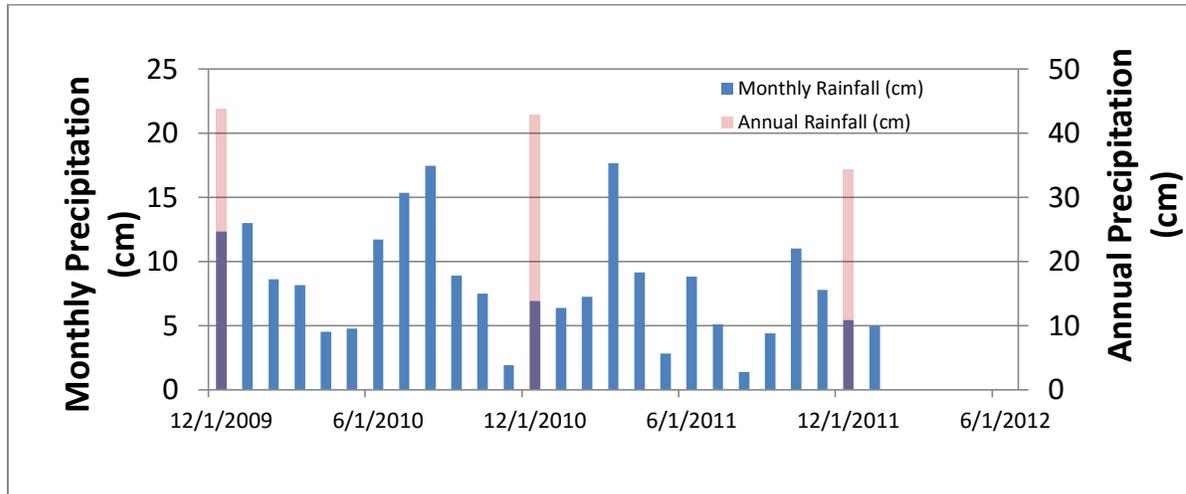
Figure 6. Monthly and annual rainfall at the Graves Mountain site.

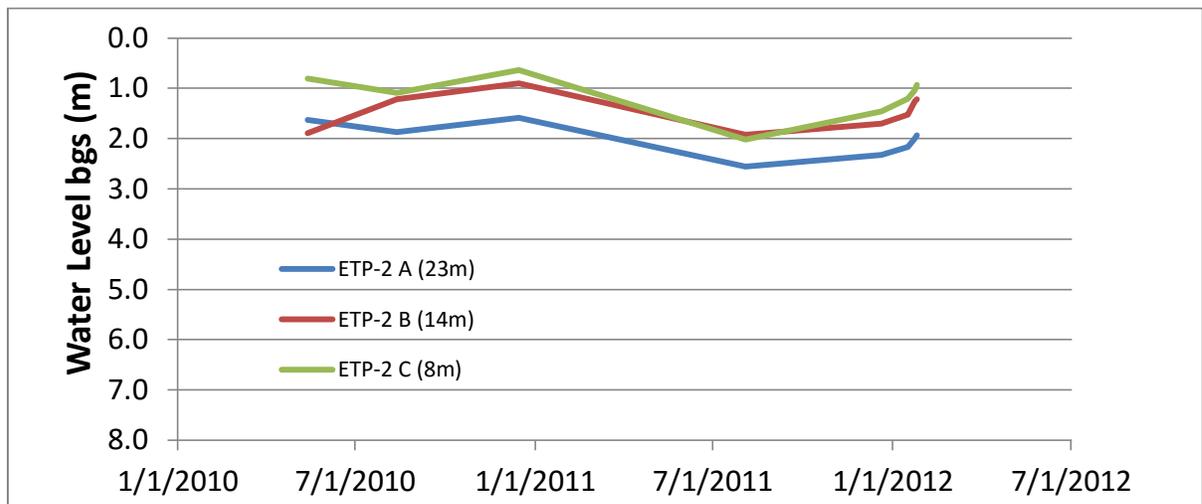
Figure 7. Depth to water level (bgs (m)) in ETP-2 A, B, and C.

As shown in Fig. 7, the ETP-2 A, B, C wells exhibited much less variation in water levels when compared to the shallower well set, ETP-1. Similarly, the deepest well also showed the greatest depth of water, albeit much less difference than in the shallow wells.

These wells also exhibit a similar increase in water levels in late 2011 as seen in ETP-1 wells, although the increases elevate the water levels to nearly the 2010 data, while the elevations in ETP-1 are still significantly below the 2010 water level measurements. This is

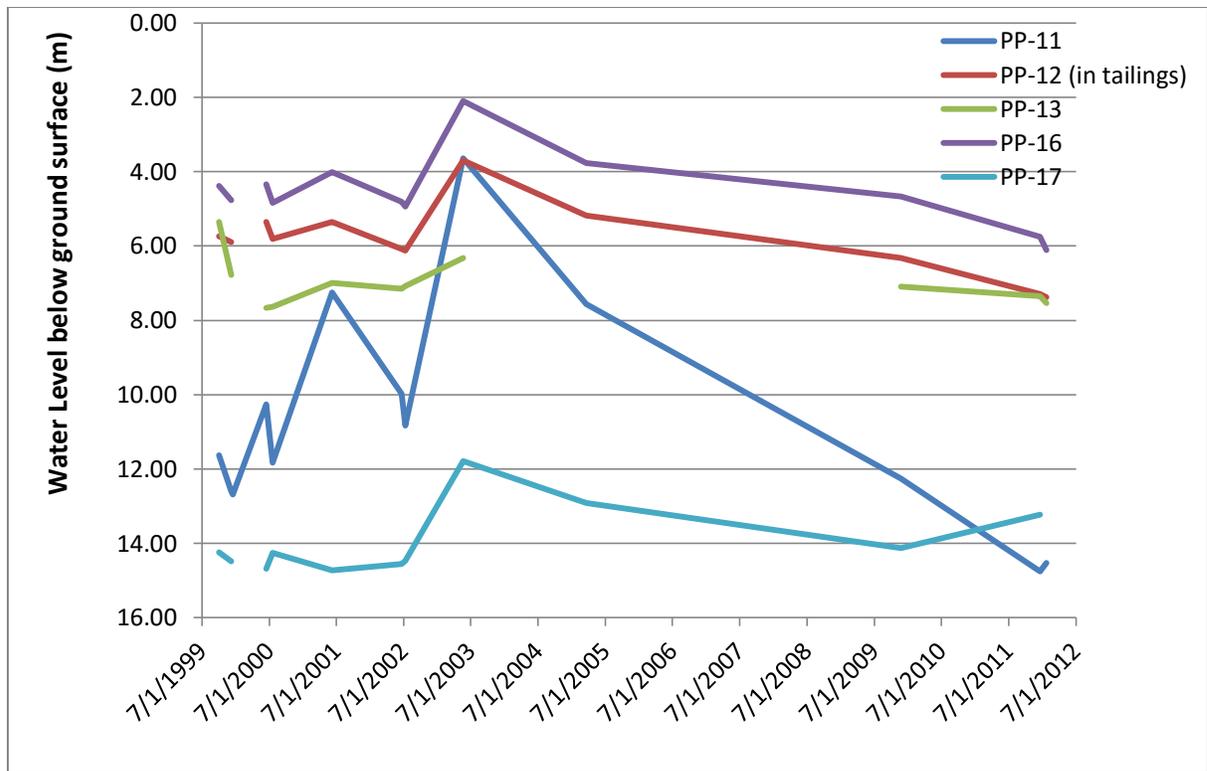
Figure 8. Water level measurements of Pyrite Pond wells.

Water level measurements from the wells in the Pyrite Pond sub-drainage basin have been intermittently collected since 1999. Measurements from Wells PP-11 and PP-17 represent water levels in sections of the site which were not mined. Well PP-11, is located south of the Pyrite Pond and was drilled into undisturbed quartzite to a depth of 25 m (81ft), the depth at which water was first encountered, but which quickly rose in the well bore to approximately 12m below ground surface (bgs). Well PP-17 is located on the drainage divide between the Pyrite Pond water shed and the watershed draining towards the north. The well was drilled to 61.3 m (200ft) at which depth water was first encountered. The wells were developed and purged. The water levels in the wells, representing the potentiometric surface of the screened interval (the bottom 1.6m (5ft)), have been monitored and the data are presented in Fig. 8. The wells generally show increased water levels in 2003 and decreasing water levels since then with the exception of PP-17 which indicates a slight increase in recent years. Well PP-11 exhibits the greatest variation in water levels and suggests that the rock may be fractured.

Wells PP-11 and PP-17, provide background against which changes in water levels within the tailings pond can be evaluated. The similarity in water levels elevations between PP-12 and PP-16 is striking; although there is an average percent difference between PP-12 and 16 of 23%, a strong relationship exists between the water levels in the two wells ($R^2 = 0.9538$). Well PP-13 had difficulties during drilling and installation and the screen may have become clogged with bentonite. Although the well was pumped and multiple attempts were made to develop it, white clay continues to be discharged during pumping and may impact water levels as well. However, PP-12 and PP-13 are in close proximity (about 3m apart) and the well casings are surrounded by water which is consistently 10 to 20 cm in depth even during very dry periods. The water levels in the wells, however, do not reflect water at the surface which reinforces the integrity of the

impermeable liner to prevent surface inflow. Given the concerns with PP-13, while the water levels are provided in the figure, they were not used in this study.

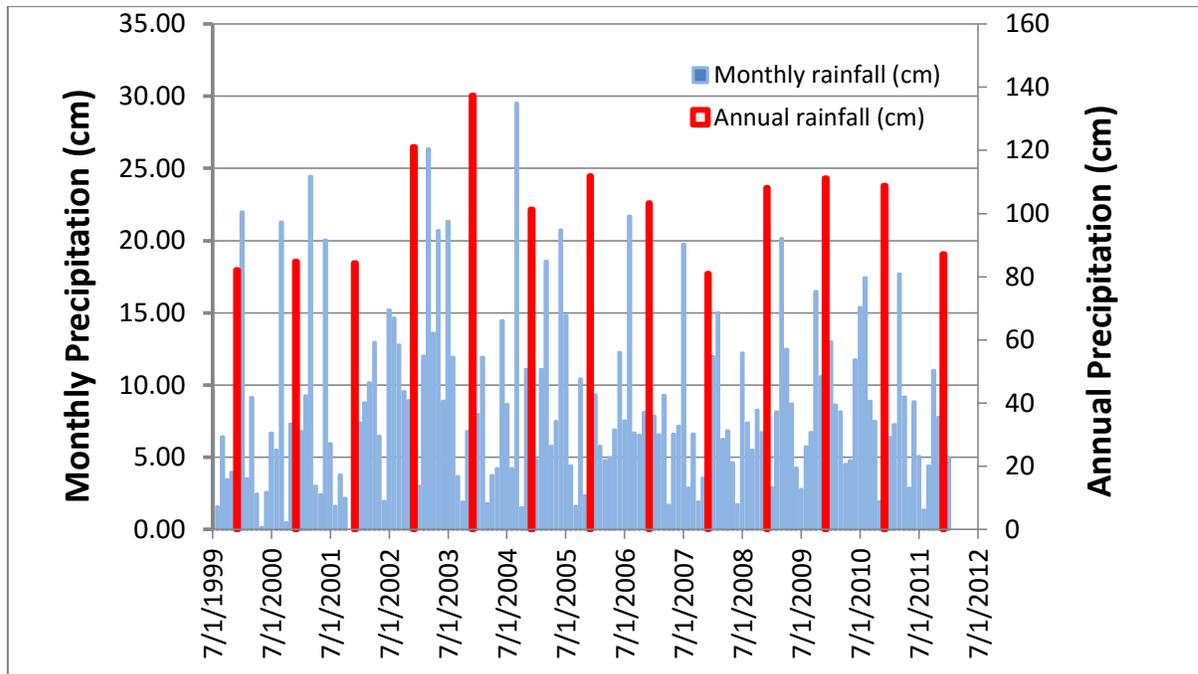
Figure 9. Rainfall at the Graves Mountain site from 1999 to 2012.

Comparing rainfall data in Fig. 9 with PP-11, suggests that ground water elevations at this location respond to precipitation. Due to PP-17’s depth, it appears to respond more slowly and subtly to precipitation events, however, it responded to the increased precipitation in 2003 as did the others.
