# Federal Agency Benefit Analysis of a Reclamation Monitoring Tool for Abandoned Mine Lands

## Abandoned Mine Lands Post-Remediation Assessment Protocols and Handbook Version 5

# Abandoned Mine Lands Post-Remediation Assessment Protocols and Handbook

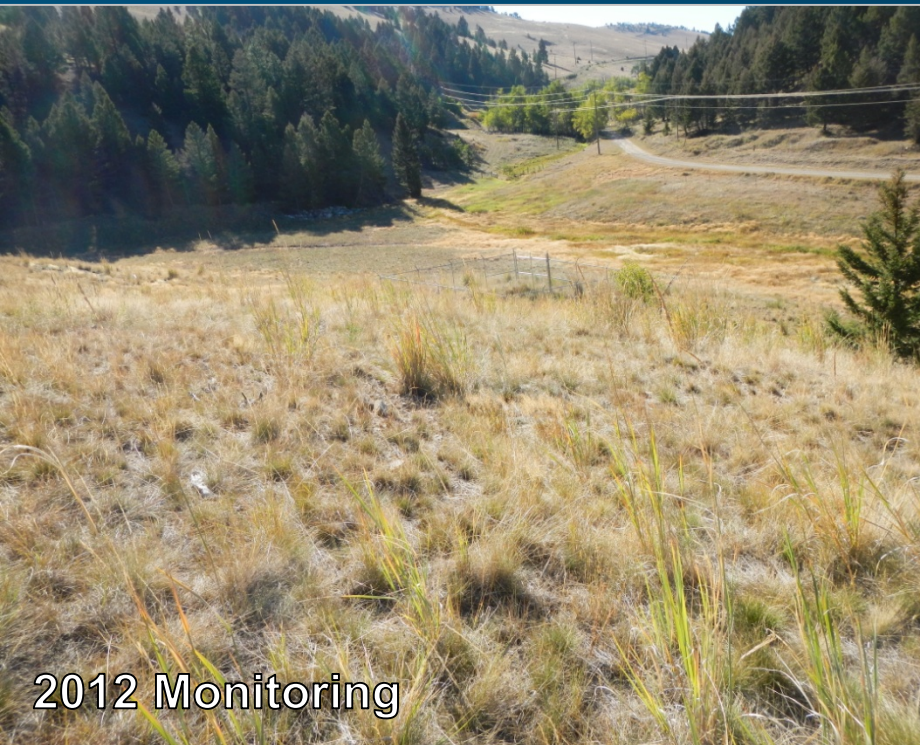
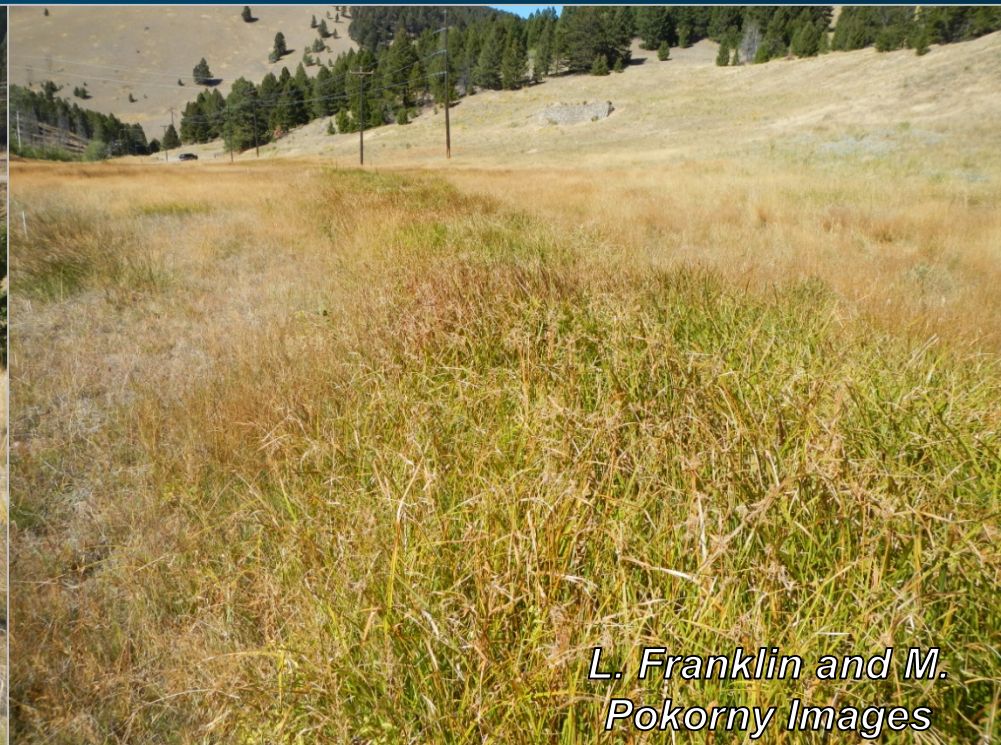
Gregory Mine and Mill,  
Gregory Creek, Montana  
(BLM and MT DEQ AML)

Historic  
Mining

2012 Monitoring

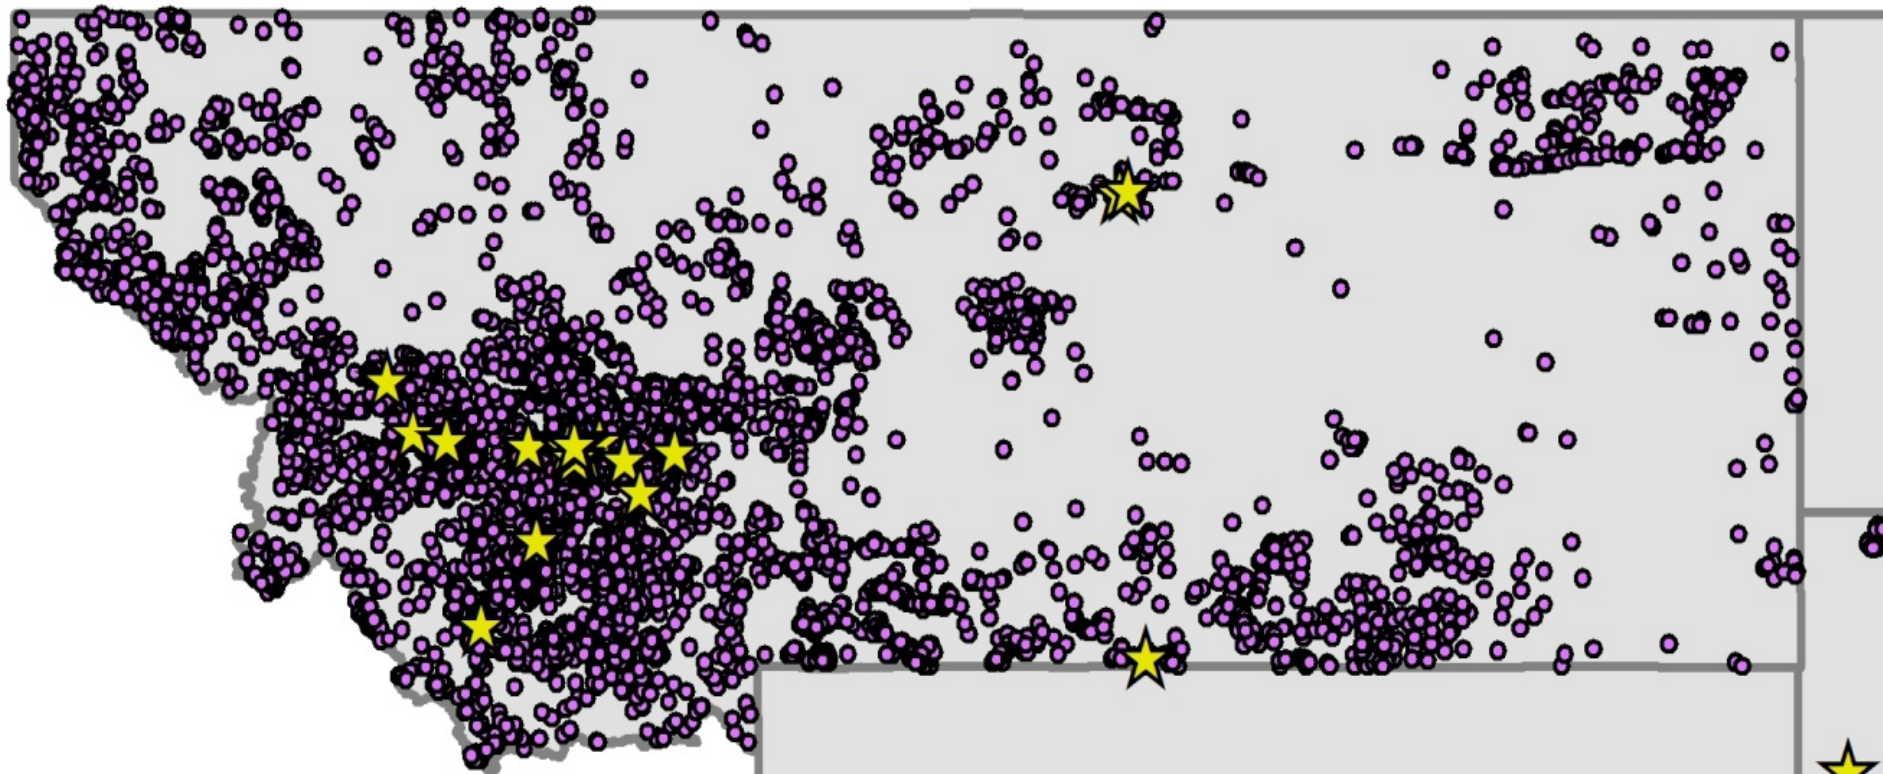
# Mines Monitored using the Monitoring Handbook

## AML Hardrock Mine or Mine and Mill Sites Monitored:

2012 (KCH/RRG) – (2 BLM)
