# THE BUNKER HILL HILLSIDES: A CASE STUDY IN THE USE OF ADAPTIVE MANAGEMENT IN EARLY SUCCESSIONAL RESTORATION ON THE NATION'S LARGEST SUPERFUND SITE<sup>1</sup>

Timothy A. White<sup>2</sup>, Carmela L. Grandinetti, Stephen D. Miller, Timothy B. Hill, Dennis L. Mengel, and Shane M. Waechter

Proceedings America Society of Mining and Reclamation, 2003 pp 1472-1500 DOI: 10.21000/JASMR03011472

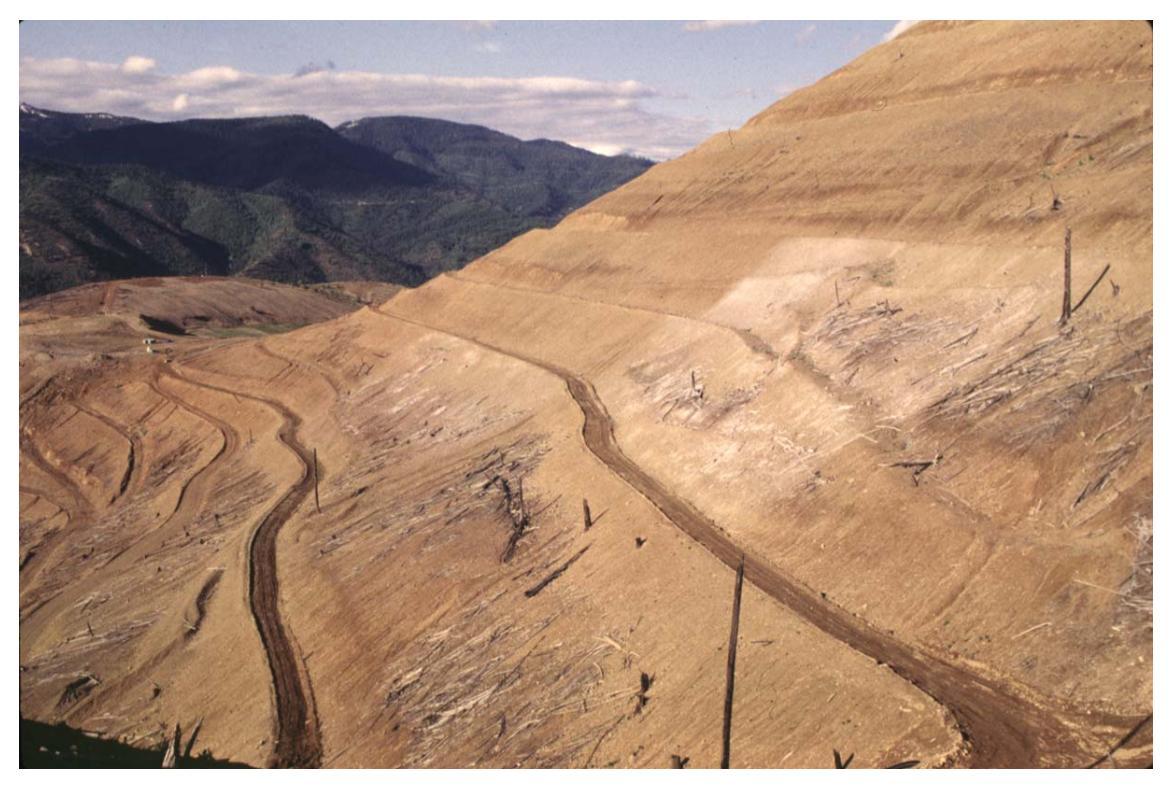
Figure 1. Pre-treatment hillsides environment in Government Gulch. Note construction of terrace benches spaced approximately 30 m apart. Steep slopes, exceeding 30 degrees (58 percent) and extending to over 500 meters in many places, dominate the site. Combined with extensive soil erosion, acidic reaction, and even steeper cut and fill slopes, the hillsides landscape is a difficult restoration challenge (photo taken in 1997).

The ultimate goal for the Bunker Hill hillsides is to return them to a coniferous forest ecosystem similar to that found elsewhere in northern Idaho. However, retention of soil resources is a first priority in restoration projects of this type and of critical importance to meeting the directives of Superfund projects. Loss of soil results in reduced site productivity and a concomitant narrowing of potentially successful restoration trajectories. The high degree to which soil resources had previously been depleted on the hillsides (Figure 1) dictated a critical need to focus on this initial target.

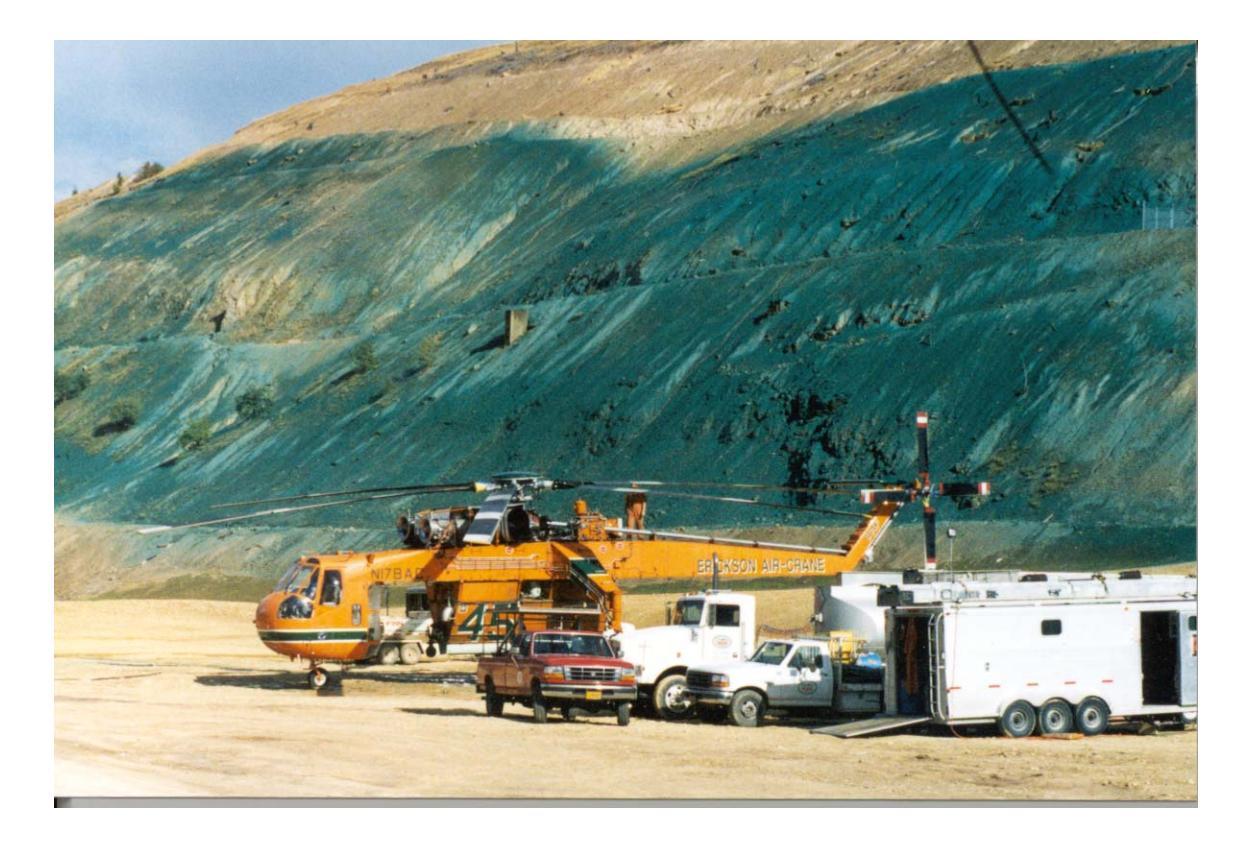
Figure 2. Steep slopes and poor access resulted in the use of aerial application techniques on the hillsides. Sikorski helicopters were used to apply most of the hillsides prescriptions. Although per hour costs are high, application rates were much higher than with other air frames and per hectare application costs were effective. Note hydroseed materials on background slopes.

Seeding activities occurred in 1998, 1999, 2000, and 2001. TriState Hydroseeding, Inc. of Kingston, ID implemented the revegetation program. Three primary work items were: 1) application of lime, 2) application of hydroseed mixtures, and 3) planting of trees and shrubs. TriState applied lime and hydroseed mixtures primarily from the air using Sikorski helicopters (Figure 2). This aircraft has an approximate payload of 10 tons. In combination with a proprietary mixing and pumping unit developed by TriState Hydroseeding, Inc., the helicopter arrived at the staging area, acquired and delivered its payload, and returned to the staging area for another load, on average, in approximately 3 minutes. Each sortie resulted in the application of materials across approximately 0.13 ha. Thus, the high hourly cost of the aircraft was offset by its high productivity (Figure 2).

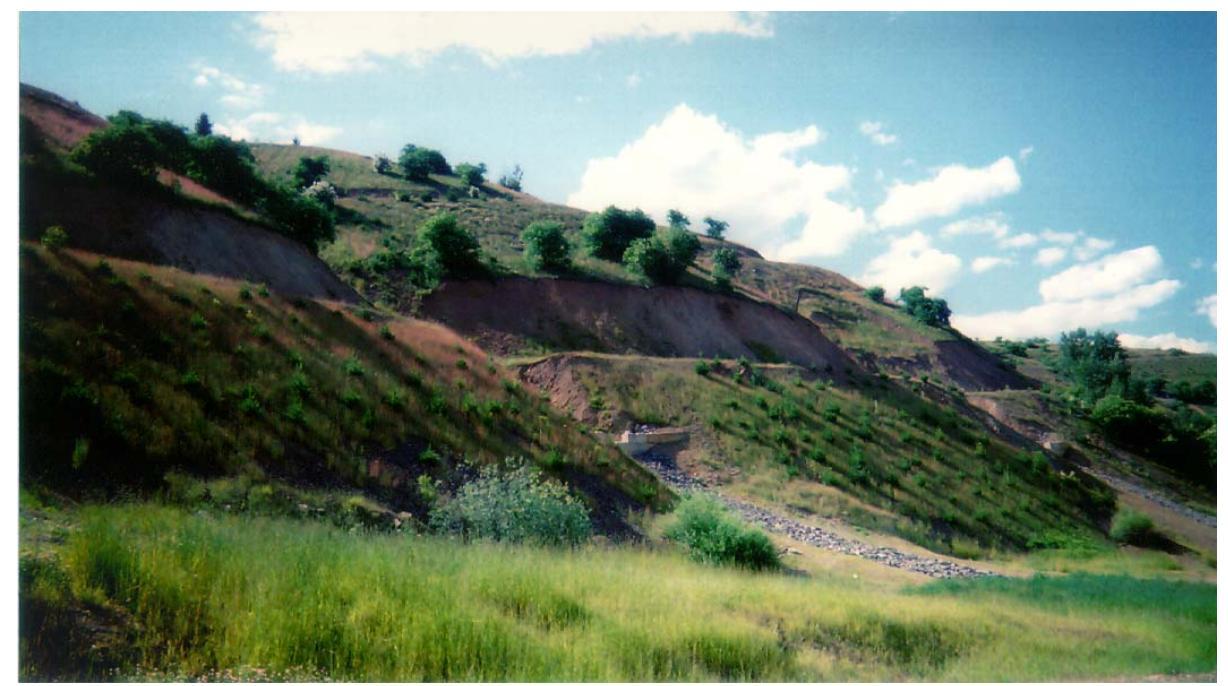
Figure 3. Early results of revegetation in Government Gulch several years after treatment application are promising. Vegetation concentrates in concavities and flatter slopes and gradually migrates to drier convex areas. The vertical faces of cut slopes make it difficult to stick restoration materials to them and so they remain largely unvegetated. Fill slopes are also problematic, but less so than cut slopes. Elsewhere, seeded vegetation is growing vigorously and previously planted trees are responding well. Photo also illustrates check dam installation in a major gully.

<u>Areas seeded in 1998.</u> Three-year results for areas seeded in 1998 are encouraging (Figure 3; Table 3). Eighty-eight percent of the hillsides area seeded in 1998 has met or exceeded revegetation cover goals. The greatest cover falls within Class 3. Overall, 62 percent of the seeded area (55.4 ha) contains Class 3 cover levels and another 26 percent (22.8 ha) has over 75 percent cover (Class 4). Meanwhile, 12 percent of the land area seeded in 1998 (10.8 ha) has less than 50 percent cover, 5.5 ha of which is Class 1. Thus, a total of 78.2 ha (88 percent) of the total land area seeded in 1998 contained 50 percent or greater cover by the early summer of 2001. This represents a 4 percent increase from levels found in 2000.

<u>Trend Analysis</u>. Using the project GIS, we compared plant cover measured during 2000 (areas seeded in 1998) to that measured during 2001 and described polygons where differences arose. This results in a geographically referenced estimate of trends in vegetative cover for these areas (Figure 4)<sup>1</sup>. Most of the seeded area has stable cover levels. Where cover class changes have occurred, east-facing slopes appear to be improving in cover, while west-facing slopes appear to be decreasing in plant cover. Approximately 12.5 ha of cover measured in 2001 shifted upward compared to similar measures in 2000. East-facing slopes of Government Gulch showed improvements in this regard, as did large areas on east-facing slopes of Deadwood Gulch. In general, Government Gulch east-facing slopes increased to Class 4, and Deadwood Gulch east-facing slopes increased from either Class 1 to Class 2 or Class 3 to Class 4. Steep cut-slopes have low cover values irrespective of gulch or aspect (Figure 3).

In large part (with some exceptions noted below), plant cover on areas seeded in 1998 and 1999 met performance goals (Figure 3; Tables 3 and 4). The overall condition of 2-year or older vegetation on the hillsides is illustrated by combining data from 1998-seeded and 1999-seeded polygons (Table 3). In combination, approximately 27 percent of the area seeded in 1998 and 1999 has less than 50 percent cover, with the remaining 63 percent achieving project performance standards. Of the 64.8 ha not meeting project standards, most the area contained at least 25 percent cover, with only 7.7 ha (3 percent of the total treated area) containing less than this amount of cover.

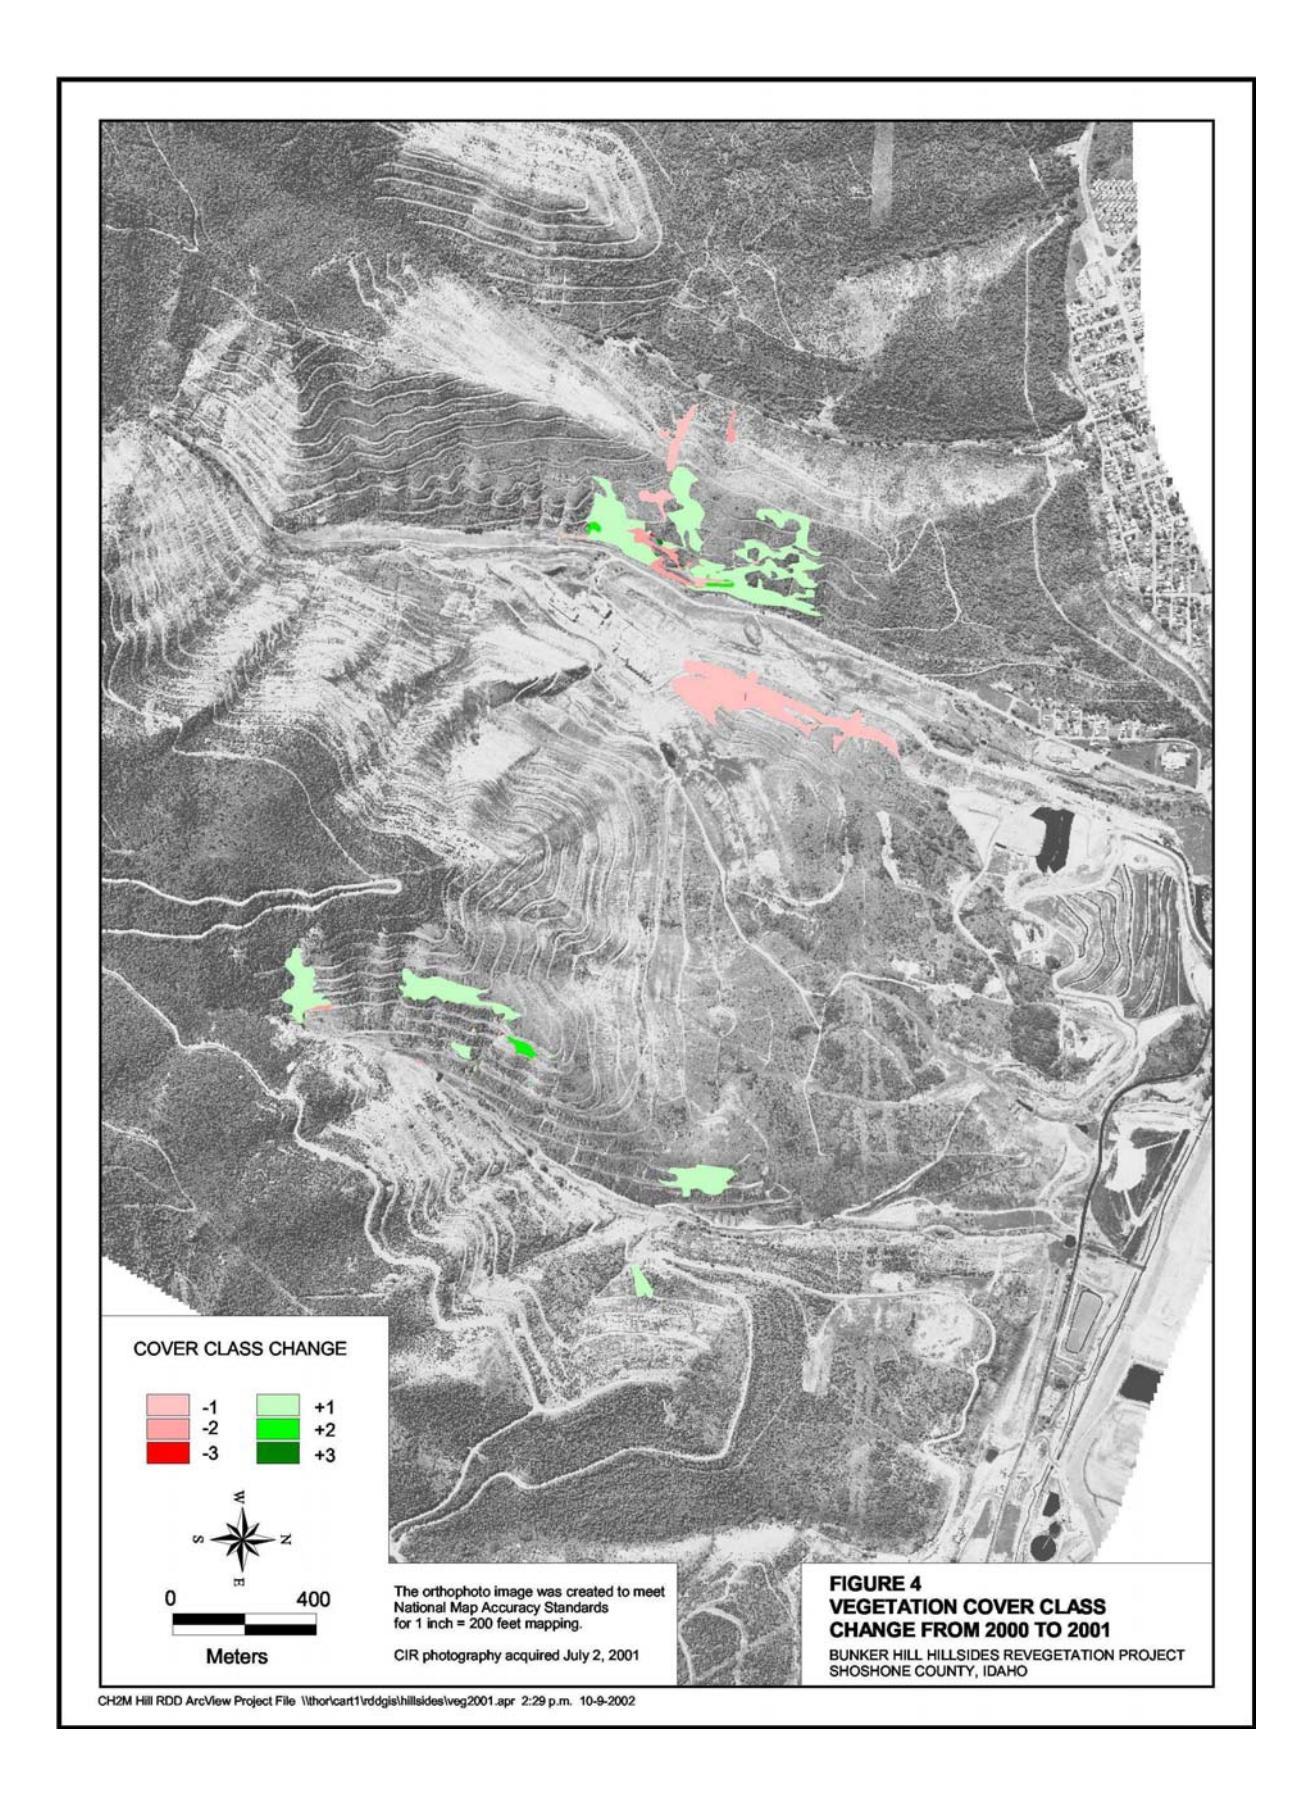
In contrast, about 4.6 ha on the west-facing slope of Government Gulch decreased an average of one cover class between 2000 and 2001. Much of this area decreased from Class 4 to Class 3 and so, despite a drop in cover class, a substantial amount of plant cover remains on the site. Moving south along the hillsides facing toward the old industrial stacks location, however, more and more area shows a downward trend from Class 2 to Class 1 (Figure 4).

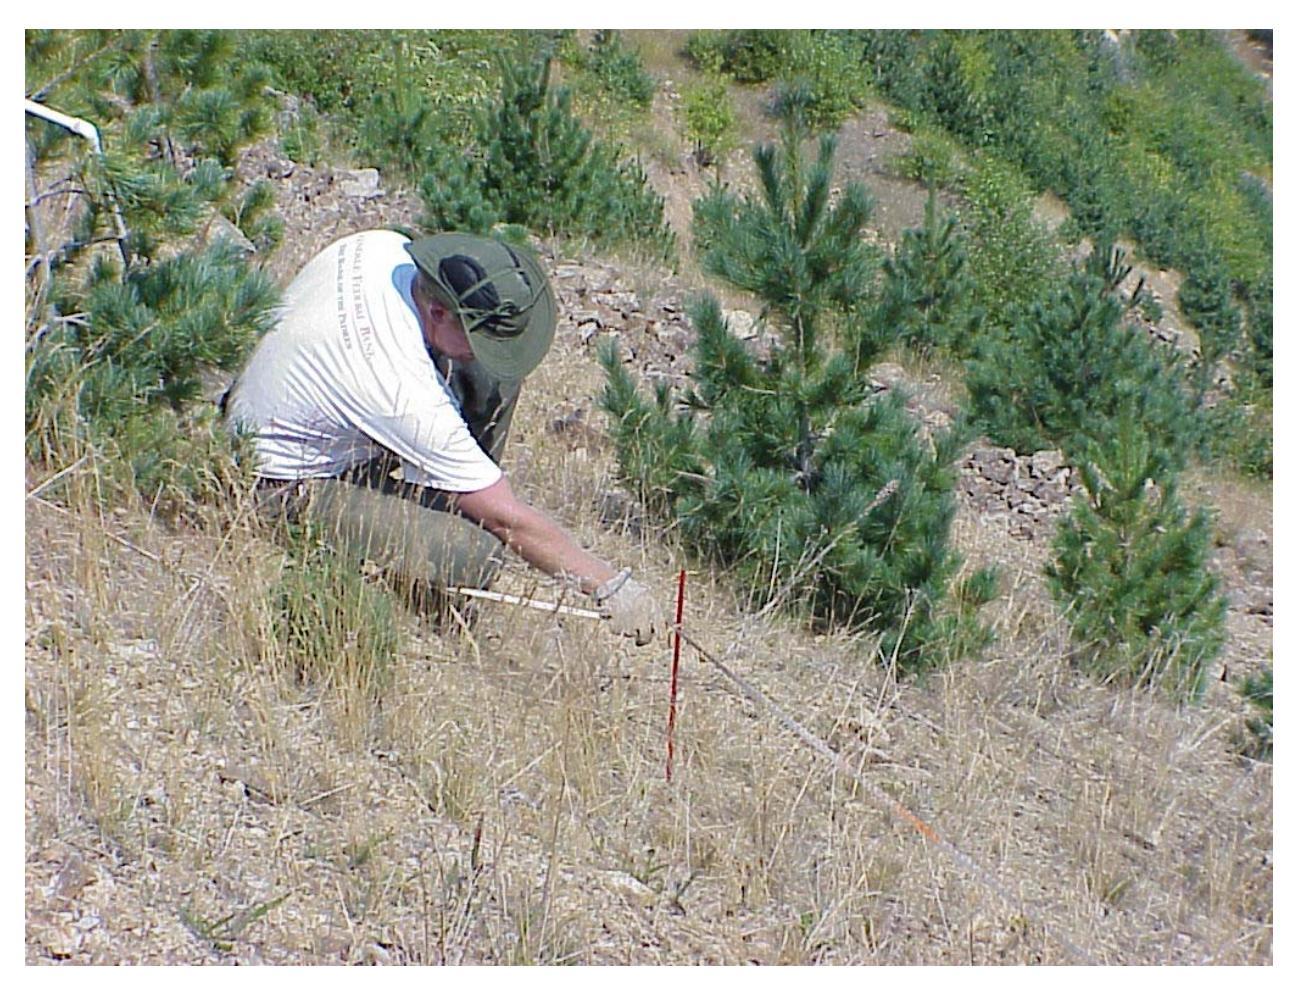
Figure 5. Fixed radius plots were established in low-cover areas and located by measuring distance and bearing from hillside landmarks and acquiring latitude-longitude coordinates using hand-held GPS. Readers should note that summer droughts produce annual die-back of vegetation bracketed by more vigorous growth during cooler portions of the growing season in the spring and fall. Note growth responses to soil amendments by western white pine saplings in the background.

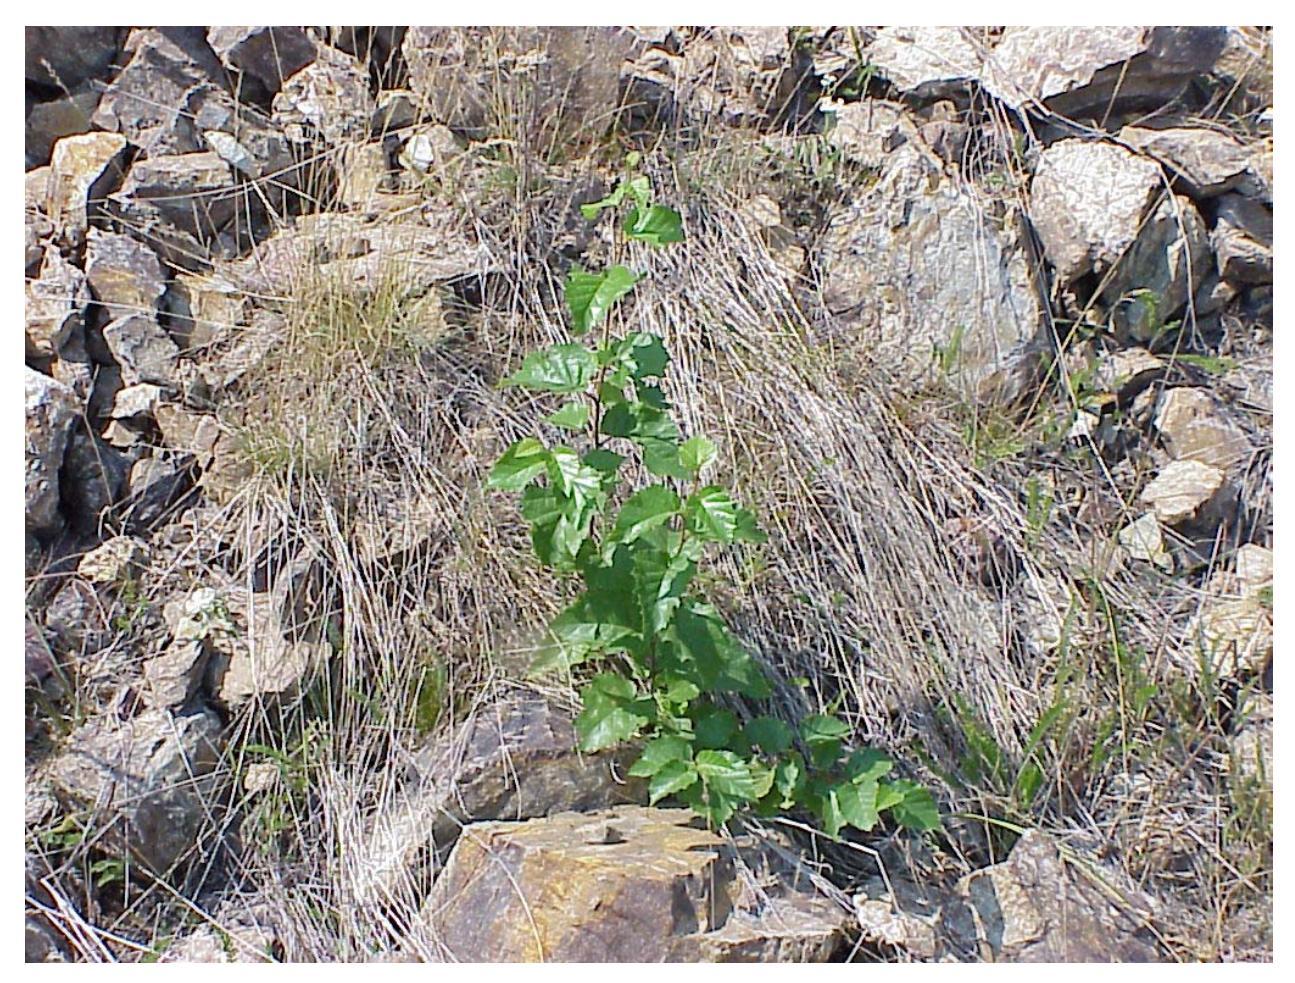
Figure 6. Deadwood High Elevation Alder Volunteer. Volunteer species continue to invade post-treatment hillsides. Here, an alder (*Alnus* sp.) seedling emerges from a largely rocky substrate along east aspects of Deadwood Gulch. Other volunteer species include ceanothus, fireweed, mountain snowberry, Rocky Mountain maple, Oregon grape, alder, gooseberry, raspberry, pachistima, and several coniferous species whose seed has migrated from higher slopes onto lower benches now more supportive of plant growth.

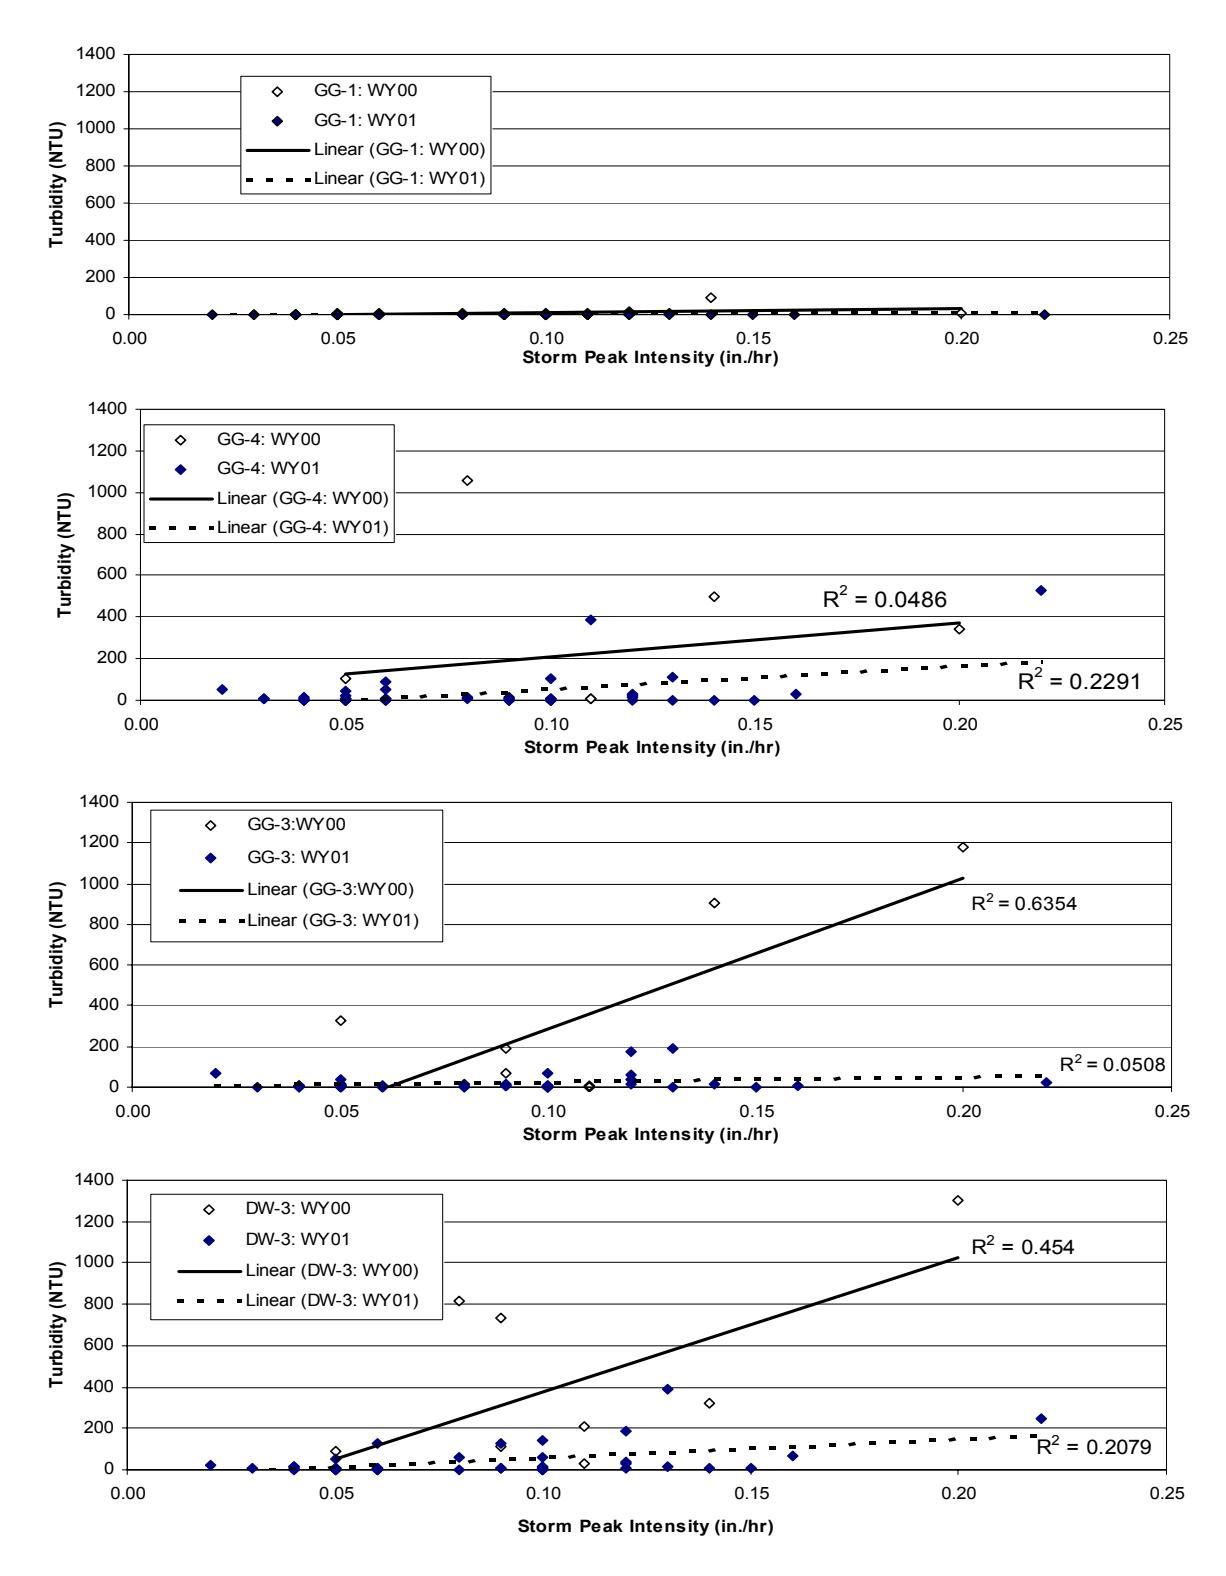
Figure 7. Storm peak intensity versus maximum hourly average turbidity. GG-1 = Government Gulch reference station; GG-3 = mouth of Government Gulch; GG-4 = Government Gulch interior station; DW-3 = mouth of Deadwood Gulch.

Two important results of hillsides vegetation are apparent. First, a substantial reduction in turbidity occurred from year 2000 to year 2001 for any level of storm intensity. Second, as storm intensity increases, the reduction in turbidity between the two water years also increases. The differences are most evident in downstream areas that are affected by runoff from previously denuded hillsides.

The difference in turbidity between the two water years is least evident, and probably not statistically significant, at reference station GG-1 (Government Gulch-1), where surface water turbidity is measured as the stream enters the hillside environment. The lack of difference at the GG-1 reference station, coupled with substantial differences elsewhere in the watershed, suggests that differences between the two water years were not the result of environmental factors ancillary to work occurring within the Government Gulch watershed, but resulted instead

from changes in watershed conditions between the GG-1 reference station and the mouth of Government Gulch.

The turbidity differences between 2000 and 2001 become progressively greater as turbidity is measured farther and farther downstream (compare differences from GG-1 to GG-4 to GG-3). This is to be expected because as one moves downstream from GG-1 to GG-3, more of the previously denuded landscape contributes to a turbidity reading, and the opportunity for greater turbidity increases accordingly. Only one station is currently established within Deadwood Gulch (at its mouth), but changes in turbidity between water years appear consistent with those found in Government Gulch.
