MONTE CRISTO MINING AREA CERCLA REMOVAL ACTION

Presented by: Ryan Tobias – CES June 9, 2016

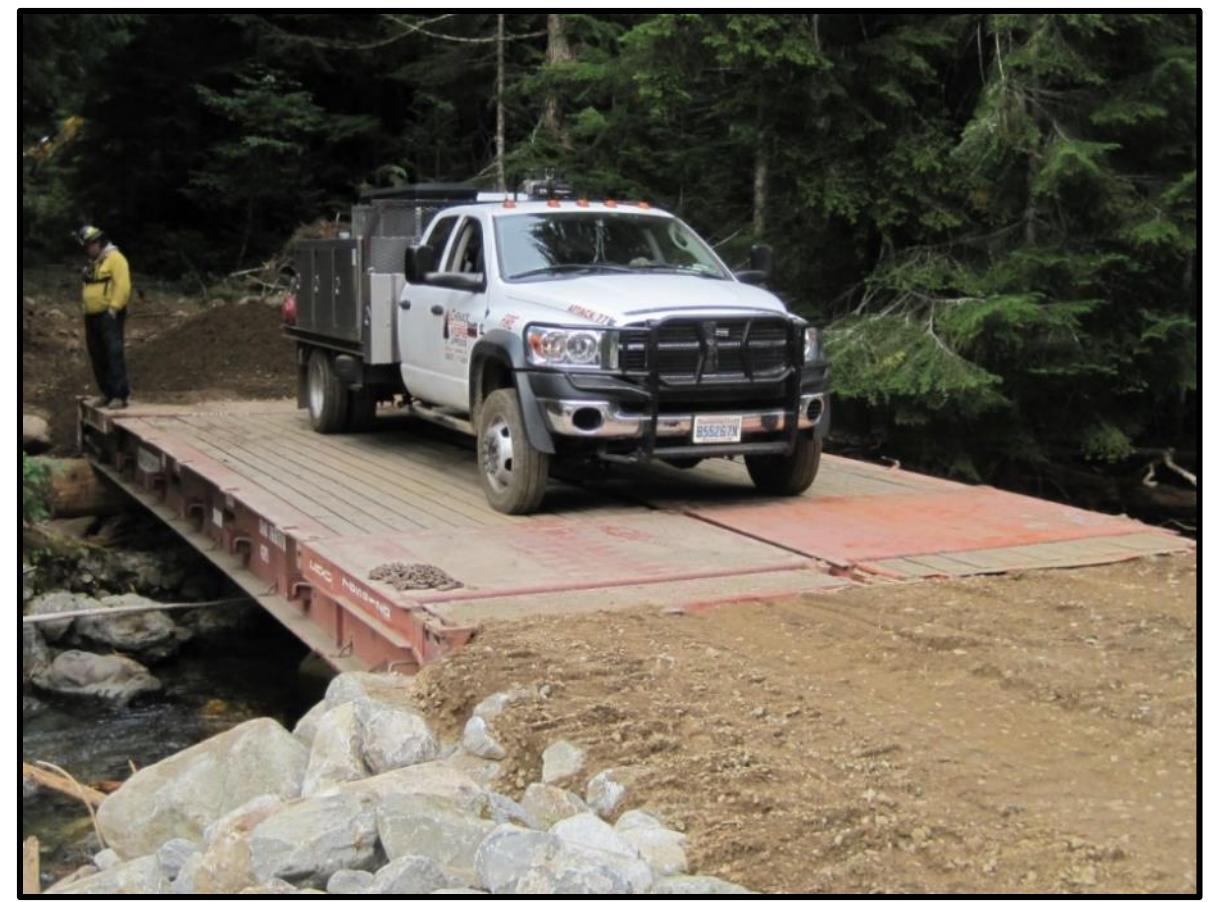
Temporary Glacier Creek Crossing

- Access to the Ore Collector, Comet Terminal, Assay
 Shack and
 Concentrator
- Removal by September 15 (Fish Window)

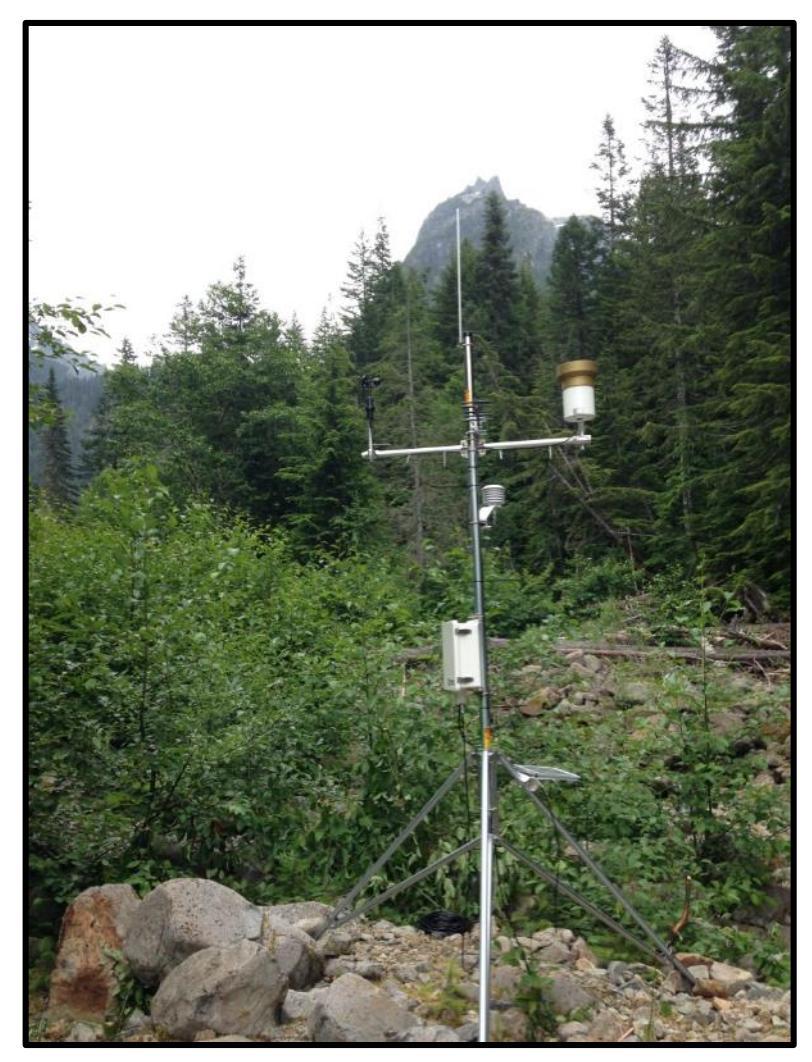
Weather Station

- Continuous Turbidity Log 300
 Feet Downstream of Bridge and Upstream from Rainy Mine (Background)
- Rain Gage, Temperature, Wind, Humidity, 7+ Inches of Rain Recorded over Labor Day Weekend
- Real Time Data for Tarp Deployment at Repository and Local Fire Managers

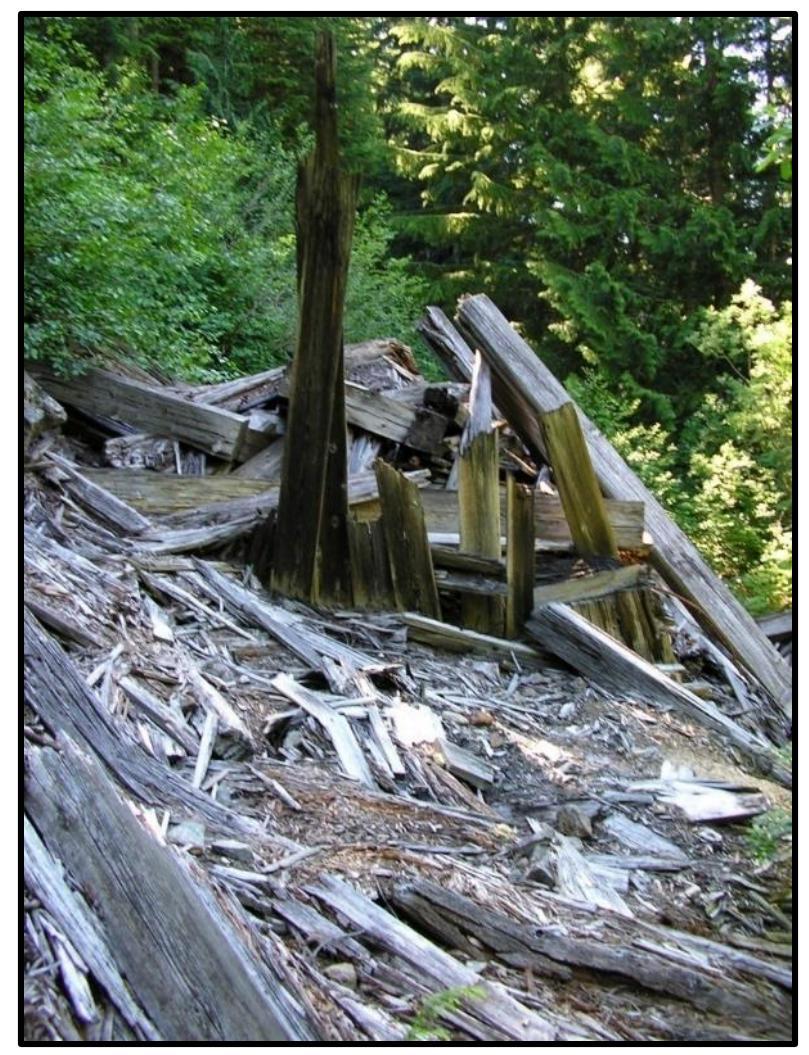
Ore Collector

- Located on Glacier Basin Trail
- Fine and Coarse Spilled Ore
 - As = 29,551 ppm (Avg)

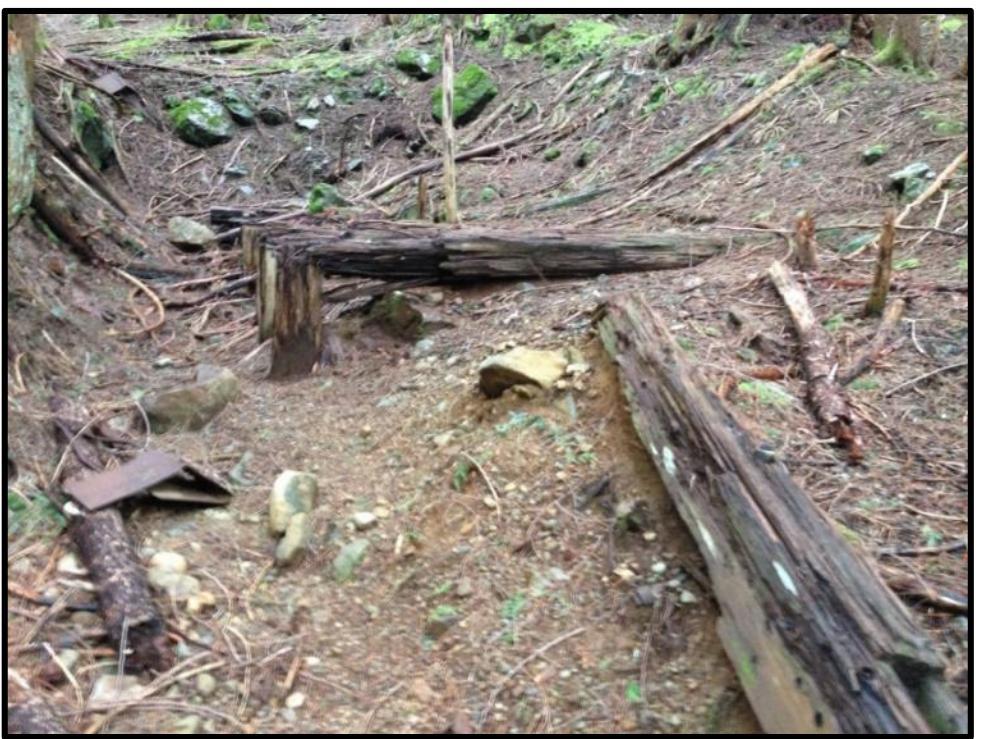
Comet Terminal

Ruins/spillage piles

- Located on Glacier Basin Trail
- Ore stockpiles/spillage piles (As up to 10%)

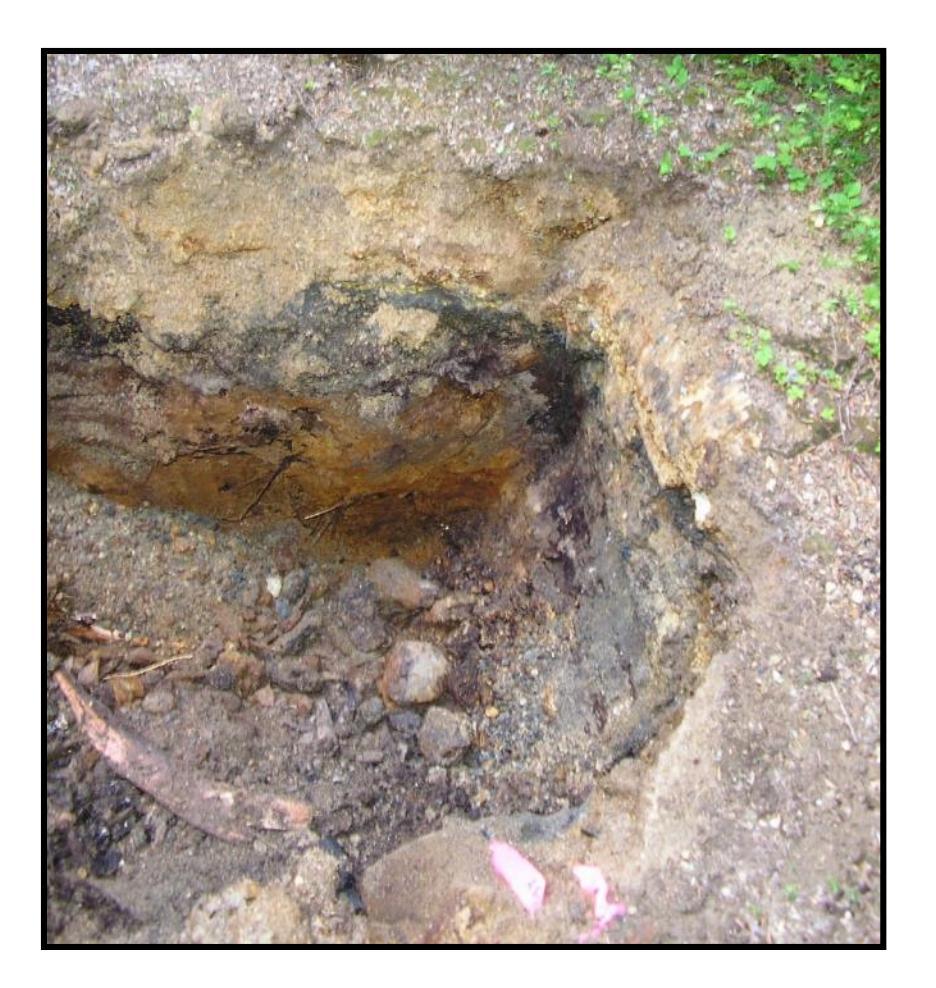
Assay Shack

- Ruins Present
- Significant Archaeological Features
 - As = 36,400 ppm (Avg)

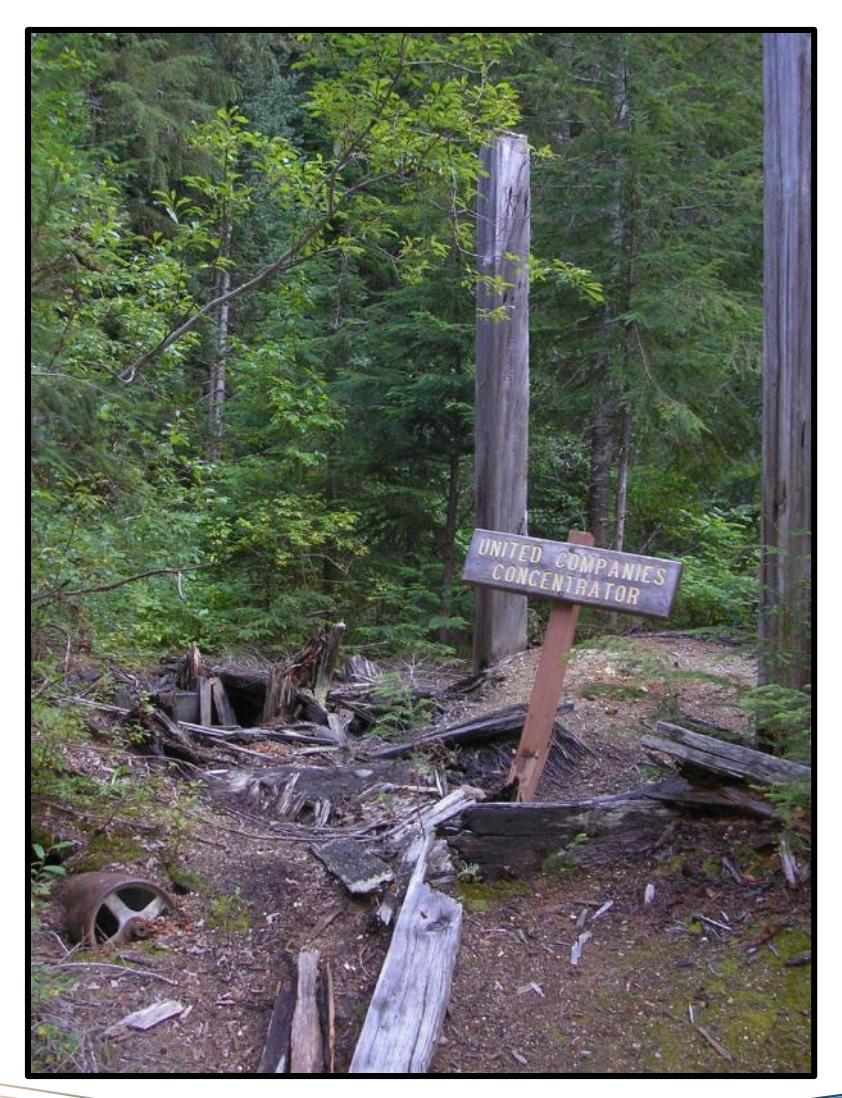
Concentrator/ Mill

• Tailings / Concentrates

- As = 21,400 ppm (Avg)
- 12 cy of Dangerous Waste
- Discharge to Glacier
 Creek

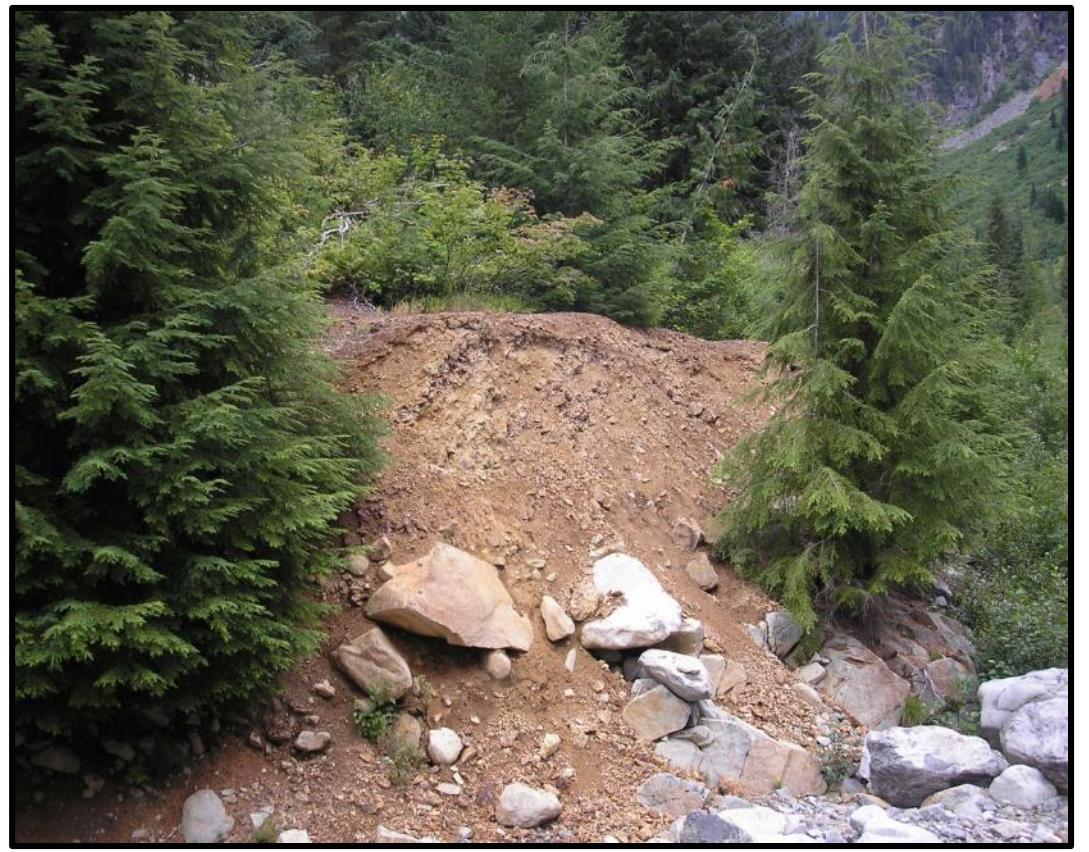
Rainy Mine

- Adit with Seep and Covered Shaft
 - As = 40,455 ppm
 (Avg)
- Eroding Waste Rock
 Dump Adjacent to
 Glacier Creek

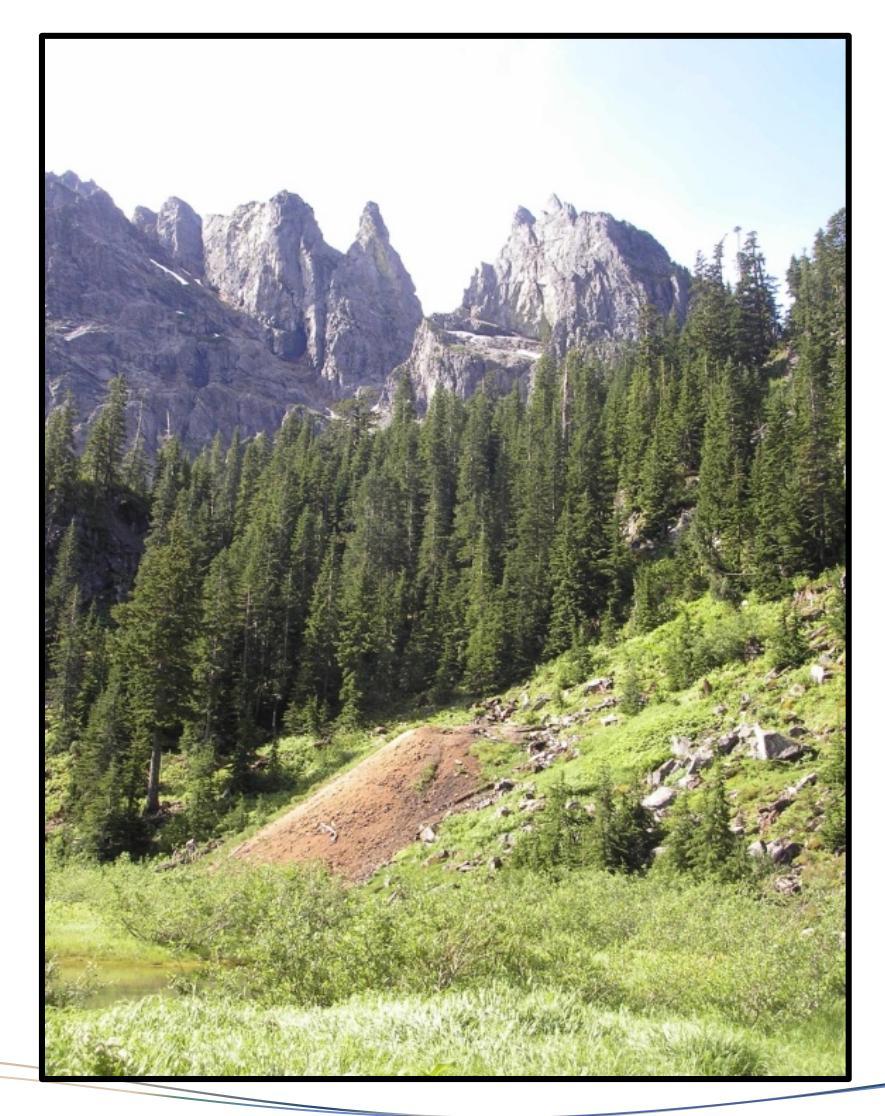
Pride of the Woods Mine

- 1 Collapsed Adit
- Located within HMJ Wilderness
 - As = 16,640 ppm (Avg)
 - Toe of Waste Rock in Glacier Creek
- Seep at Toe of Waste Rock
 - Up to 4,060 ppb (As)

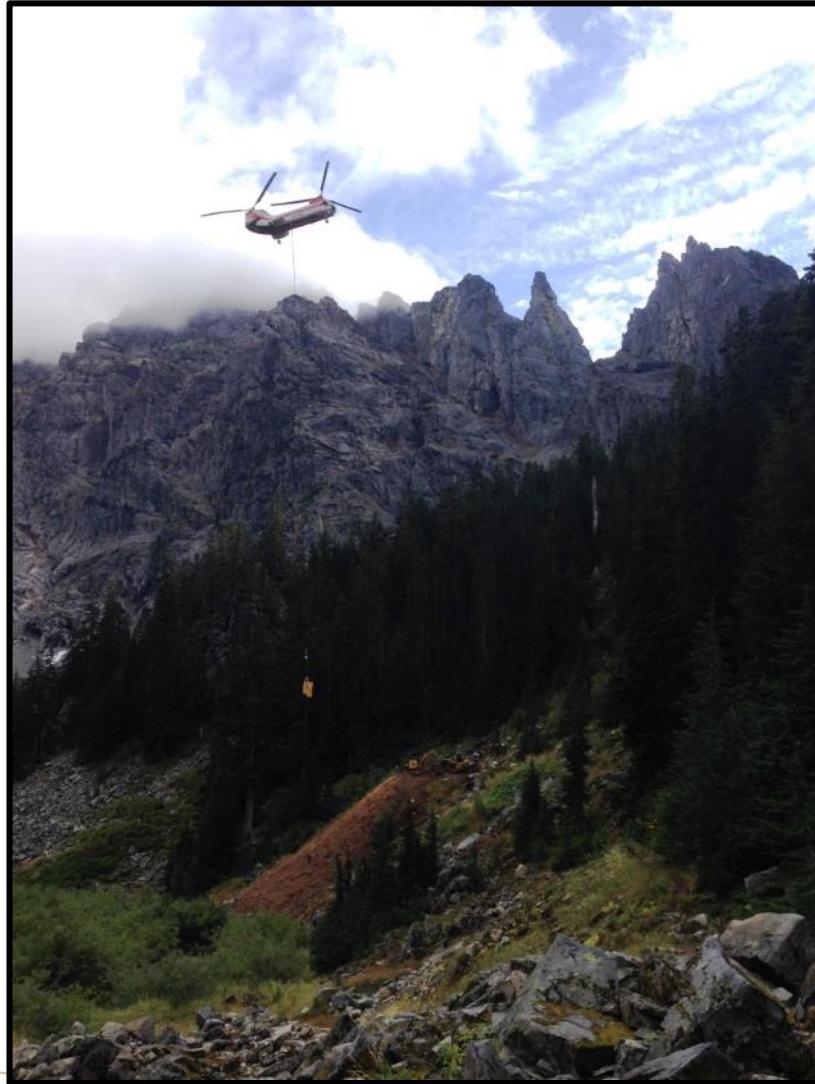
- Columbia Vertol 107 10,000 lb Lift Capacity
- Self-Dumping Bins (2.2 cy Capacity)
- Three Mini Excavators
 Flown to the Top of the
 Pile
- 887 Round Trips from POW to Drop Zone at the Rainy Mine

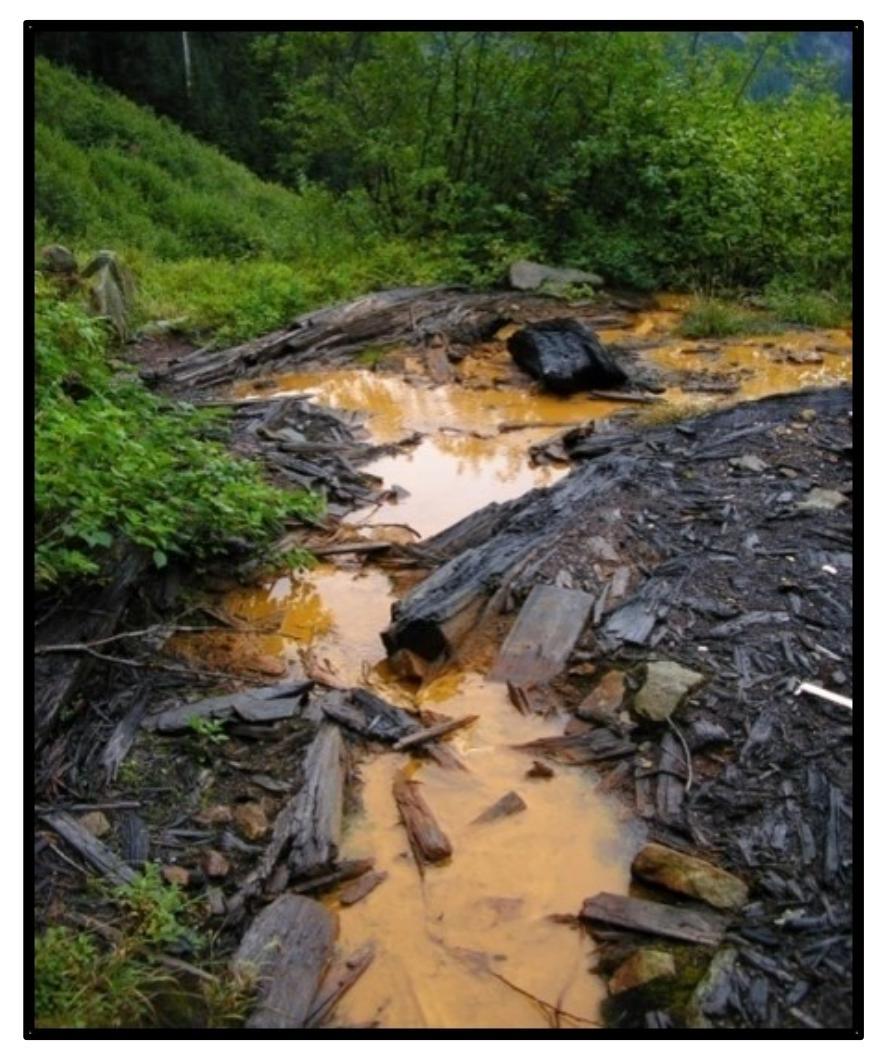
Mystery Mine

- Adit #3 Diversion
 - <40 gpm / 3,300 ppb
 (As)
- Seep Below Waste Rock
 <4.5 gpm / 1,100 ppb (As)

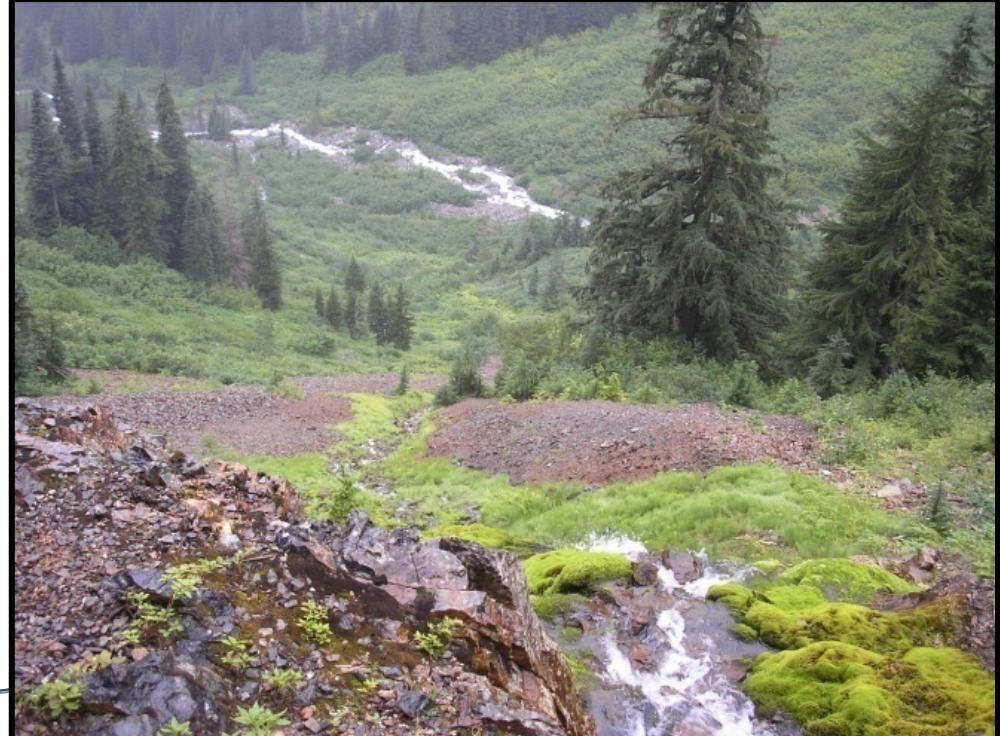
Justice Mine

- Main Adit Diversion
 - 90 gpm & 712 ppb (As)

- Seep Below Waste Rock at Glacier Creek Trail
 - 1.35 gpm & 261 ppb
 (As)

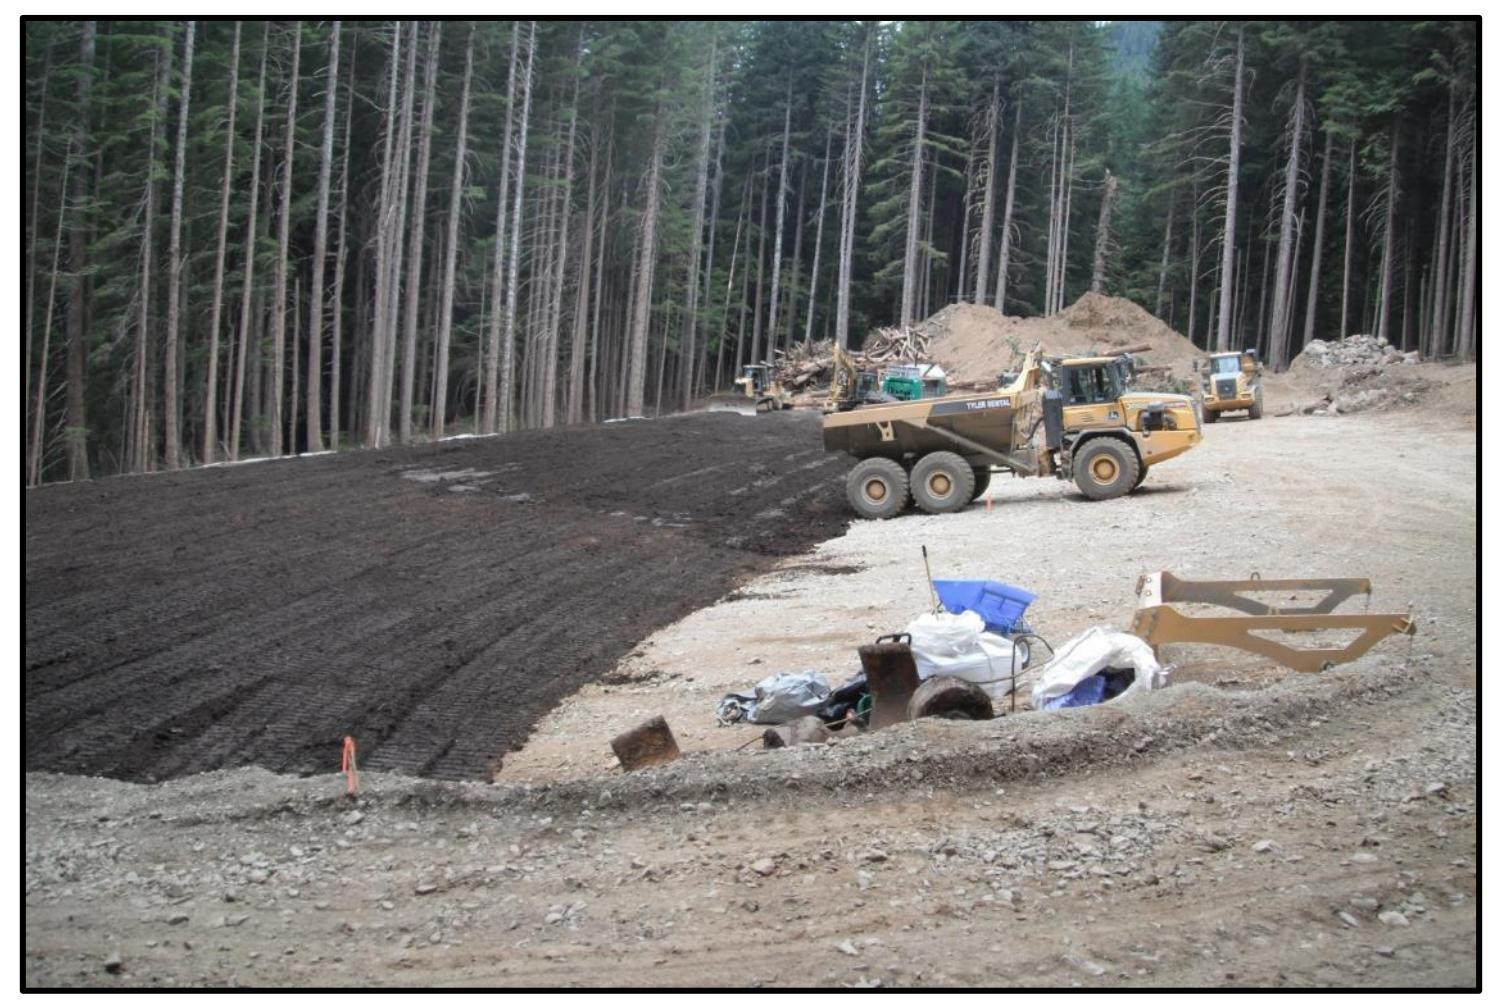
Repository – Waste Rock Placement

- Slope Varies from 2.5:1 (Bottom) to 10:1 (Top)
- Waste Rock Consolidated with Tailings
- Lime (Calcium Carbonate) Additions to Provide Neutralization and Drying Capacity
- Covered with Tarps During Rain Events
- 12-Foot Wide Terrace Drain to Divert Water Away from the Face of the Slope

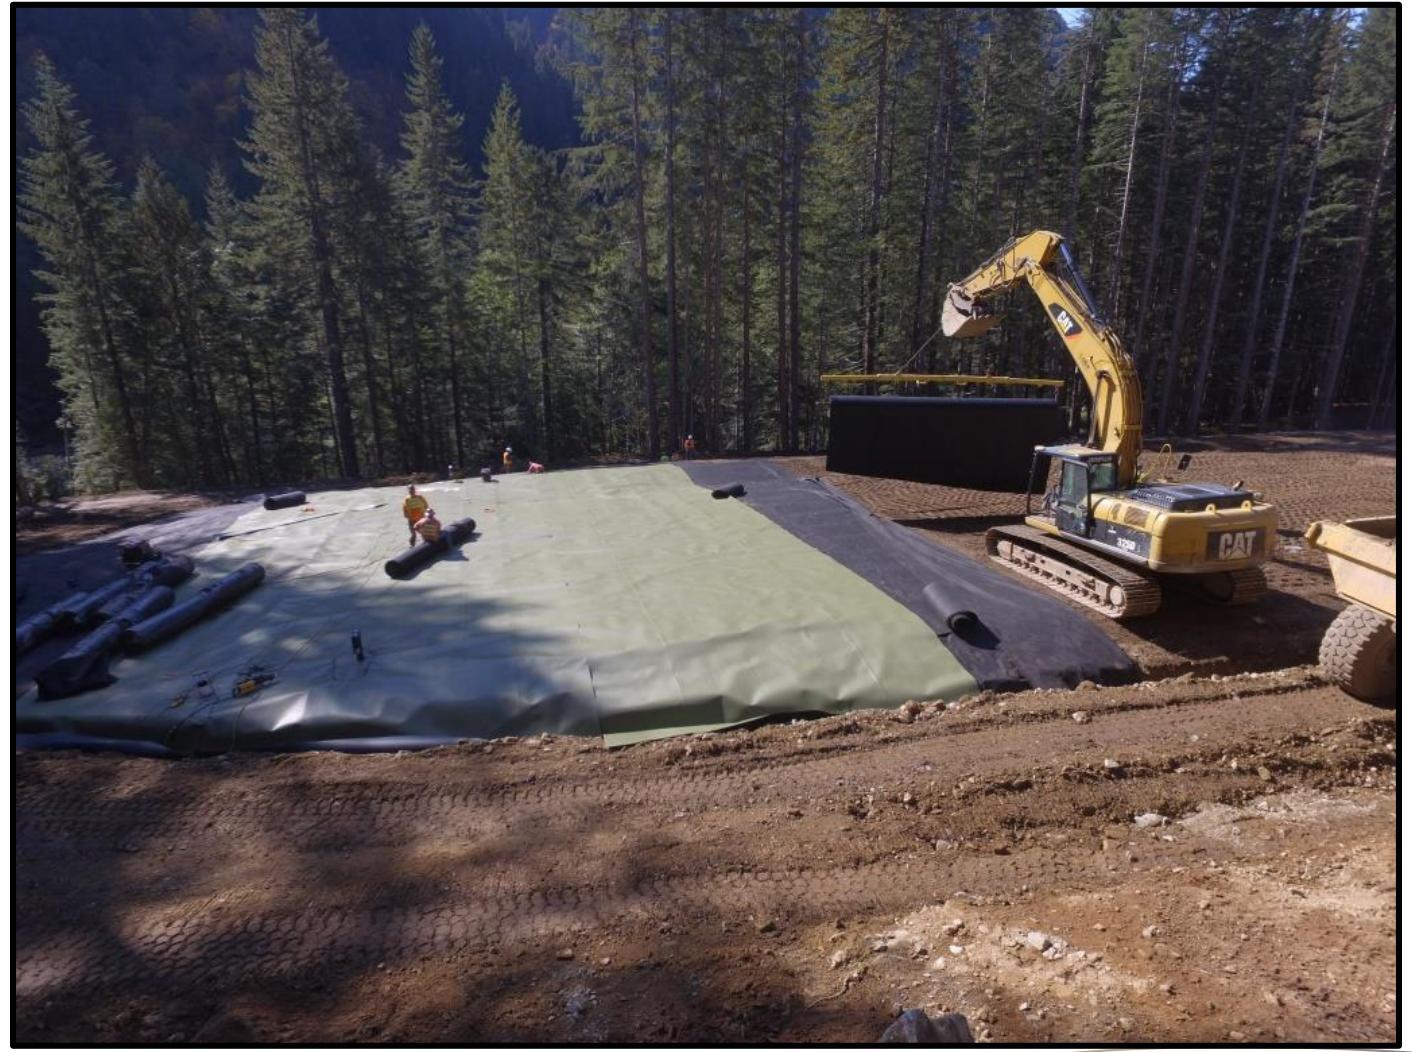
Repository – Liner Placement

- Cover Soil Generated and Screened Onsite Top Three Feet
- 200-300 mil Geocomposite Drainage Geotextile
- 60-mil HDPE Membrane; 6 Vents
- 12-oz Nonwoven Geotextile
- Six-Inch Buffer of Screened Topsoil
- Waste Rock / Tailings Bottom
