RESULTS OF INNOVATIVE CONTRACTING AND RECLAMATION METHODS USED FOR THE FONDAWAY CANYON MINE CLOSURE PROJECT, FALLON, NEVADA¹

Abstract: This presentation provides an overview of the contracting and implementation processes used to close and reclaim the inactive Fondaway Canyon Mine. The closure and reclamation of the Fondaway Canyon Mine is now considered the “standard of reclamation” by the BLM in Nevada. The mine is located approximately 40 miles northeast of Fallon, Nevada on the western flank of the Stillwater Mountain Range. The site is subject to mining claims held by EPEC Minerals Company–Nevada, a subsidiary of El Paso Corporation, and has been inactive for over 10 years. The project was a medium-scale open-cut and underground gold and silver mining operation, with a heap leach pad and Merrill-Crow recovery plant. Golder’s scope was to identify current methods for the closure of all facilities, negotiate appropriate changes to the existing reclamation plan and permit, develop construction level designs, conduct a bidding process, and oversee the implementation of the reclamation plan. Golder developed innovative reclamation and erosion and sediment control methodologies for

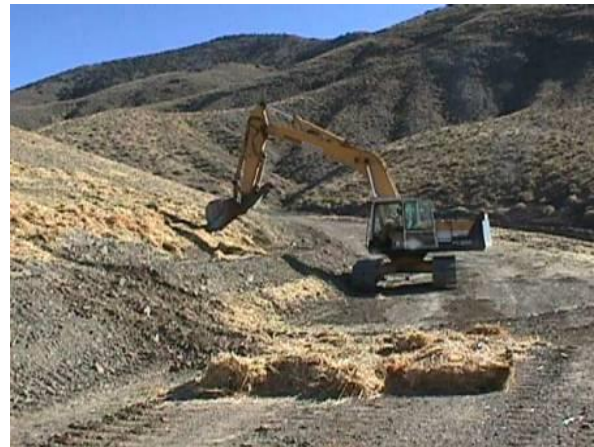
**South Waste Rock Dump
Plant Growth Medium,
Mulch, and
Ripped Surface under construction**

- Random convex and concave slopes, depressions and ridges shall be created during grading and contouring.
- The surface of redistributed soils or re-graded areas shall be left in a rough, unfinished condition by gouging the surfaces with an excavator bucket or dozer-mounted ripper. When complete the surface will be very difficult for a person to walk across regardless of slope gradient.
- Plant growth medium shall not be fertilized.
- Mulch shall be crimped into the re-graded or topsoiled surface of critical sidecast road fills and waste rock covers.

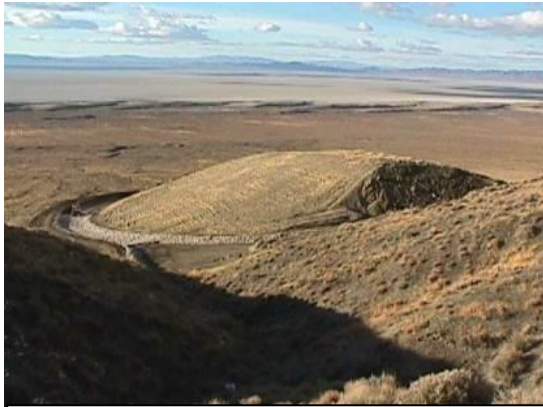
South Waste Rock Dump after completion

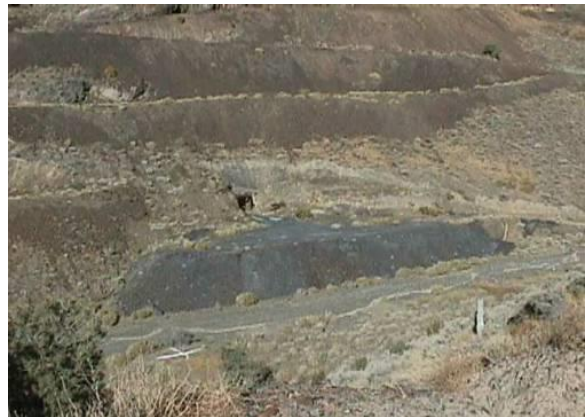
Adit Before closure

approved by the agencies and is also in use on several other similar mines in Nevada. The adit was closed by placing a clay barrier berm to prevent drainage from exiting, and subsequently backfilling the entrance with waste rock from the initial excavation. Following closure, draindown water quality and quantity monitoring and observations for seepage from the Half Moon adit were required semi-annually for approximately three years following closure.

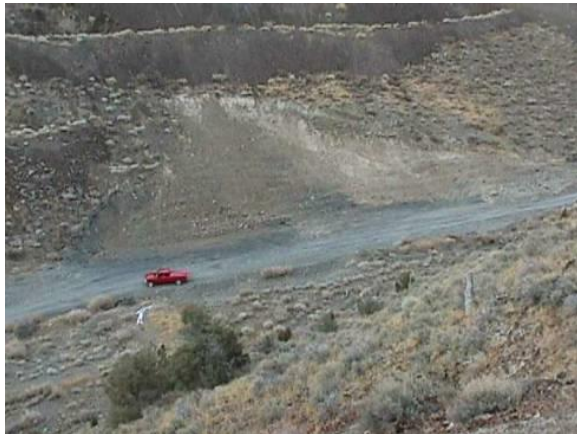
Adit after closure

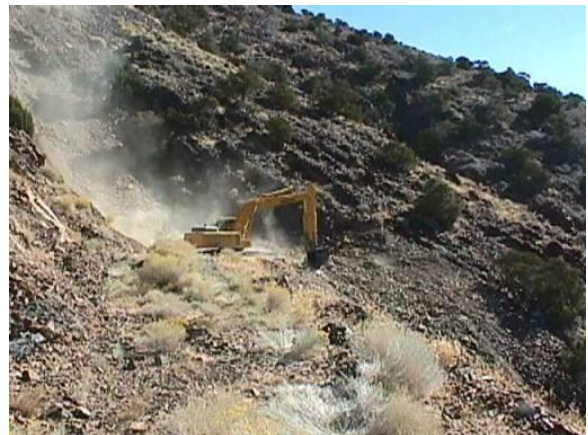
Exploration Roads – before recontouring at South Hamburger Hill
