# EGG-CRATE MINE SUBSIDENCE<sup>1</sup>

Maynard L. (Mike) Dunn, Jr.<sup>2</sup>

**Abstract:** Steep-sided or near-vertical ground failures over shallow room-and-pillar works are well known and thoroughly covered in the literature. Various terms such as pothole, sinkhole, cockpit, and chimney (or chimney cave) subsidences, these failures tend to occur without warning and sometimes many years after mining, usually as single or small clusters of events. Recently, during background work on a Pennsylvania bituminous AML fire, a regular pattern of light and dark areas on vintage aerial photographs was seen to closely match abandoned room-and-pillar works. On the ground, this pattern proved to be complete subsidence into the mine voids with only minor settling over the pillars and ribs. The differential subsidence has produced a topography closely resembling an egg crate – thus the term coined here, “egg-crate subsidence.” Examination of additional historic aerial photographs of the region revealed the egg-crate patterns are common. Where egg-crate subsidence patterns exist, secondary mining seems to be rare owing to roof support problems during the initial mining. Unmined coal and old

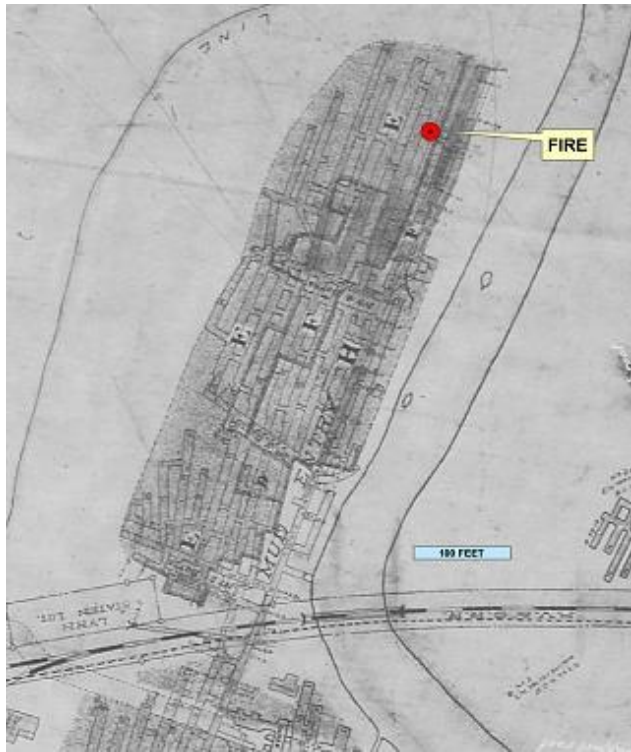
Figure 1 1914 Mine map.

In 2006, background work on a Pittsburgh coal mine fire required georeferencing a 1914 map of the Lynn Station Mine (Fig. 1) to a 1938 aerial photograph (Fig. 2). During the process, a striking geometric light/dark pattern in the photo was observed to clearly coincide with old workings in the affected section of the mine.

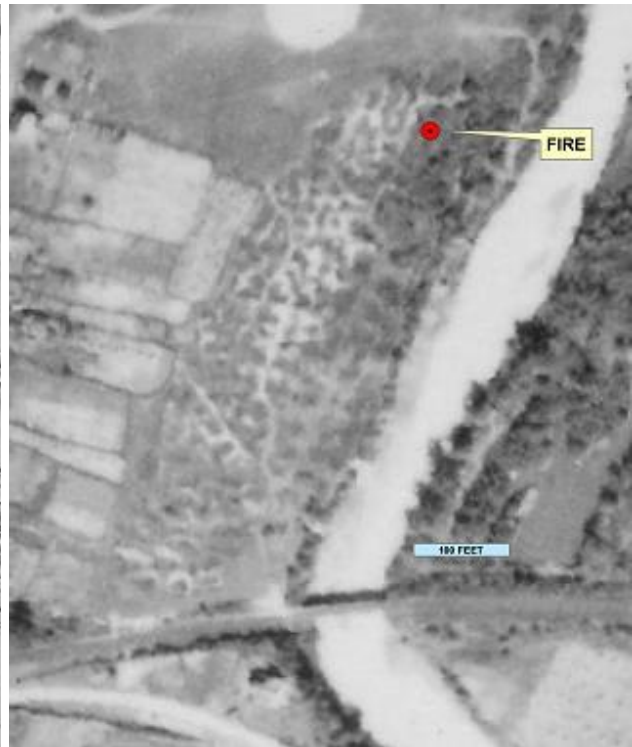
Figure 2 1938 Aerial photograph.

The site's surface consists of 3- to 8-foot hummocks on about 20-foot centers and looks very much like a snow skier's mogul field or a foam "egg-crate" mattress pad. Trenches dug to access the fire revealed that mining was advance only and conducted under less than 15 feet of cover consisting of weathered shale, alluvium, and soil (Fig. 3). Some entries were open but roof collapse had filled crosscuts.

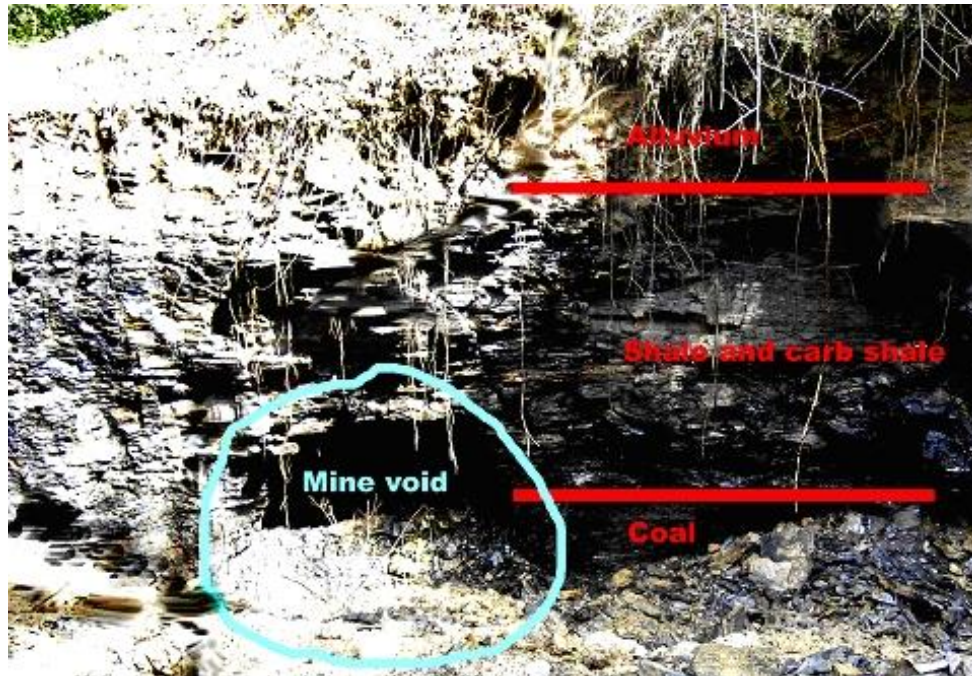
Figure 3 Exposed mine works and cover.

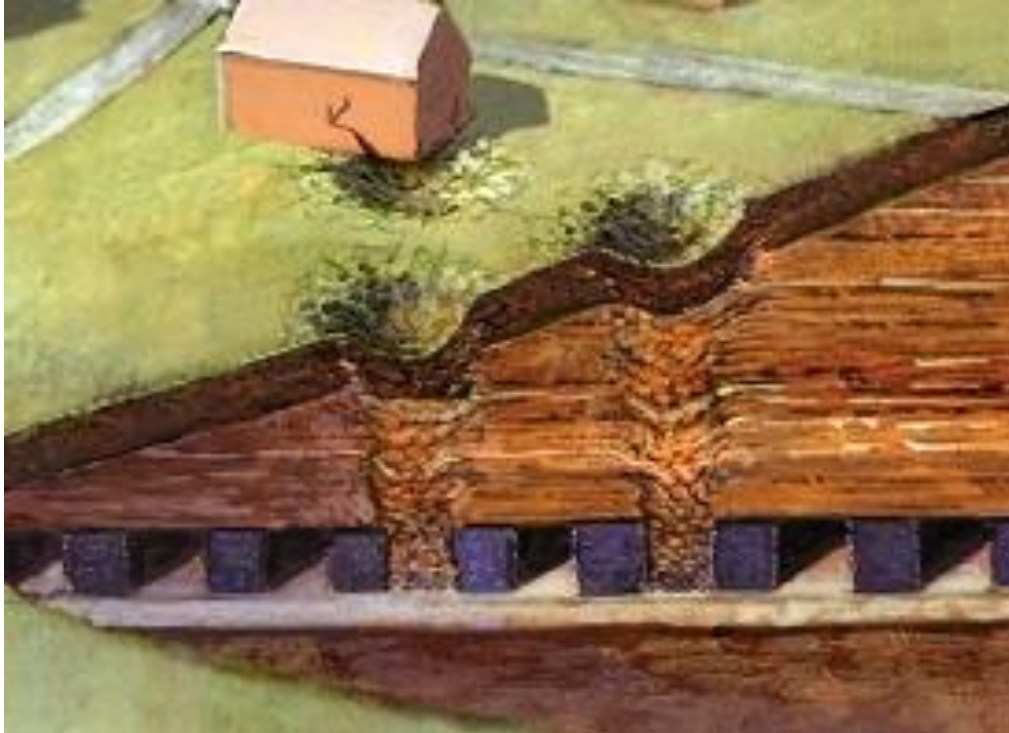
Figure 4 Sinkhole subsidence (excerpt from [www.pamsi.org](http://www.pamsi.org) poster).

Shallow subsidence usually presents itself as scattered individual pits resulting from cylindrical or conical collapse of overburden into the mine void. Shallow subsidence depressions can also occur when unconsolidated granular overburden pipes or flows into the mine void through subsidence cracks. After second mining, trenches or swales may develop first and followed later by pit development. Several terms, among them sinkhole, cockpit, pothole, and chimney – are descriptive and appropriate. Many decades may pass between mining and individual events that are typically singular and sporadic (Fig. 4).

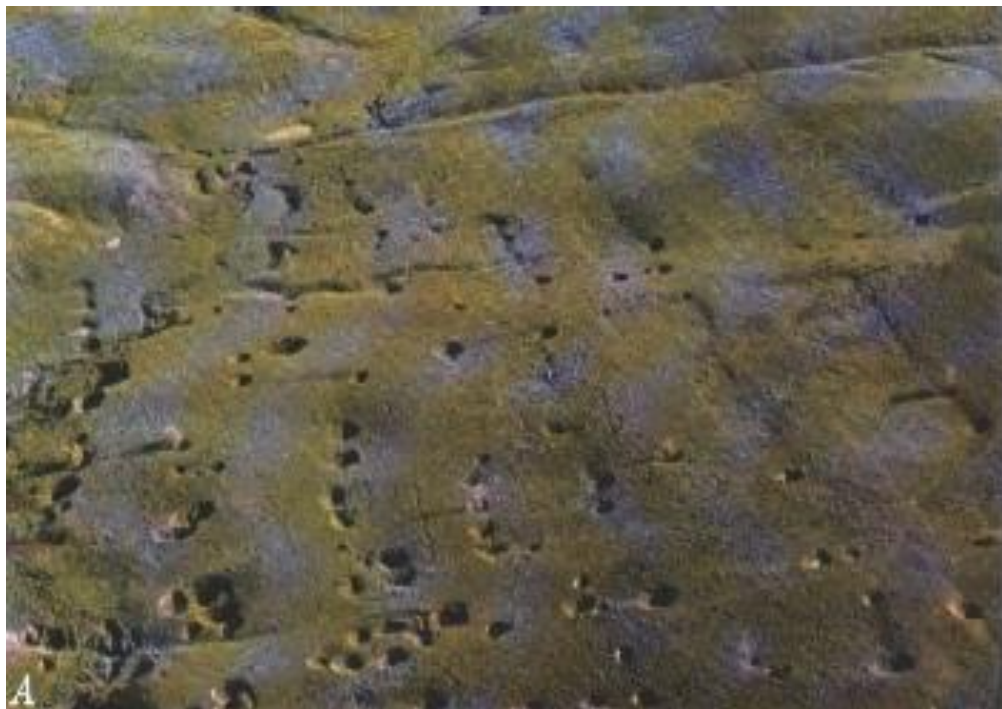
Figure 5 Sean Carroll subsidence field, WY.

Multiple sinkholes develop following chain reaction pillar collapse, surface loading, and floor punching. These sinkhole swarms are more likely in the less indurated strata of the younger coal basins (see Fig. 5, Sean Carroll, WY and Fig. 6. Scranton, ND).

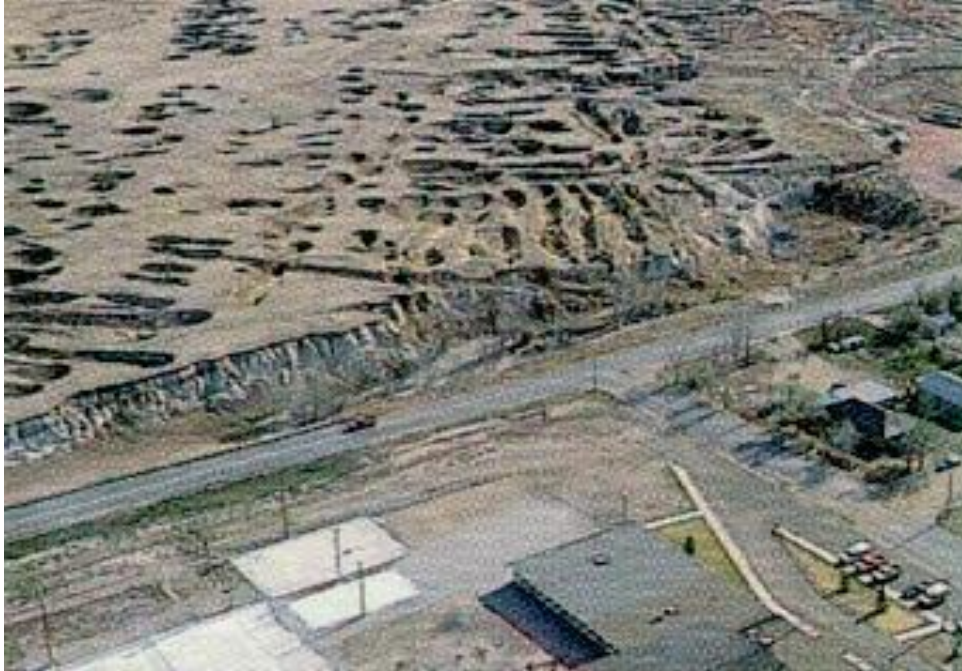
Figure 6 Scranton, ND

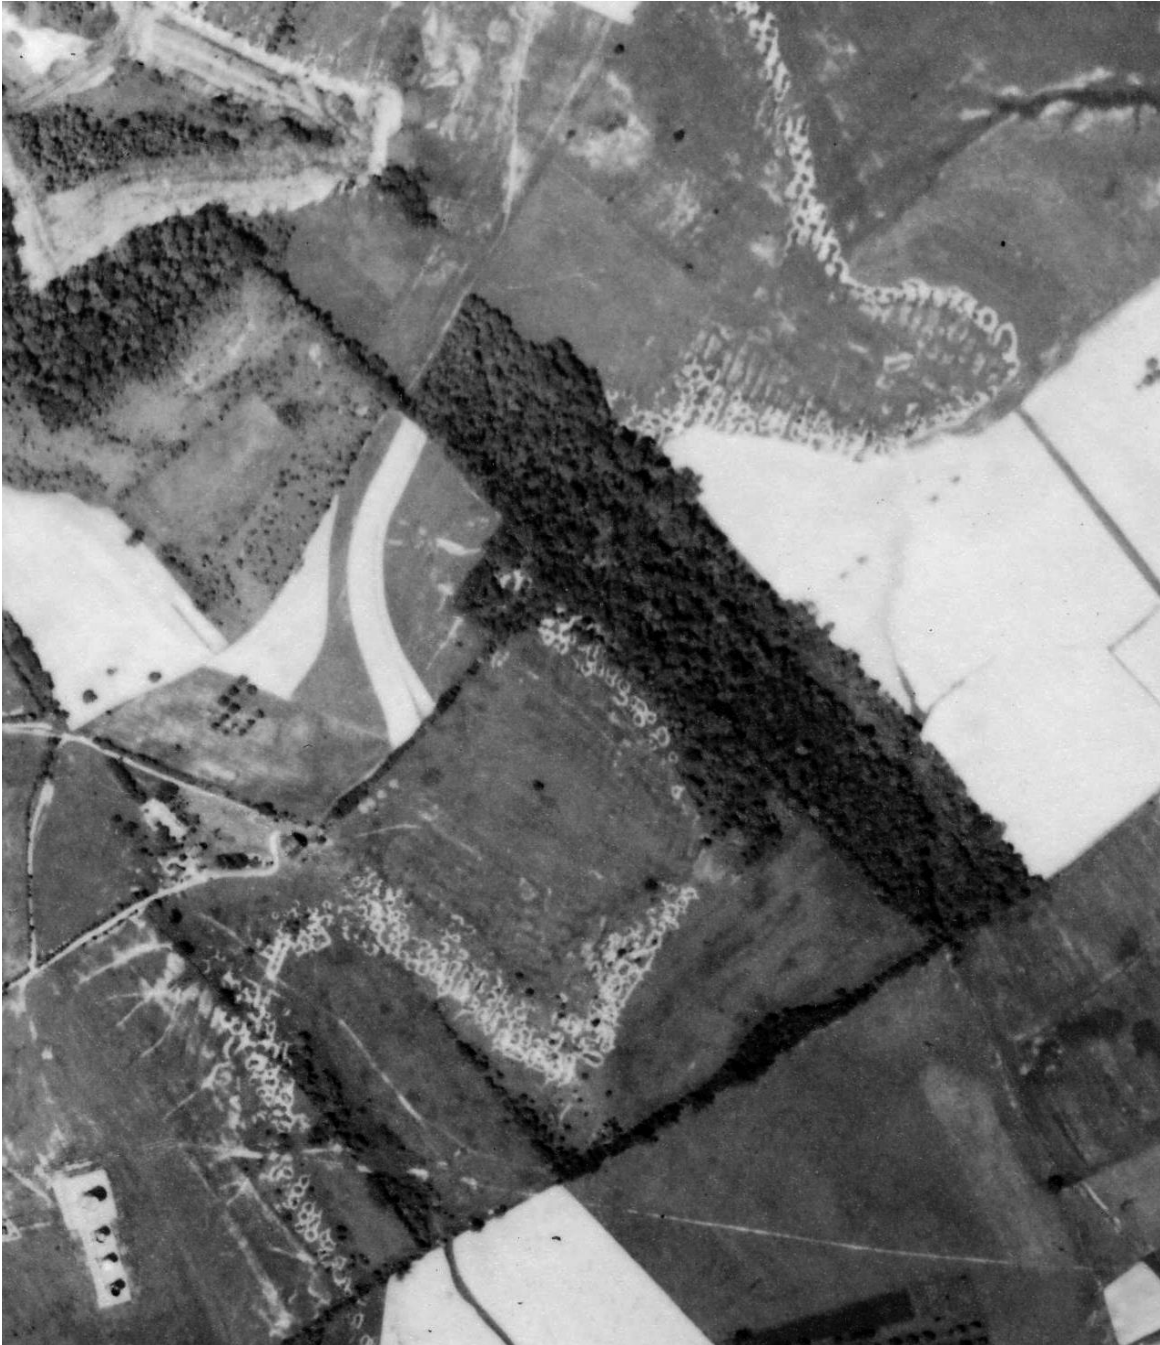
Figure 7 Shallow subsidence patterns near Delmont, PA (north to top).

Pattern variations in this photograph illustrate a wide range of shallow subsidence features. The spots on the photograph are evidence of subsidence that appear as: (1) sinkholes in the southwest and center, (2) probable egg-crate patterns, and (3) subtle linear troughs in the northeast center inside the cropline. Light colors adjacent the spots may be bare soil but are more likely water-stressed vegetation. The band's width varies with slope, narrow on steep slopes and wider on gentler slopes. Finally, the band is completely hidden by the canopy of the woodlot near the center.

The patterns seen on the old aerial photographs over the Lynn Station mine and near the deep mine discharge were so striking and so nearly mirrored the shallow mine works, they were considered a potential guide to similarly mined areas. These patterns were sought on other vintage aerial photographs taken of southwestern Pennsylvania. The photographs were taken in the late 1930's and early 1940's and 800 dot-per-inch scans of contact prints have been put online through PennPilot (2007). The search focused on upland areas where the Pittsburgh coal was shallow and mining likely. The egg-crate and similar patterns were soon found – and in abundance. Significant groupings occur near Uniontown, Fayette County; Delmont and Export, Westmoreland County; and Renton, Allegheny County. A typical grouping near Delmont is shown in Figure 7 (an enlarged 1939 photograph).
