A CASE HISTORY: RECONSTRUCTION OF THE EAST FORK OF THE ARKANSAS RIVER AT THE CLIMAX MINE¹

Kathryn Malers, P.E.², R. Spotts, P.E., K.E Carlson, and B.R. Romig

Additional Key Words: geomorphic design, channel restoration, mine reclamation

¹ Paper was presented at the 2011 National Meeting of the American Society of Mining and Reclamation, Bismarck, ND *Reclamation: Sciences Leading to Success* June 11 – 16, 2011. R.I. Barnhisel (Ed.) Published by ASMR, 3134 Montavesta Rd., Lexington, KY 40502.

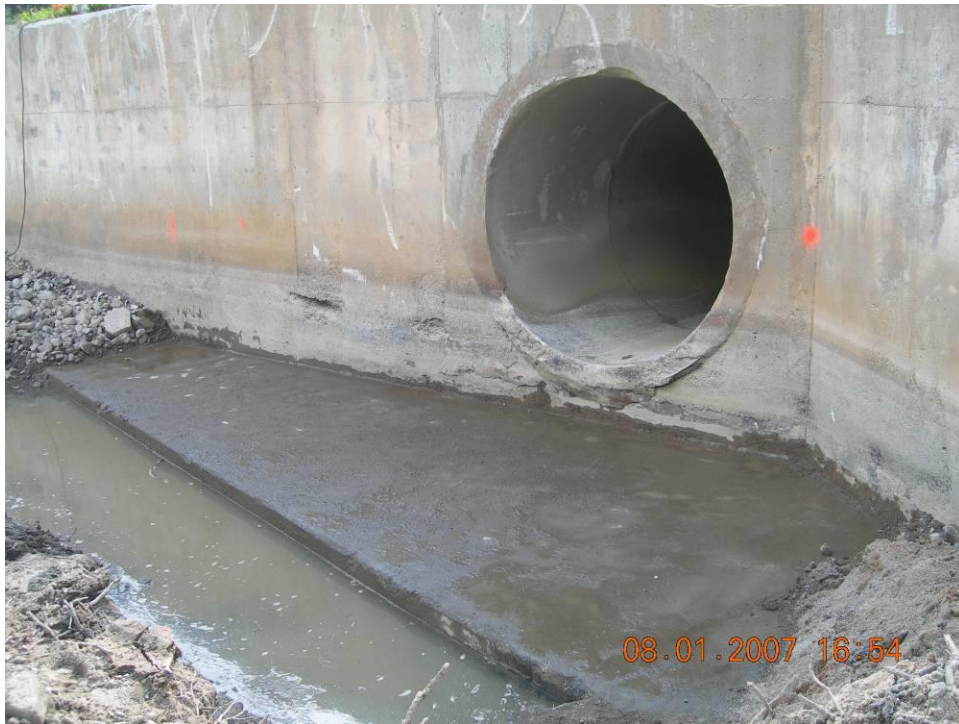
Figure 3. Uncontrolled entrance to the Storke Yard pipeline.

The pipeline that conveyed the river beneath the Storke Yard was to be retained during construction and at least throughout a 3-year reclamation and monitoring phase after construction. In the long-term the pipe can be sealed or preserved to allow Climax to divert flows from the river during flood events or to regulate stream flow during spawning to promote recovery of the fishery. Given the short growing season at the project altitude, retaining the pipeline provided an opportunity to moderate extreme flows during the crucial early years of revegetation establishment before reintroducing the river's full flow into the restored reach. The berm and retaining wall that served to divert the river into the pipe (Figure 3) had to be retrofitted to safeguard the pipe entrance and to allow flow to be diverted to the new channel. An inlet box with Waterman slide gates was designed to govern flow between the restored river channel and the 7-ft diameter pipe. A similar Waterman slide gate was fitted to the culvert that conveys the river beneath the berm and into the restored channel, allowing flows to be diverted completely into either conveyance or split between them (Figure 4). The layout of the restored reach was required to accommodate a perpendicular cut through the berm for the culvert, and to avoid the inundation of the retaining wall in the berm at the peak design flow.

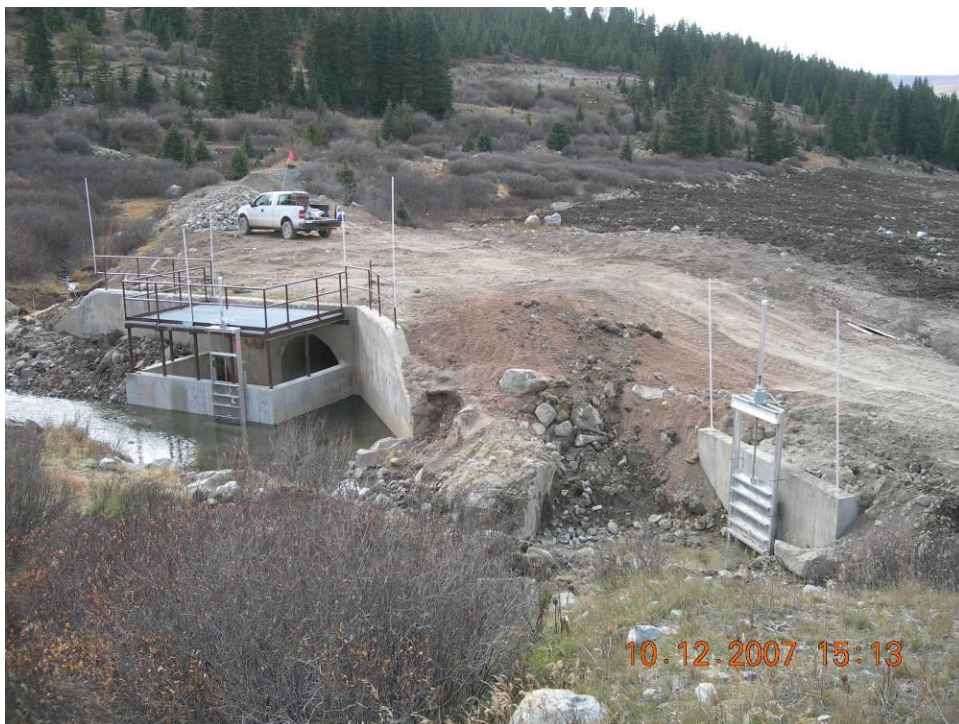
Figure 4. Finished pipe and channel inlet structures.

An inlet box was attached to the 7-ft diameter pipe, building off the footer of the existing concrete headwall and doweling into the wall face. Once the inlet box was completed, a 36-in diameter Waterman slide gate was bolted to the inlet box. A steel platform was built over the inlet box to allow access to the mechanism that raises and lowers the slide gate (Figure 34). The inlet box was left open at the top, allowing flood waters to overtop the wall and bypass the river.

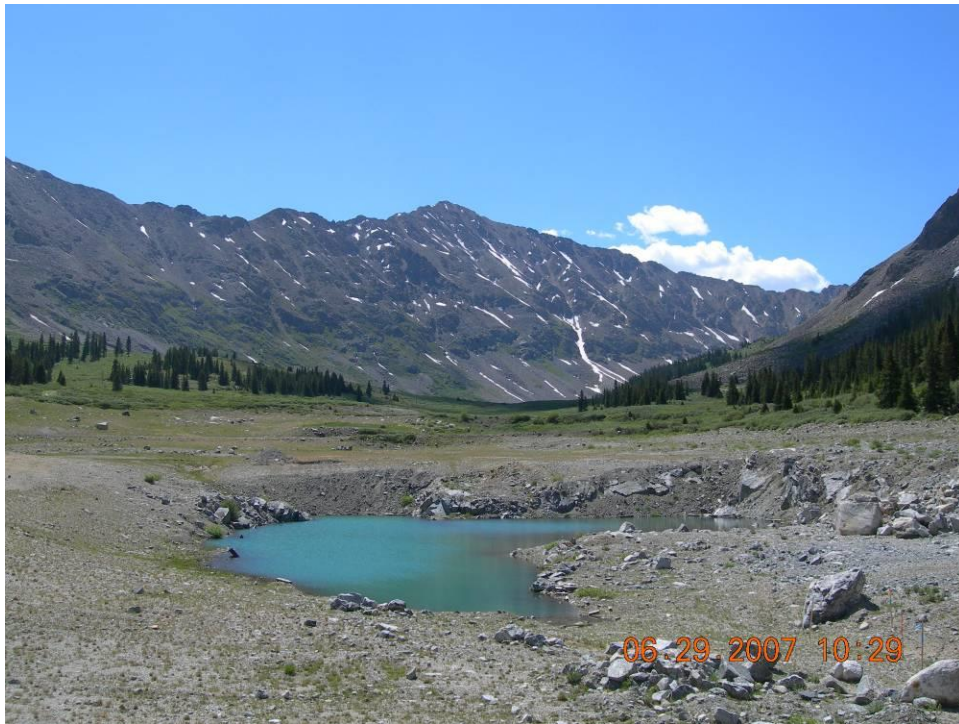
Figure 5. Lake prior to restoration.

An opportunity existed to incorporate a small lake (Figure 5) that had formed at the location of an excavation for a reclaim conveyor into the restored channel reach. The ultimate design expanded the lake's surface area by raising its water surface elevation (Figure 6), and shallow areas and benches along the perimeter of the lake were constructed to expand aquatic habitat, specifically trout-spawning habitat. Retaining the lake divided the restored alignment into two channel reaches, one Upstream and one Downstream of the lake. Given the water surface elevation at the lake, a 5.6% average gradient was required for the Upstream reach above the lake. A step-pool bed form design for this reach was designed to facilitate Climax's desire to maintain fish passage through the Upstream reach and into the undisturbed watershed upstream of the project area.

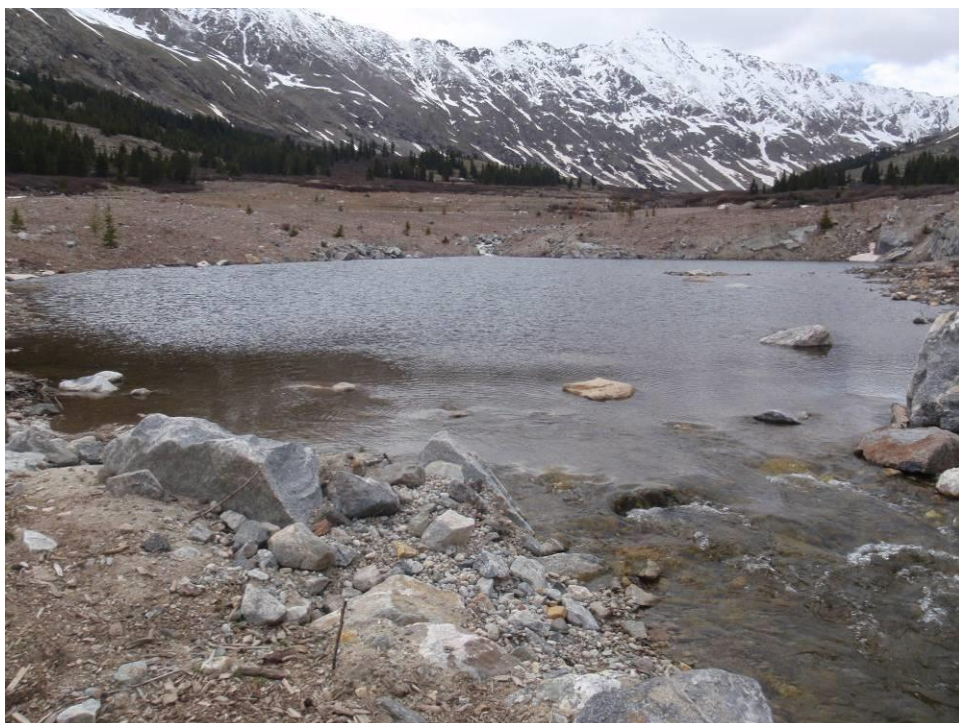
Figure 6. Lake after restoration.

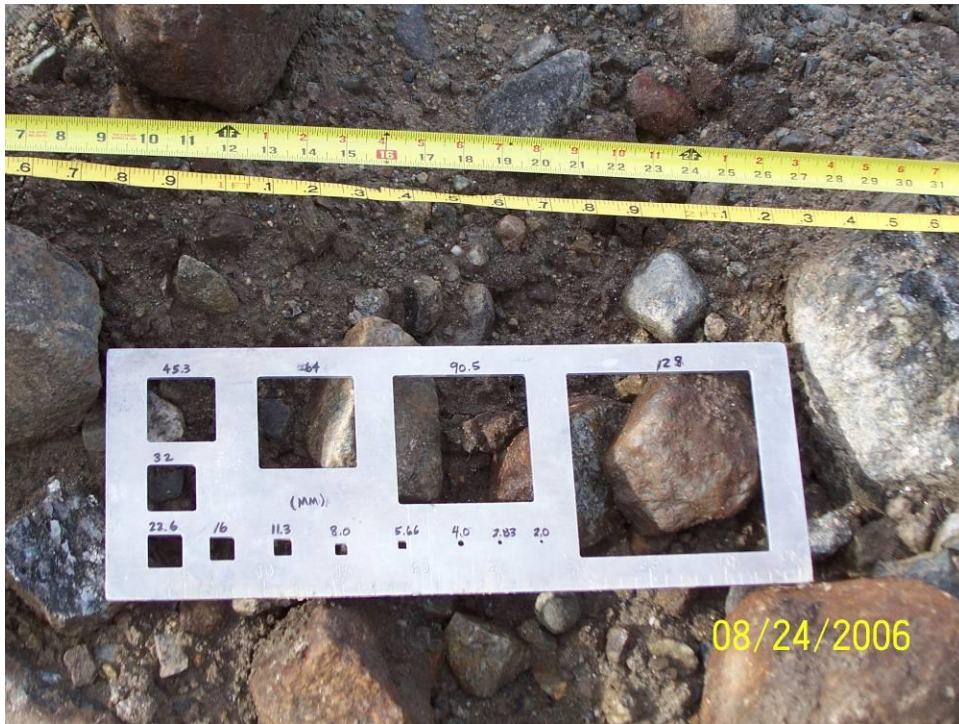
Figure 7. Material encountered in a test pit excavation.

A test pit investigation was undertaken to determine the composition of the fill material along the proposed river alignment and characterize its suitability for sealing the channel base. Eight 3 to 4.5 feet-deep test pits were excavated and the material was analyzed with a tape measure and a gravelometer to estimate the incidence and size distribution of rocks (Figure 7). Samples of the finer (less than 3-inch diameter) material from each test pit were collected to conduct sieve analysis and determine particle size distribution. The investigation supported the conclusion that the excavated material, when properly placed and compacted, could be used to seal the channel. Even in the uncompacted state that existed in the Storke Yard, the test pits provided evidence of a relatively low permeability for the material in the valley. After excavation, a significant storm event filled the test pits with water, and the water remained for many days (Figure 8).

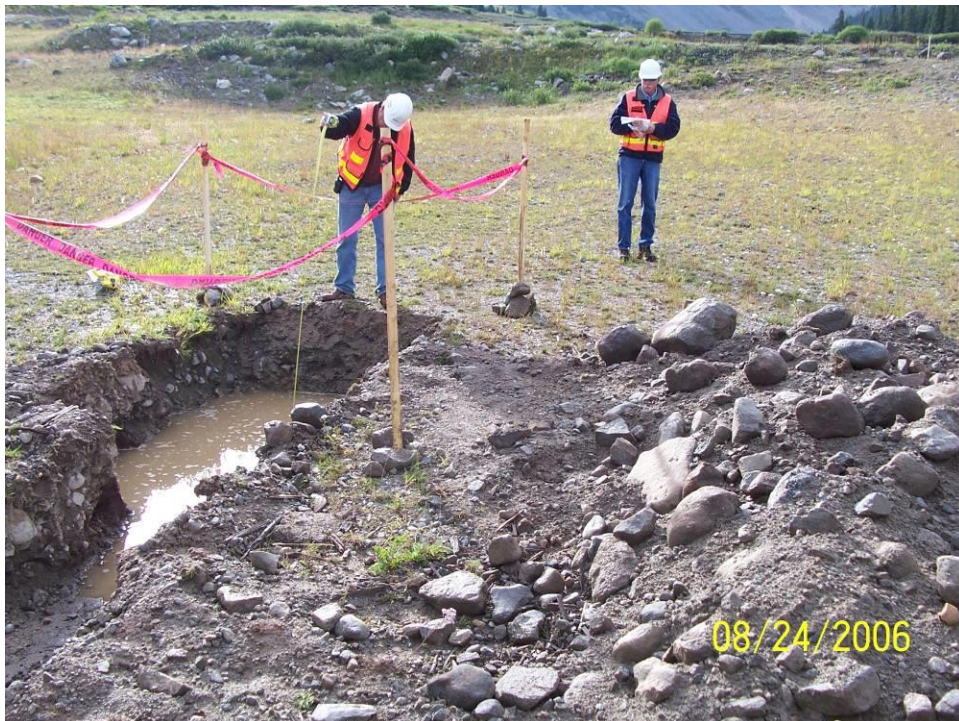
Figure 8. Test Pit 8 filled with rain water.

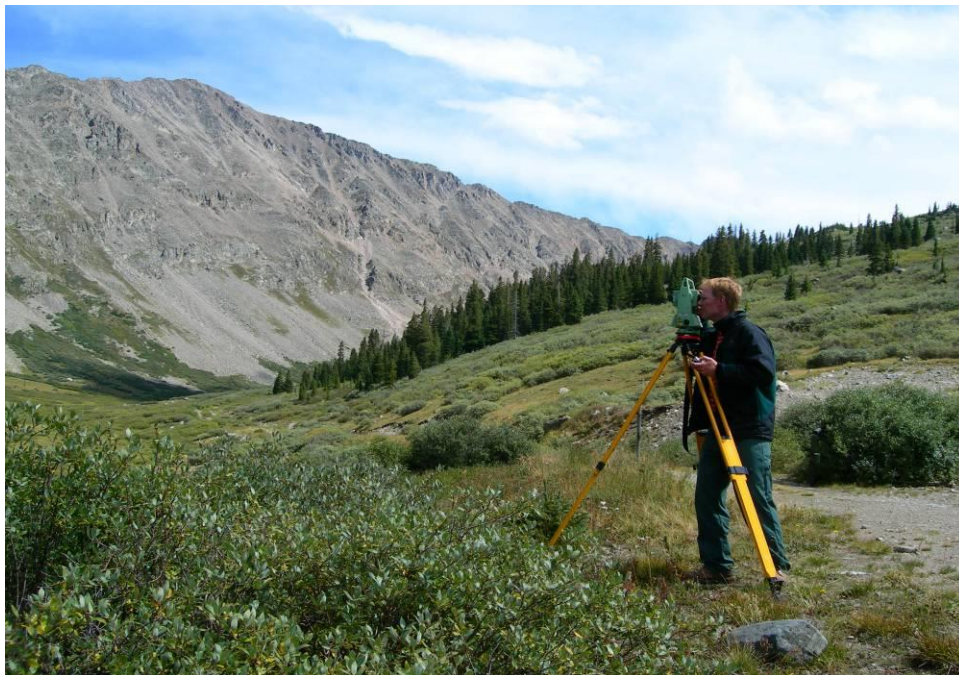
Figure 9. Surveying fluvial geomorphic characteristics of reference reaches.

A complete survey to quantify parameters characterizing the fluvial geomorphology in potential reference reaches was conducted in August 2006 (Figure 9). Channel slope, sinuosity, meander frequency and other characteristics were compiled for representative reaches of the undisturbed river in the project area using standard methods for geomorphic field investigation (Rosgen, 1996 and 2006). Data collected from the reference reaches were used as a template to design moderate- to low-gradient plan and cross-sectional bed form and river bank geometry. Design for the Upstream reach was modeled on a 5.6% step-pool reach of the East Fork of the Arkansas River upstream of the Storke yard. The Downstream reach was similarly modeled on an upstream 2.8% riffle-pool reach. Target values for geomorphic parameters, especially the meander length and width, were modified to allow the realignment to fit onto the Storke Yard topography in an aesthetic arrangement that could be made to work with the other layout criteria. Riffle-pool or step-pool sequencing, rock placement and substrate composition were analyzed in the reference reaches. A summary of the geomorphic parameters measured in the reference reaches is provided in Table 1.

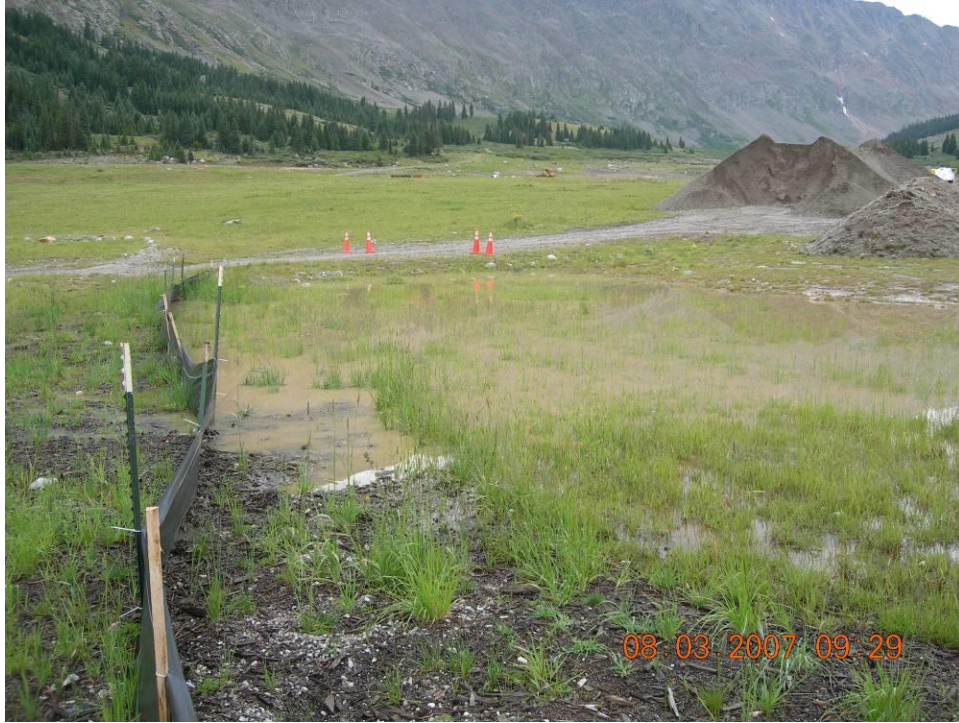
Figure 10. Silt fence along the downstream perimeter of the project site.

Silt fence was installed around the downstream perimeter of the project site and adjacent to fresh water bodies (Figure 10). Sediment logs were installed in swales to facilitate sediment deposition prior to stormwater discharge. Stormwater retention areas were also utilized to attenuate discharge and reduce offsite impacts. All BMPs were monitored and repaired as needed throughout the two-year project. BMPs were left in place at the end of the 2008 season to continue to protect waterways until the vegetation community established. All BMPs were removed in 2009.

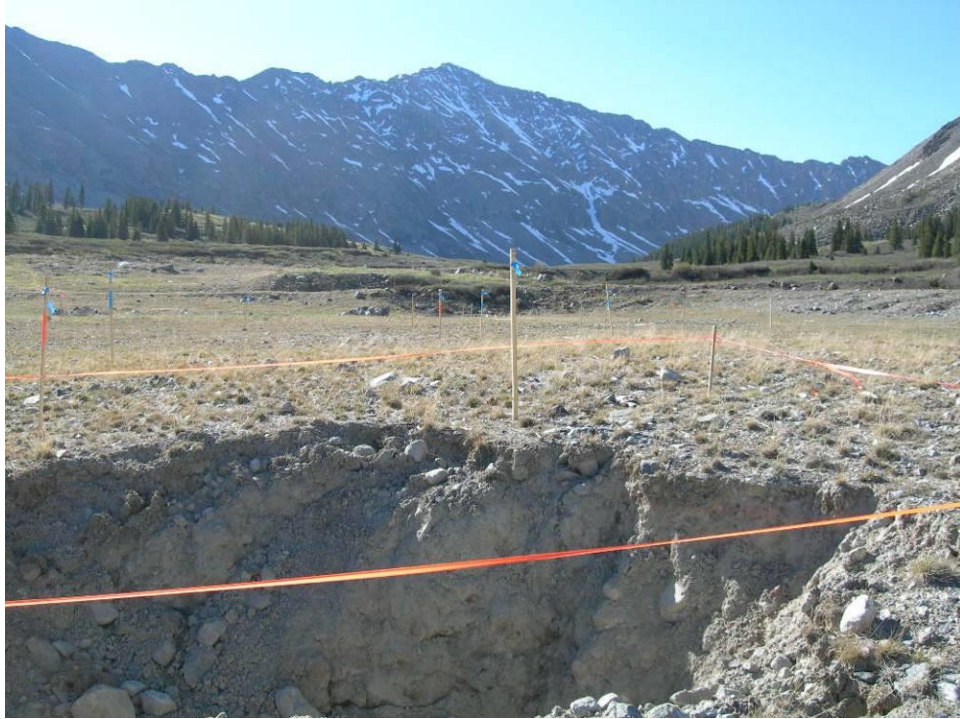
Figure 11. Construction staking in the upstream channel.

Construction staking (Figure 11) was performed using high resolution Leica survey grade GPS equipment. Transects were projected across the post-construction digital terrain model, loaded into the Leica GPS equipment and field located. Cut and fill depths were assigned to construction stakes based on the elevation of the existing ground surface relative to the proposed ground surface of the terrain model.

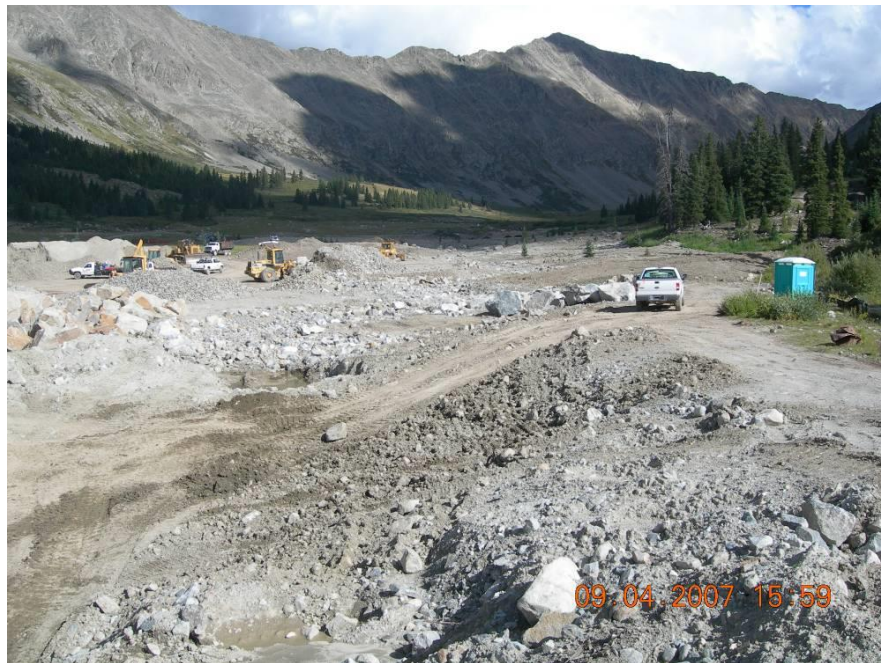
Figure 12. Excavating materials from the downstream channel.

Construction began on June 4, 2007. Initial excavation of the channel began at the downstream end and worked up the valley. Using a Caterpillar D-9 bulldozer, materials were pushed from the channel center line towards the edges (Figure 12) where they were stockpiled for later screening and terrain construction. Excavation for the drop structure was performed using a Komatsu 300 excavator and occurred contemporaneously with the material removal in the lower channel. Work began in the upper channel on August 16, 2007, once excavation in the lower channel and at the drop structure had been completed.

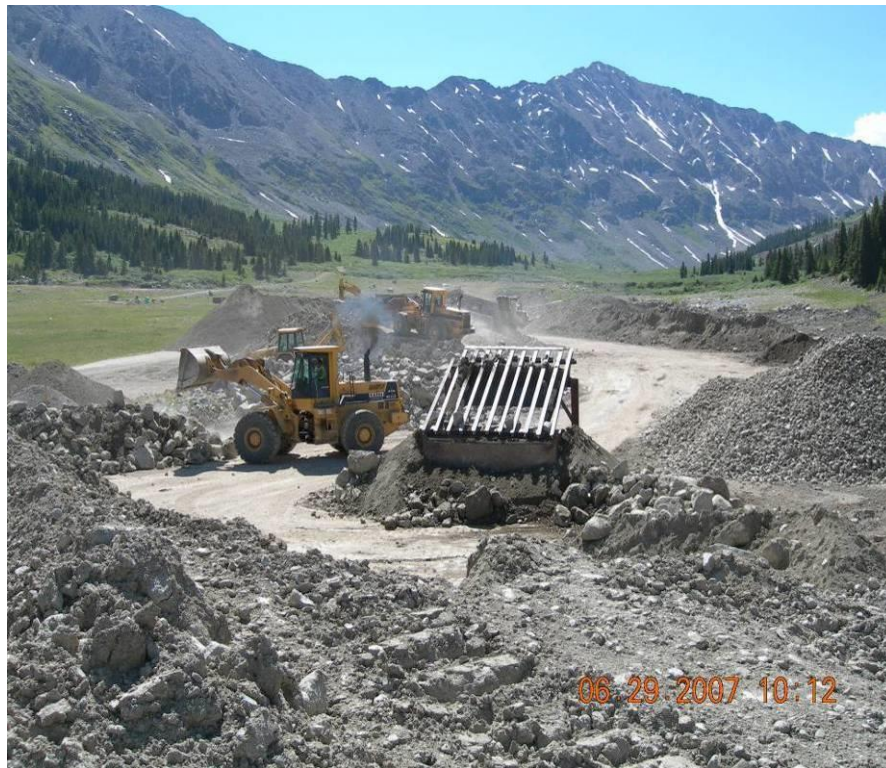
Figure 13. Grizzly operation sorting boulders and finer materials.

The screening operation began on June 18, 2007 and continued through July 13, 2007. Screening activities were located along the north side of the lower stream channel in the pre-defined staging area. Screening started once an adequate stockpile of excavated material had been created. Boulders measuring 24 inches and greater in diameter along their widest axis were set aside during channel excavation. Materials measuring less than 24 inches in diameter were run through a grizzly mechanism (Figure 13) to acquire the 12- to 24-in materials. Materials passing through the grizzly were run through a Clemro self-contained screen plant (Figure 14).

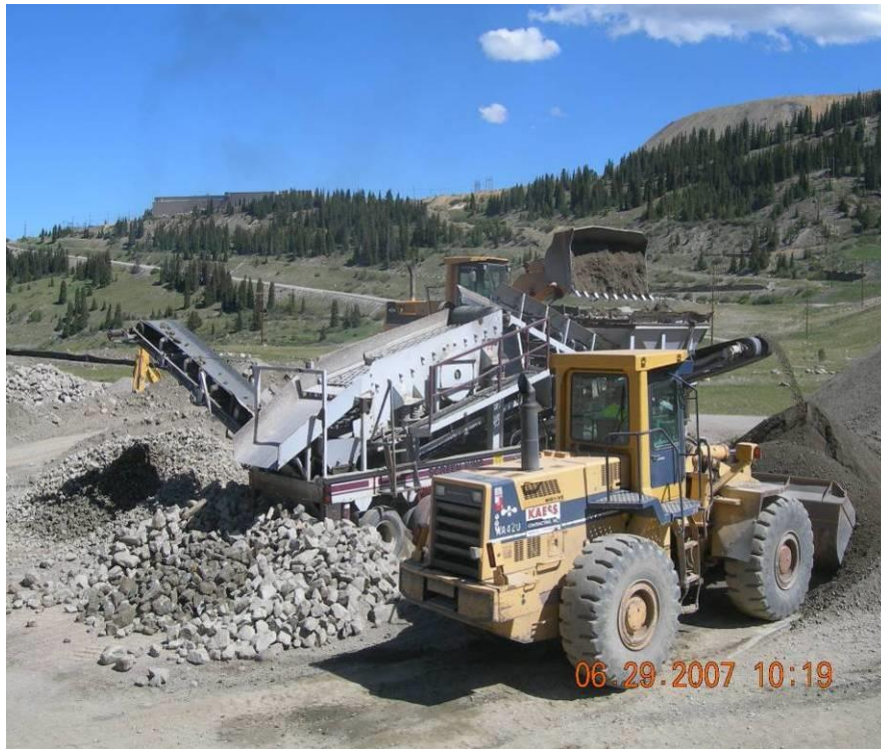
Figure 14. Clemro screening plant sorting 12-inch minus material.

The screening plant produced four rock sizes including 2-inch minus, 2 to 5-inch cobble, 5 to 8-in rock and 8 to 12-in riprap. All sorted materials were stockpiled for later use in the construction of the channel seal, bed forms, banks, riprap armoring and the drop structure. Additional boulders were imported from an on-site limestone rock quarry located on the northwest side of the Climax Mine (Figure 15). Approximately 300 boulders measuring > 4 ft across their median axis were imported to the Storke yard for use in the stilling basin and in the face of the drop structure.

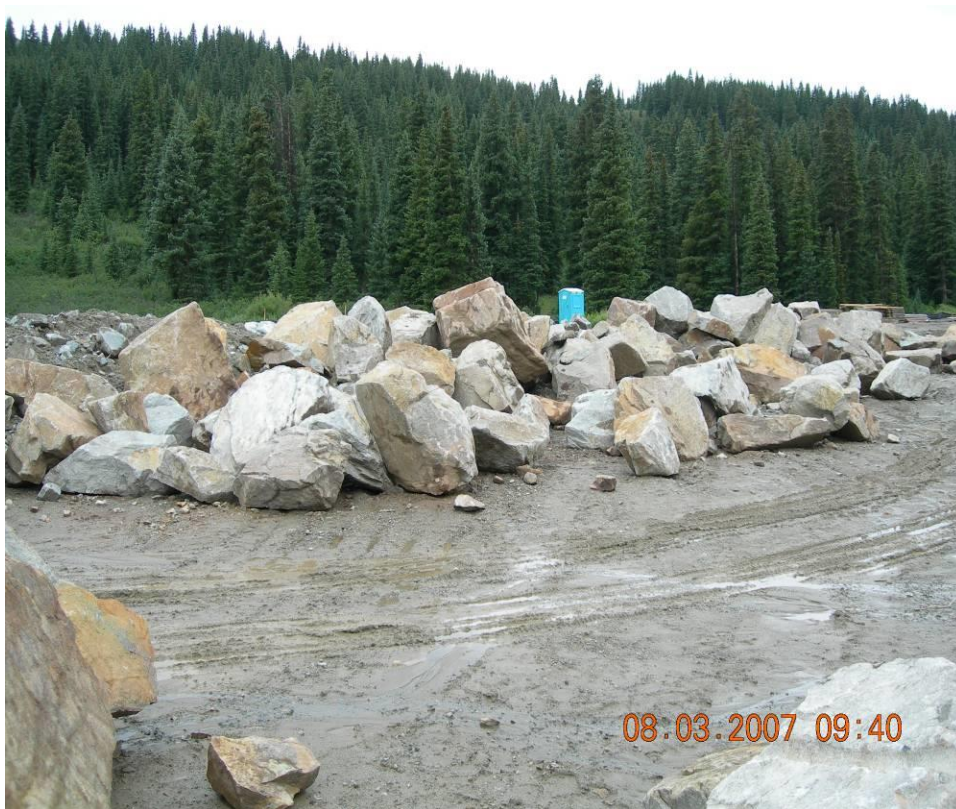
Figure 15. Limestone boulders imported from the Climax quarry.

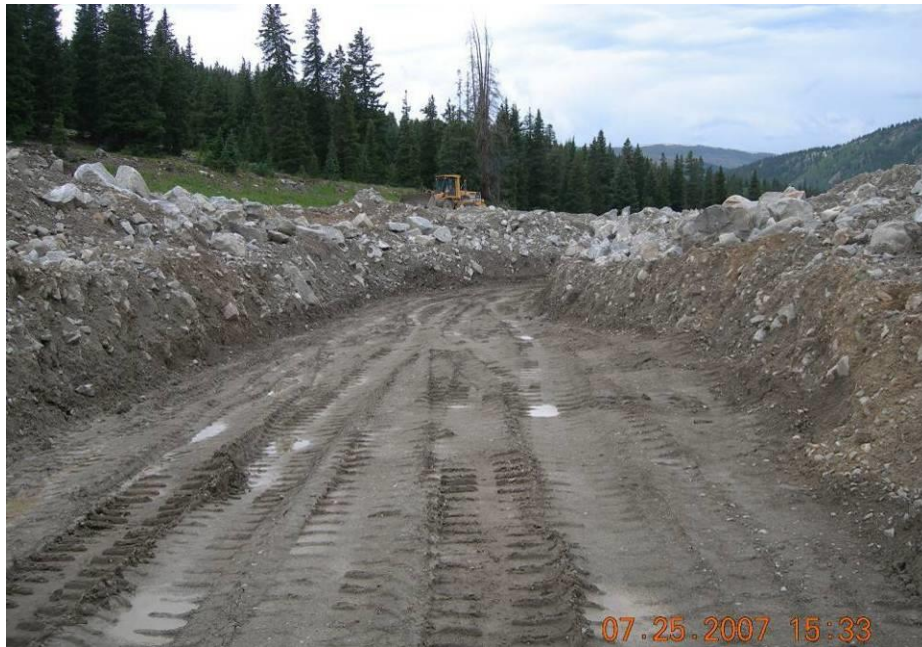
Figure 16. Compacted 2-inch minus material in the Downstream channel.

The channel substrate was constructed after the layout and over-excavation of the new channel alignment. A minimum 1-ft layer of the 2-in minus material from the screening plant was used to create a seal bed which was compacted like road base to achieve maximum impermeability. This material was placed in 6-inch lifts in the bed, toe trenches and bank areas and wheel packed by the front end loaders and also compacted by vibrating compactors (Figure 16). Large boulders were then positioned in the channel at the cut banks and riffle-pool or step-pool structures, secured by toe rock keyed into the trenches. The overbank and bank fill material

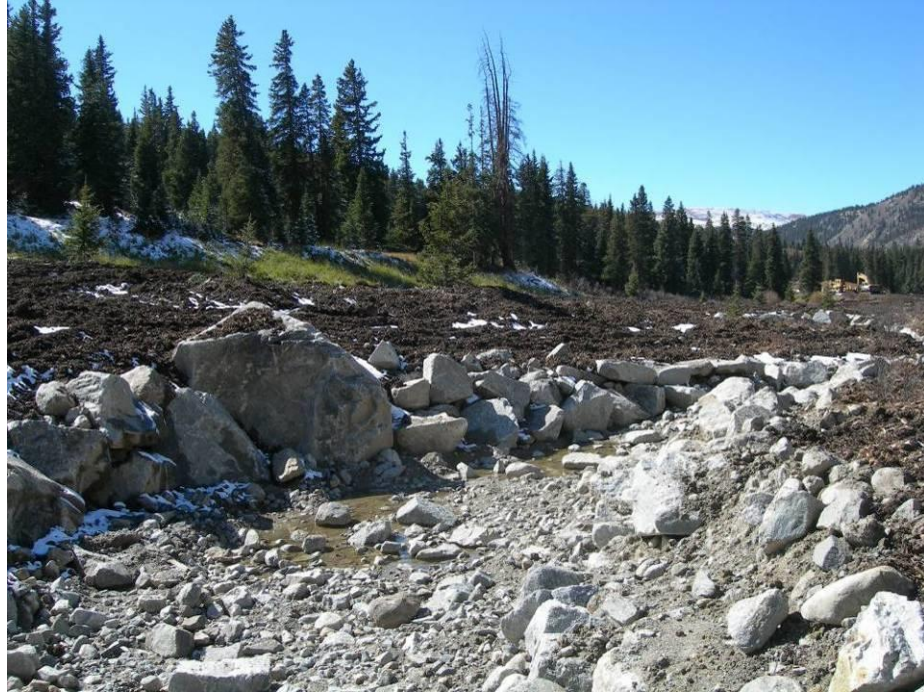
Figure 17. Keystone boulder and armoring at the outside of a meander.

Natural fluvial geomorphic processes create dynamically stable streams as a result of flow dynamics within meandering channel geometry. The sinuous alignment of the restored river was designed to encourage the development of point bars through these processes. Lower side slopes on the inside of meanders allow the river to access its floodplain, expanding and slowing flow and causing the deposition of sediments. On the opposite bank, at the outside of meanders, stockpiled material was used to provide armoring for steeper side slopes that are not overtopped during 100-year design storm. Boulder walls at these steep banks were configured specifically to prevent bank scour. Keystone boulders (Figure 17) were placed above footer rocks keyed into the toe trench and buried in the substrate. Additional boulders were set contiguous to the keystones for a distance of approximately 50 to 100 ft in both directions. These boulders were all placed in a manner to protect adjacent rocks from scour by tucking the upstream edge of the downstream boulder behind the next successive upstream boulder. This configuration deflects water away from the gaps between boulders which could be susceptible to infiltration or scour from flowing water. Once boulder placement was complete, areas behind the constructed banks were backfilled and bucket packed and smaller rip rap was installed along the length of the channel (Figure 18). Similar rock linings were observed in the reference reaches (Figure 19).

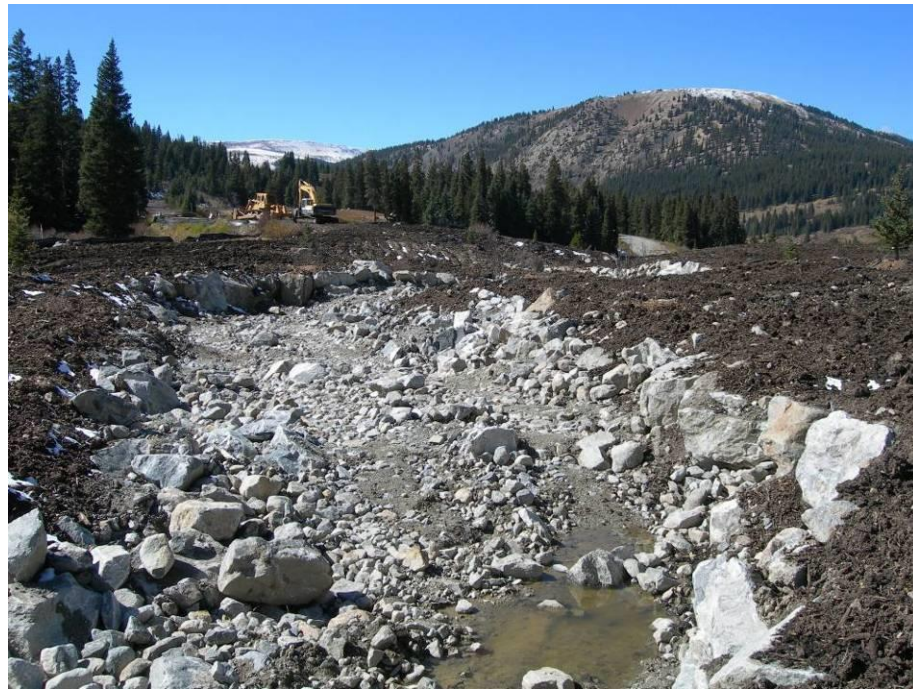
Figure 18. Incised channel will be overtopped by high flows at the inside meander to encourage point bar formation.

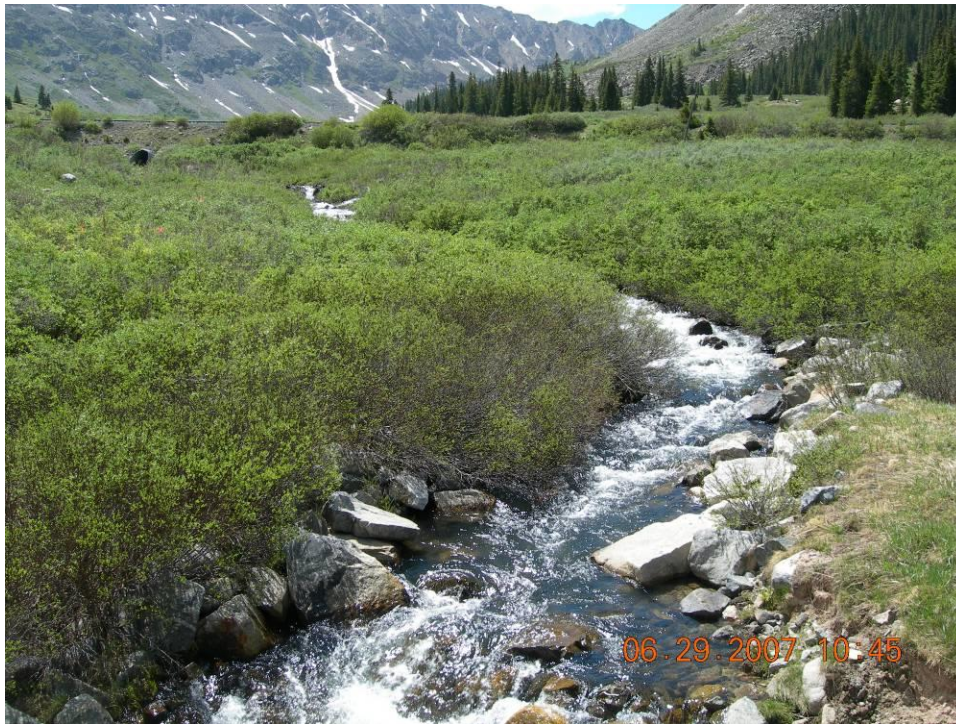
Figure 19. Reference reach incised channel geometry and rock armoring.

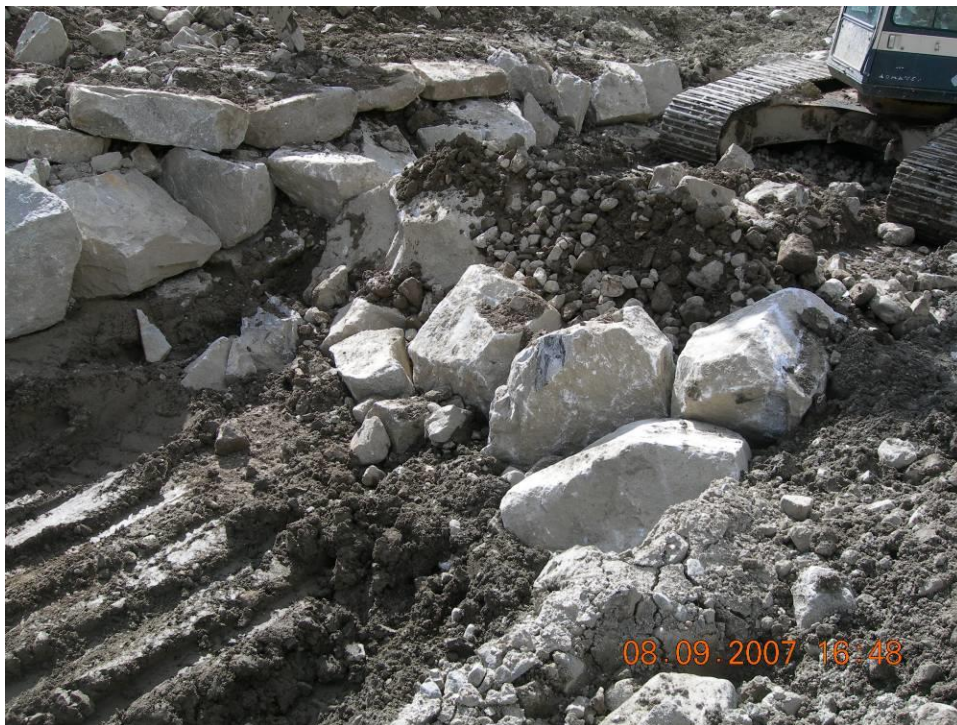
Figure 20. Riffle structure during construction.

Riffle-pool and step-pool sequences were created by placing boulders, keyed into the banks 3 to 6 feet deep, across the new channel to define the upstream pool and stabilize the downstream riffle or create the drop (Figure 20 and Figure 21). Encounters with bedrock outcrops (Figure 22) throughout the upper channel required some modifications to the design bed form. However, the overall grade of the upper channel remained 5.6% from the inlet to the lake. The bedrock outcrops were incorporated into the channel design as much as possible by redistributing the step-pool sequences. In all instances modified profile was within 1 ft of the specified elevations on the design plan. At several locations within the upper channel, bedrock was used as the substrate in place of the mix material and is visibly integrated into the bed and banks (Figure 23). Individual large rocks were placed in riffle reaches to enhance the aquatic habitat.

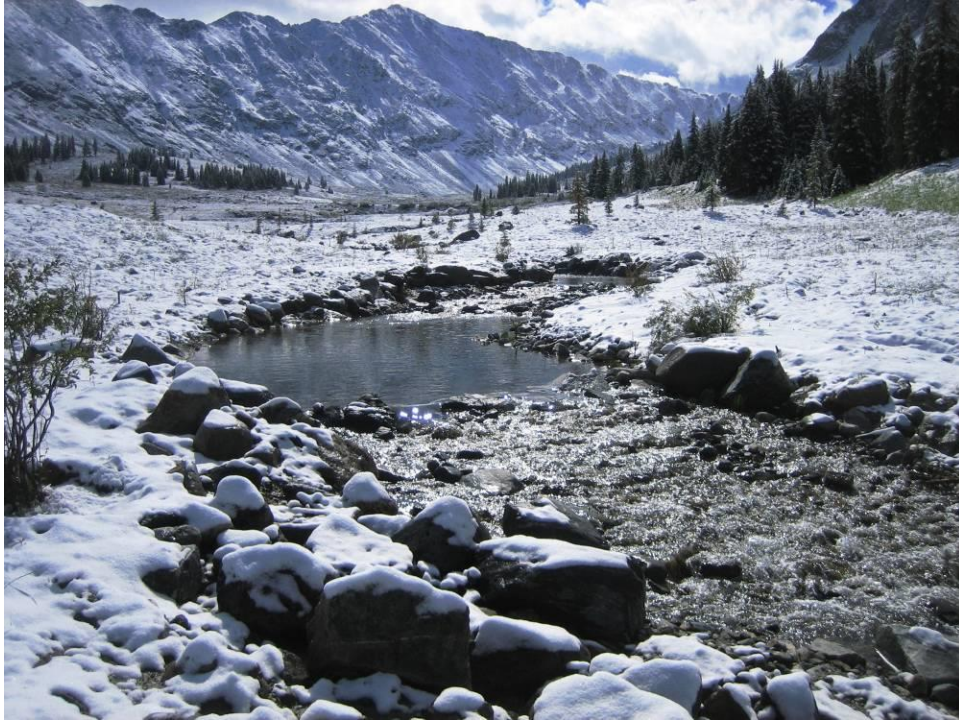
Figure 21. Completed riffle structure.

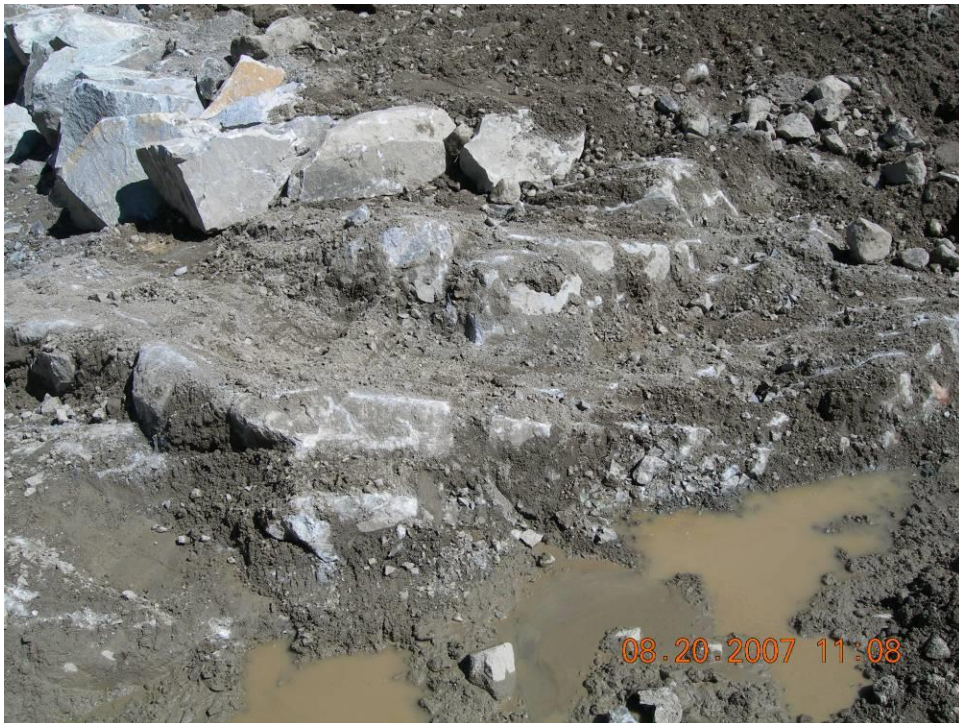
Figure 22. Bedrock outcrop encountered during construction.

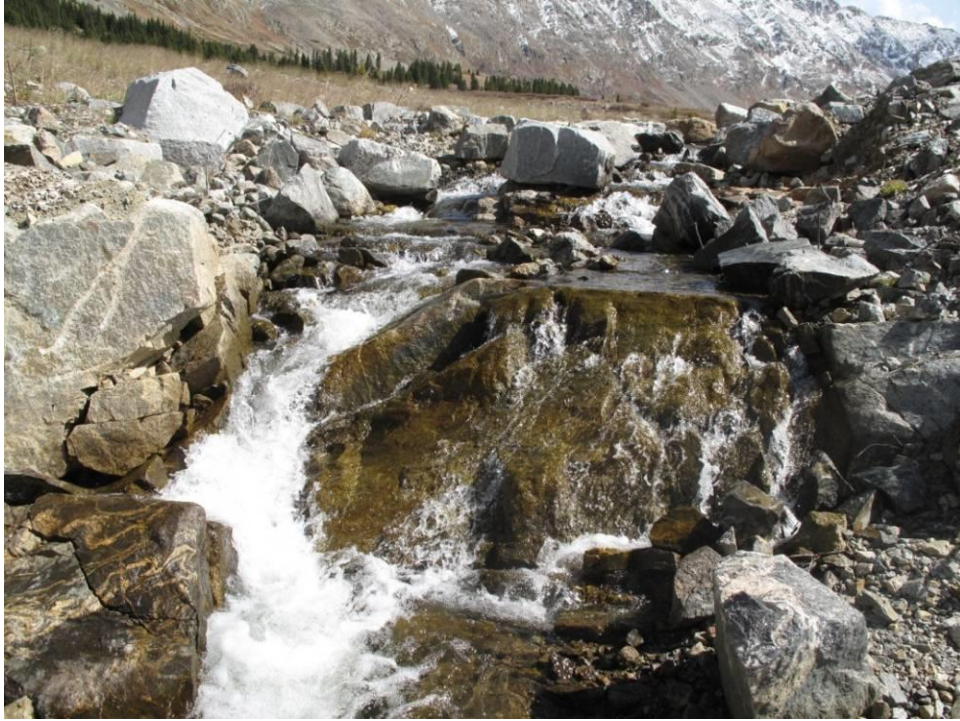
Figure 23. Bedrock outcrop incorporated into river bed and bank.

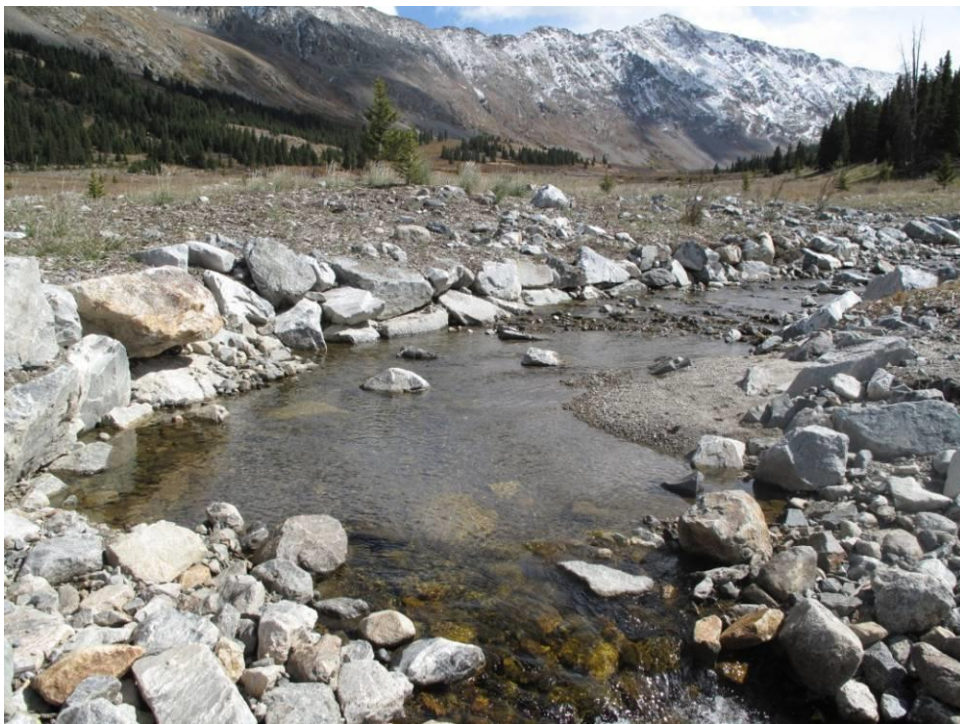
Figure 24. Point bar deposition at an inside meander.

geomorphic processes by the river during subsequent high flows. Fine materials have been redistributed in the channel by fluvial processes as expected, without a significant loss of material from the reach. Substrate diversity can be seen throughout the channel (Figure 24, Figure 25 and Figure 26), with the deposition of fines in pools, the formation of sandy point bars and cobbled thalwegs all occurring at various stream locations.

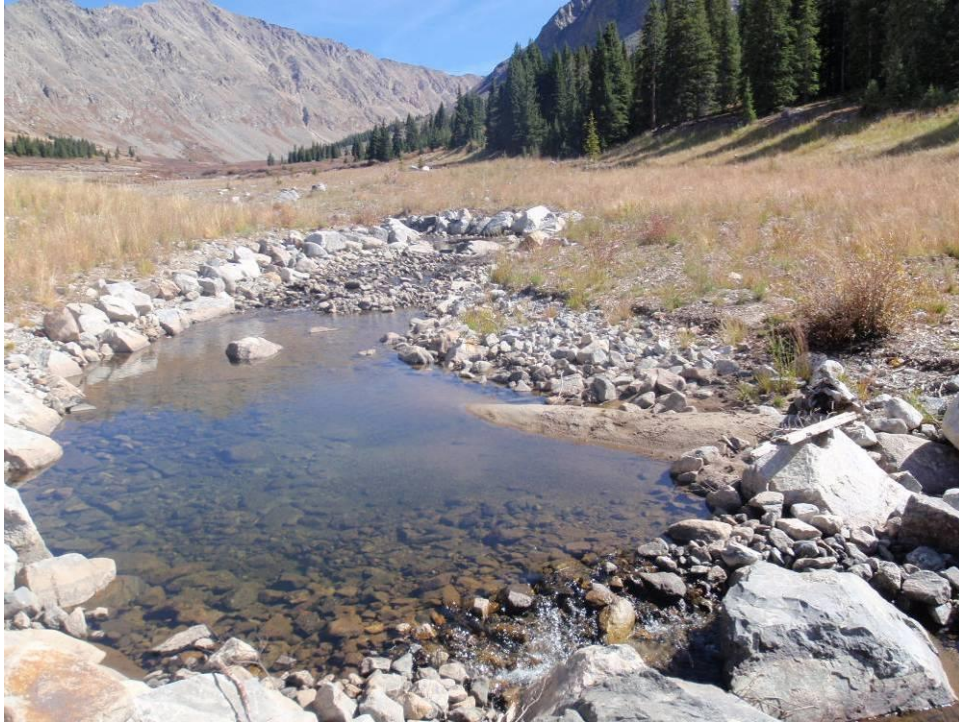
Figure 25. Deposition at an inside meander.

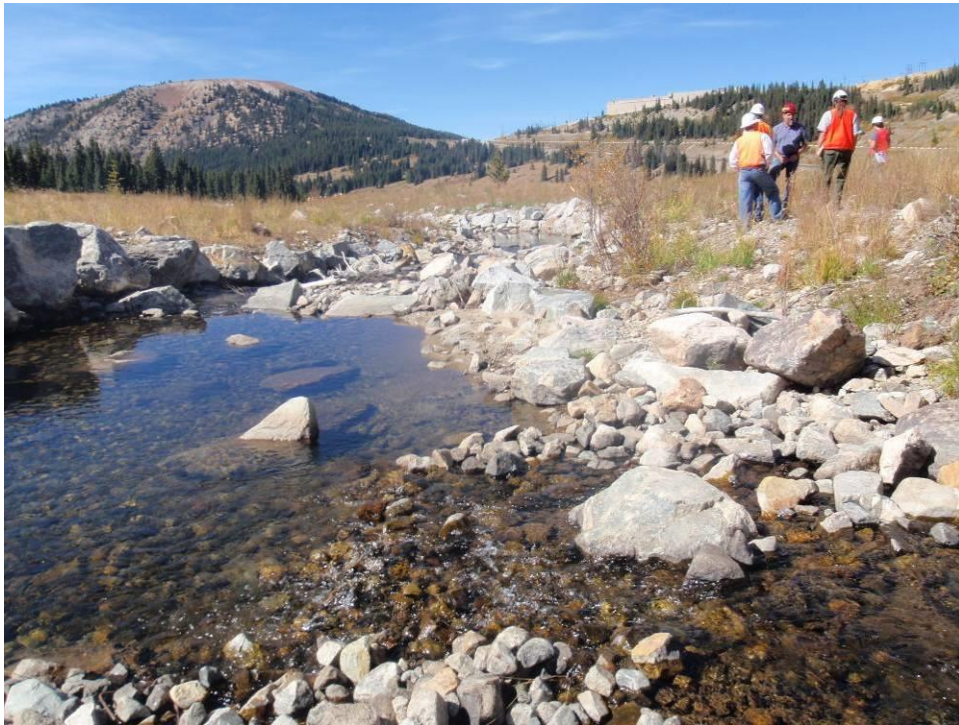
Figure 26. Deposition on the inside meander at a pool.

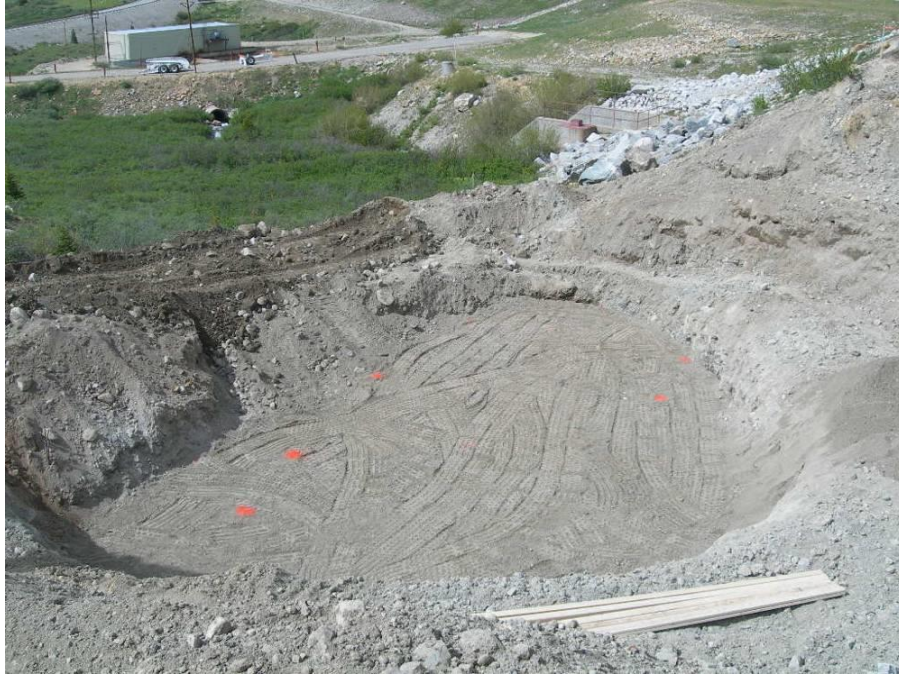
Figure 27. Compacted sub-grade for retaining wall of drop structure.

Phase one of the cut-off wall construction required the removal of approximately 10,000 yd³ of fill material to make space for the concrete wall. A structural engineer oversaw subgrade preparation due to the occurrence of organic materials in the substrate and the relatively fine textured footer materials (Figure 27). Starting on June 25, 2007, lifts of the subgrade, in 1 ft increments, were constructed to reach the desired elevation of 11,104.5 ft. Each lift was compacted with a mechanical sheep's foot and tested with a nuclear gauge to measure proctor densities. All measured densities were recorded at or above 98%.

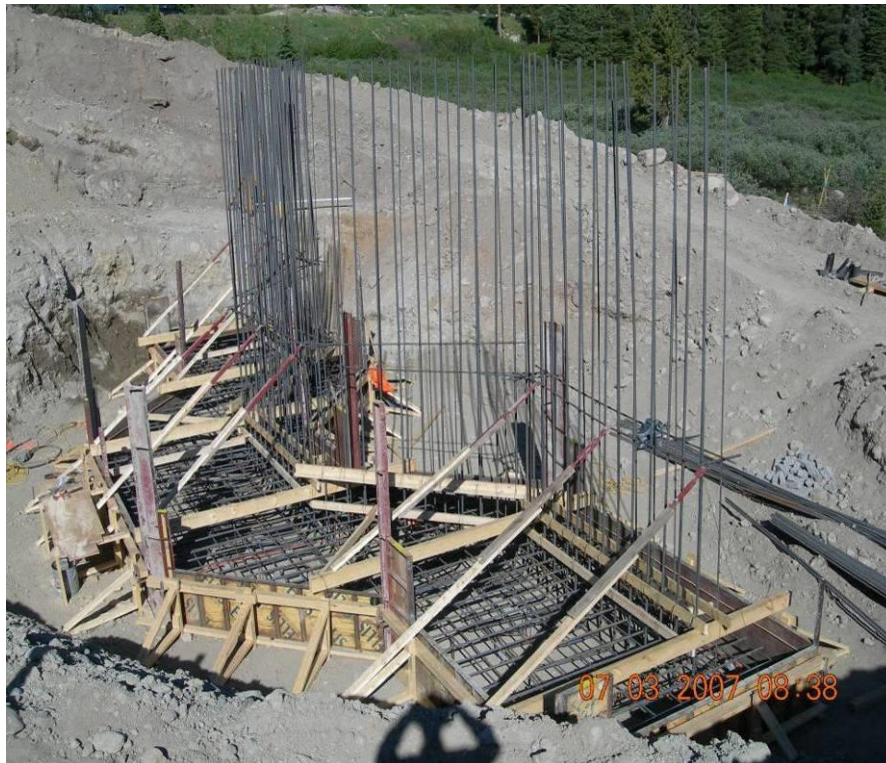
Figure 28. Rebar skeleton of drop structure retaining wall.

Construction of the cut-off wall began on June 5, 2007 with the layout and erection of the rebar skeleton (Figure 28). Fabrication of the cut-off wall occurred simultaneously with the channel excavation and construction of the lower reach. The concrete footer was poured on July 3, 2007 and the upper portion of the retaining wall was poured on July 16, 2007. Both pours were conducted with concrete pump truck and a CDOT Class D highway mix intended to break at 4500 PSI in 28 days. Slump and air entrainment tests were performed during the cut-off wall pour to quantify concrete break strengths. Once completed, the cut-off wall was left to cure above ground for approximately 45 days (Figure 29).

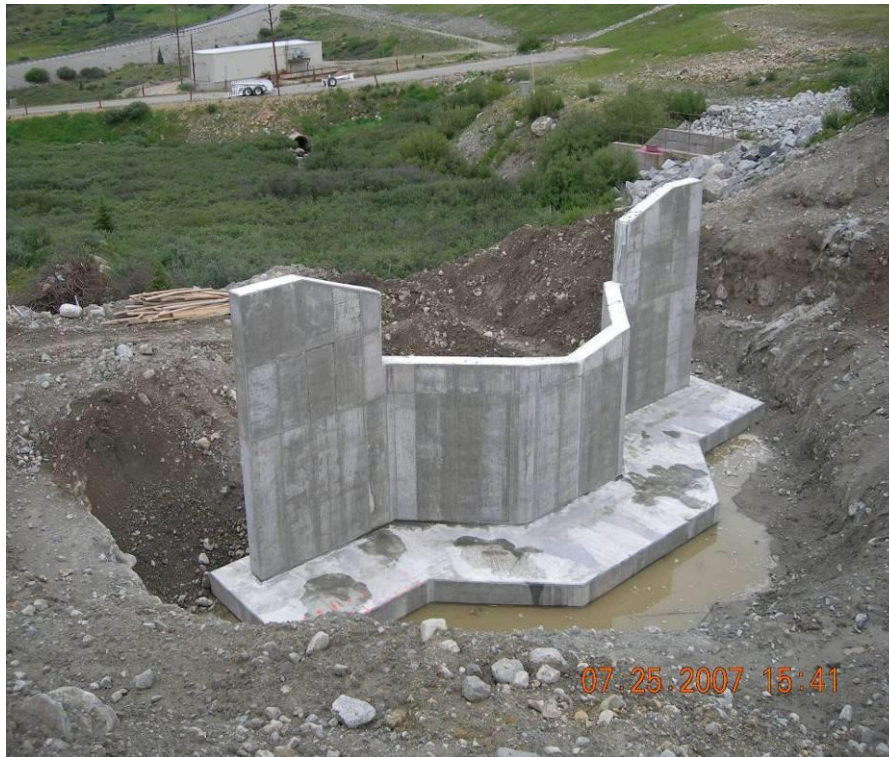
Figure 29. Finished retaining wall during 45-day cure period.
