A CASE HISTORY: RECONSTRUCTION OF THE EAST FORK OF THE ARKANSAS RIVER AT THE CLIMAX MINE¹

Kathryn Malers, P.E.², R. Spotts, P.E., K.E Carlson, and B.R. Romig

Additional Key Words: geomorphic design, channel restoration, mine reclamation

¹ Paper was presented at the 2011 National Meeting of the American Society of Mining and Reclamation, Bismarck, ND *Reclamation: Sciences Leading to Success* June 11 – 16, 2011. R.I. Barnhisel (Ed.) Published by ASMR, 3134 Montavesta Rd., Lexington, KY 40502.

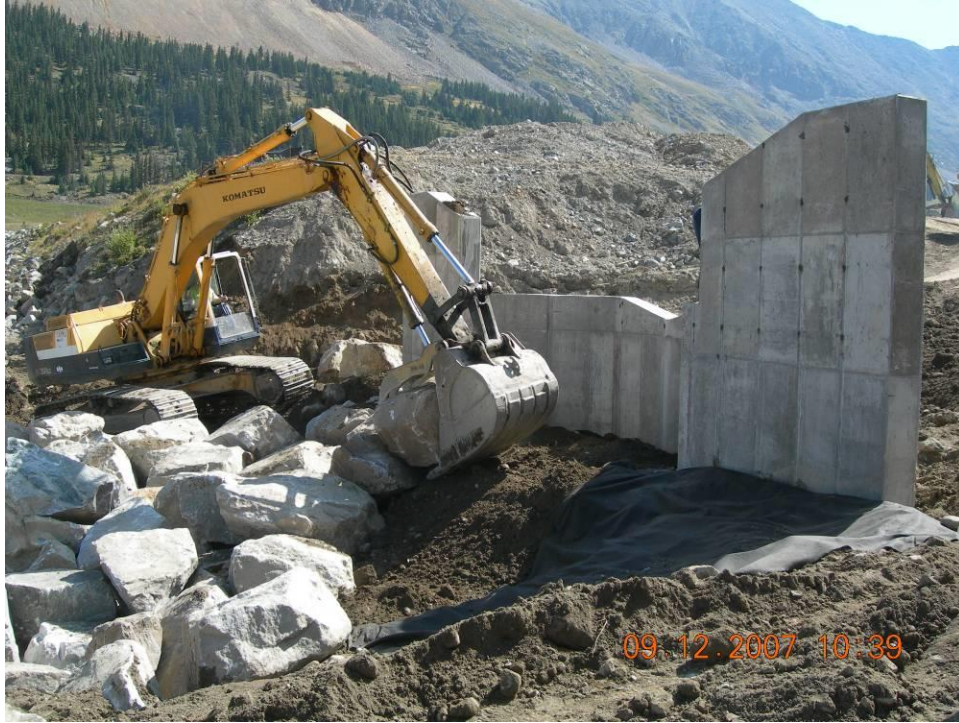
Figure 30. Placement of boulders over bedding materials and geotextile.

The downstream side of the waterfall required the over-excavation of an additional several thousand cubic yards of fill material. Boulder placement began once these materials had been removed and the stream channel above the drop structure had been completed. The stilling basin was constructed from the bottom up with two layers of 4- to 7-ft diameter boulders placed over a layer of geotextile and bedding material. Boulders were then placed up the face of the drop structure with the same overlapping method used for the river banks, eventually tying into the top of the cut-off wall (Figure 30). The inlet to the cut-off wall and drop structure was constructed with 2-ft diameter riprap placed over an impermeable 12 mil (.012-inch) thick vinyl geomembrane anchored to the wall (Figure 31). Once all boulders and rock had been placed, a concrete pump truck was used to grout the structure (Figure 32). Approximately 118 yd³ of a seven sack concrete grout were used to fill the voids on the face of the structure and the stilling basin. An additional 18 yd³ of grout were used to cement in the inlet and to pour a 4-ft deep cut-off wall. The completed drop structure provides visual interest from Highway 91 (Figure 33) and makes a discontinuity between aquatic biota in the river upstream and downstream of the feature.

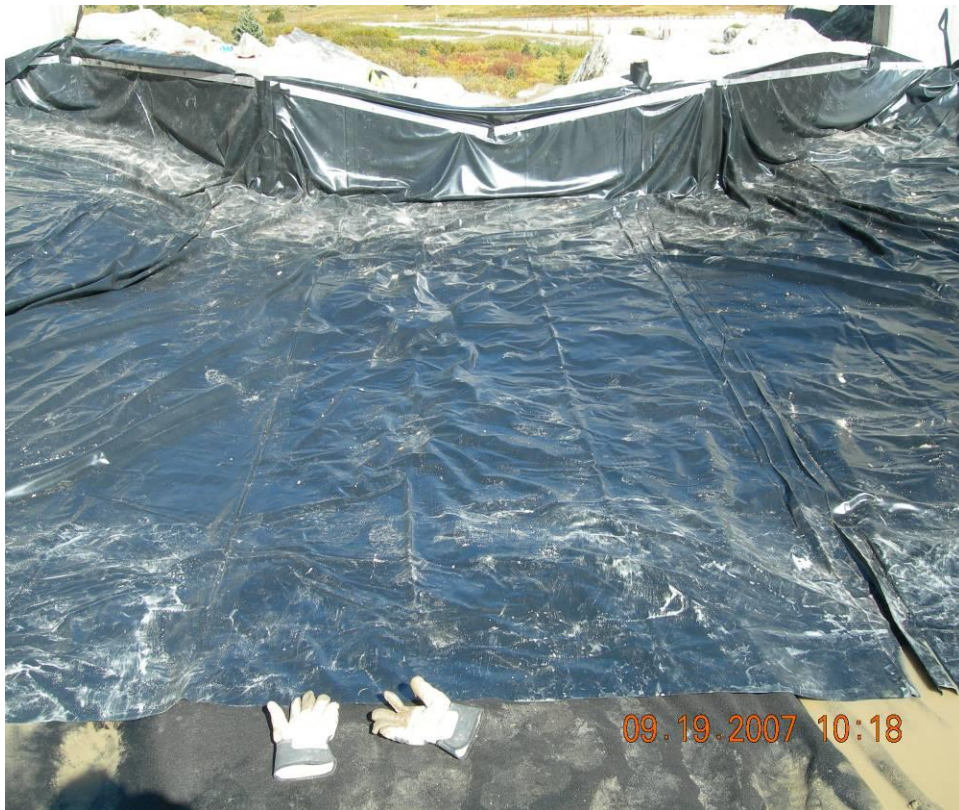
Figure 31. Geomembrane bolted to the retaining wall of the drop structure.

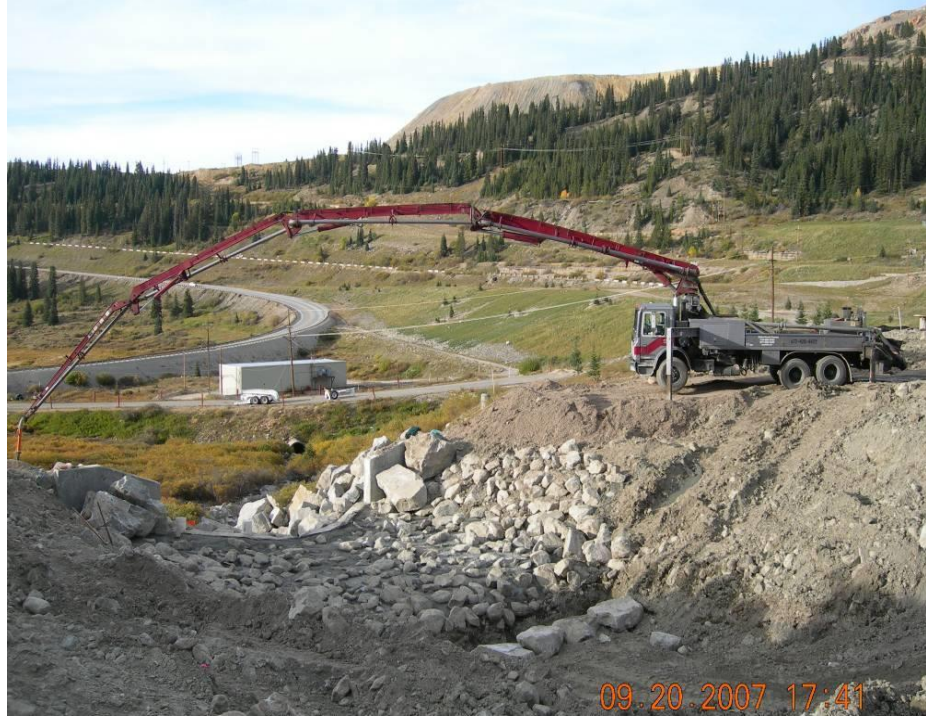
Figure 32. Concrete pump truck grouting drop structure.

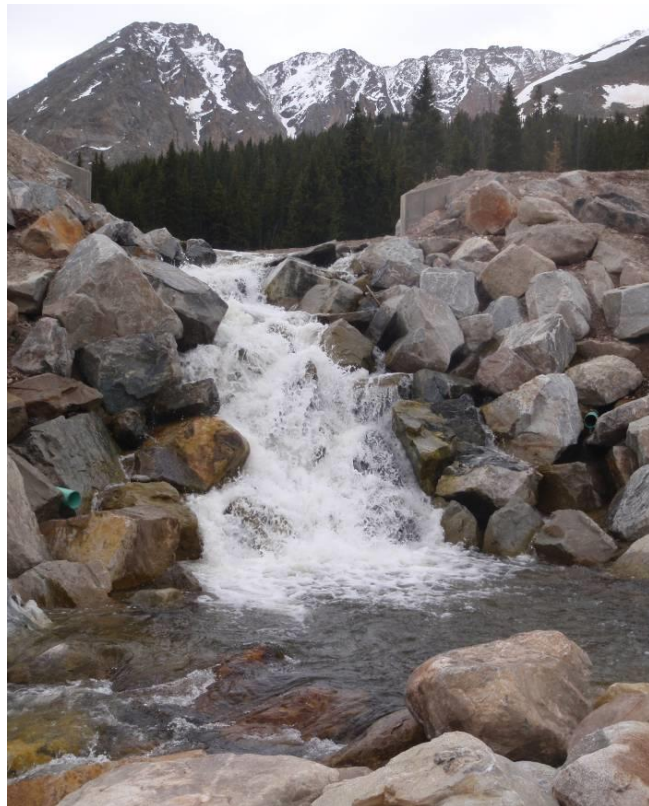
Figure 33. Completed waterfall feature.

The drop structure was designed to transition the newly constructed river channel from the fill material in the Storke Yard to the native hill slope below the fill embankment and to fulfill a request by Climax for a waterfall feature visible from Highway 91. Construction of the waterfall included placement of a concrete cut-off wall to prevent seepage through the structure that would potentially winnow the fine material from the foundation. The horizontal alignment of the concrete cut-off wall was configured to focus the water conveyed over the crest to the center of the plunge pool. Conveyance of the 100-year discharge will be accommodated within the notch of the cut-off wall. To ensure stability during the 100-year discharge and potentially greater events, 4 ft of freeboard has been engineered into the design of the drop structure as a safety factor. Adjacent areas upstream of the drop structure have between 2 and 4 ft of freeboard.

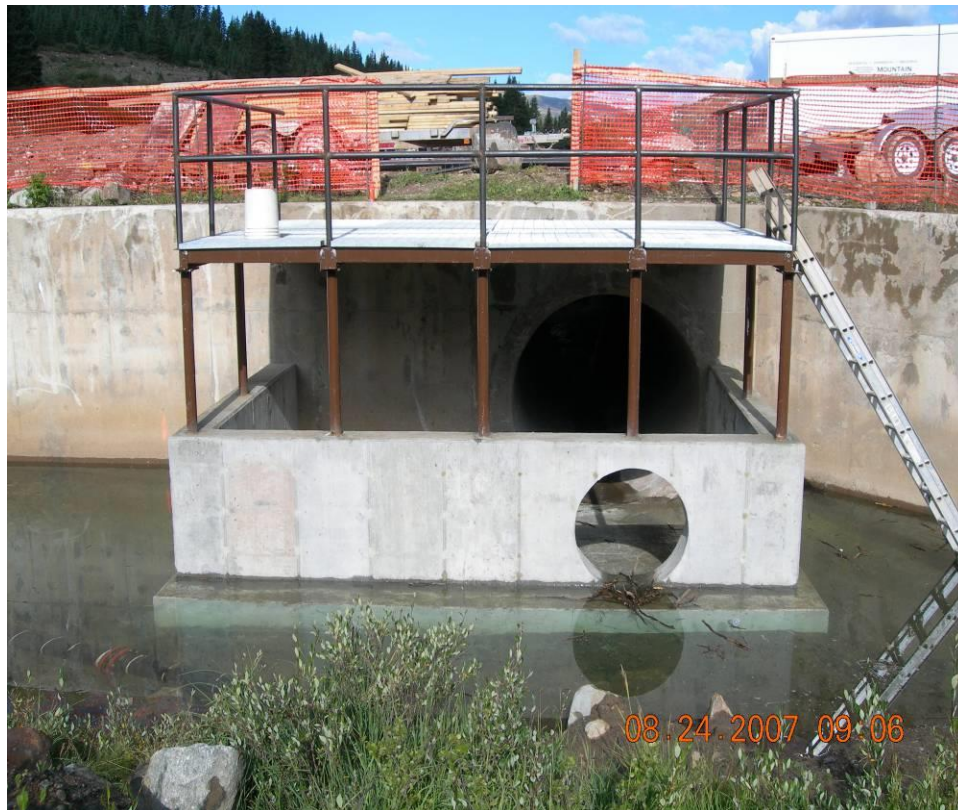
Figure 34. Inlet box with upper steel structure.

An inlet box was attached to the 7-ft diameter pipe, building off the footer of the existing concrete headwall and doweling into the wall face. Once the inlet box was completed, a 36-in diameter Waterman slide gate was bolted to the inlet box. A steel platform was built over the inlet box to allow access to the mechanism that raises and lowers the slide gate (Figure 34). The inlet box was left open at the top, allowing flood waters to overtop the wall and bypass the river.

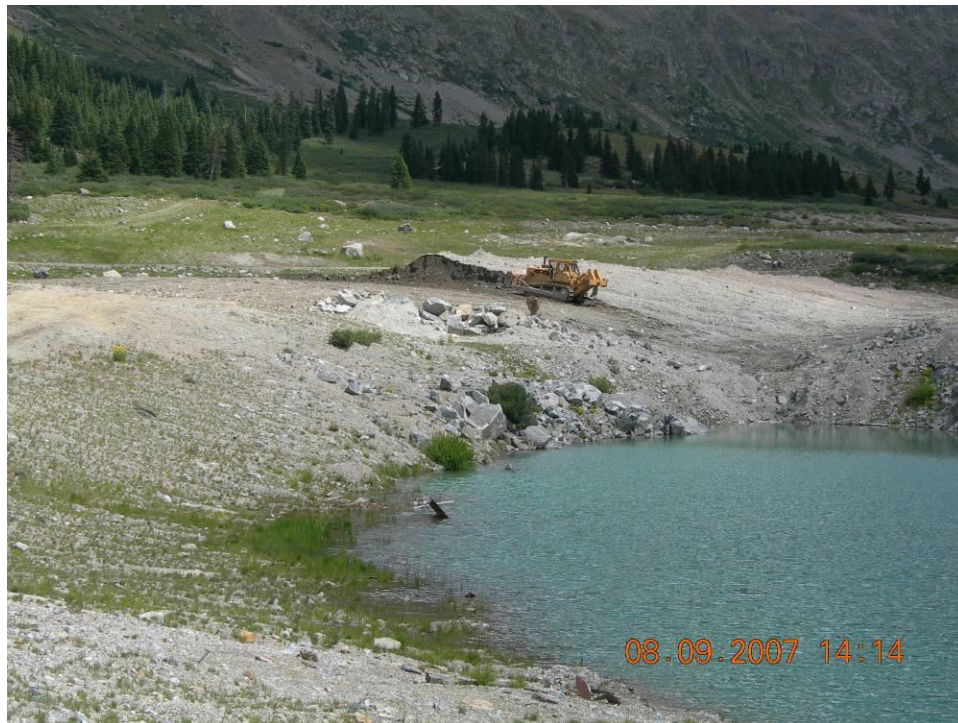
Figure 35. Pushing a materials stockpile into final topography.

Once channel reconstruction was completed, adjacent ridges and valleys were formed throughout the disturbed area of the Storke Yard and the reclaimed landform was tied to existing
