# ASSESSMENT OF WATER STORAGE COVER FOR QUESTA TAILINGS FACILITY, NEW MEXICO<sup>1</sup>

**Abstract.** A test plot study has been initiated to study the performance of a water storage cover consisting of alluvial soil over tailings proposed for final closure of a large 260 ha (640 acres) tailings facility located near the town of Questa, New Mexico. The test plot study has been designed to meet the following objectives (i) measure climatic conditions at the site; (ii) measure in-situ material properties (characteristic curves); and (iii) calibrate a soil-atmosphere model in order to predict net infiltration. The test plot study consists of two closed lysimeters covered with 0.25m (9") and 0.60m (24") of alluvial soil (silty gravel) over backfilled tailings, respectively, and an instrumented deep tailings profile with a 0.25m (9") thick alluvial cover and existing vegetation and a fully automated weather station, which monitors all relevant climate parameters (including actual evapotranspiration). The lysimeters are free-draining and leachate from the test plot is collected and monitored using a tipping bucket. All test plots were instrumented with temperature/suction sensors and m

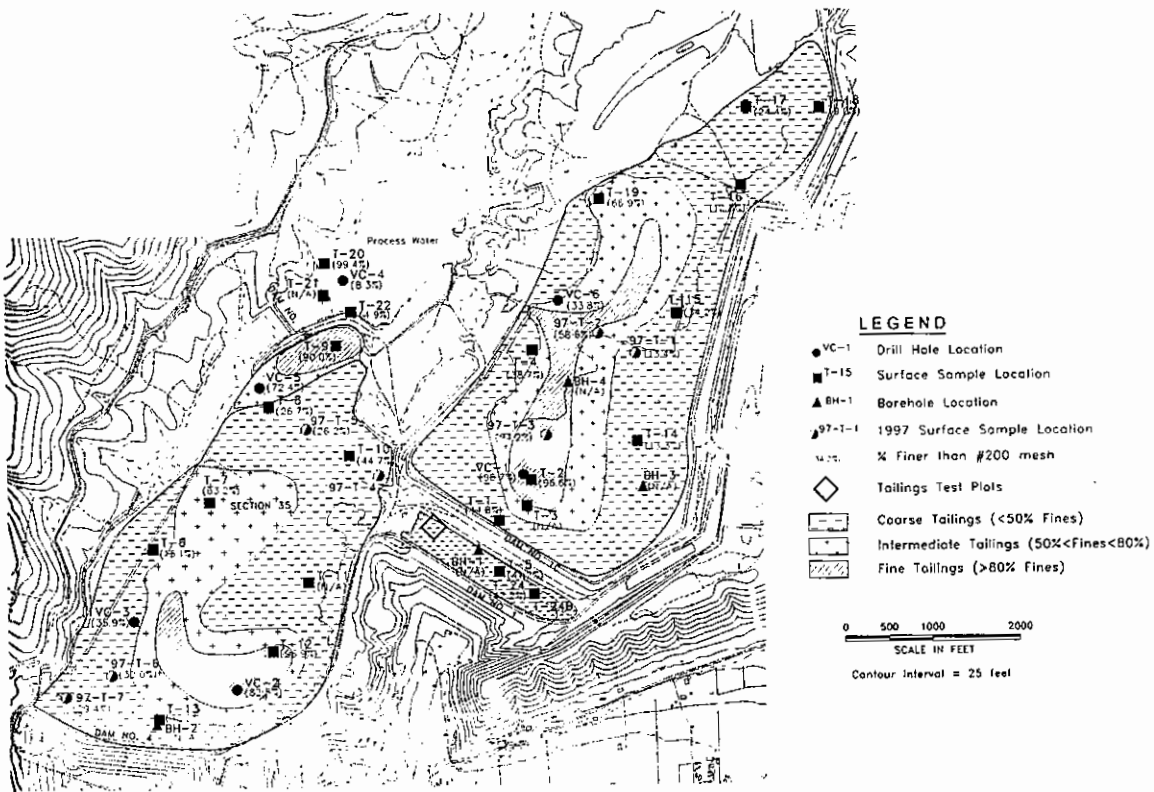
Figure 2. Tailings Characterization Plan for Questa Tailings Facility.

The test plots for this study were constructed on the tailings beach between Dam 1 and Dam 1C (Figure 2). Dam 1 was constructed in 1966 as an earthfill dam across an arroyo and was raised by downstream construction using earthfill. In 1975, "Old" Dam 1C was constructed of cycloned sand 200m upstream of Dam 1. In 1981 "New" Dam 1C was constructed at its present location (Figure 2). This 'new' dam replaces the old dam, which is

from the near surface were selected for analysis. Figure 2 shows the sampling locations.

Figure 2 shows the spatial distribution of these tailings classes in the tailings impoundments behind Dam No. 4 and Dam No. 1/1C as inferred using the laboratory results, surface topography (indicating beaches), current extent of surface ponding and a general understanding of the operation of these tailings impoundments.

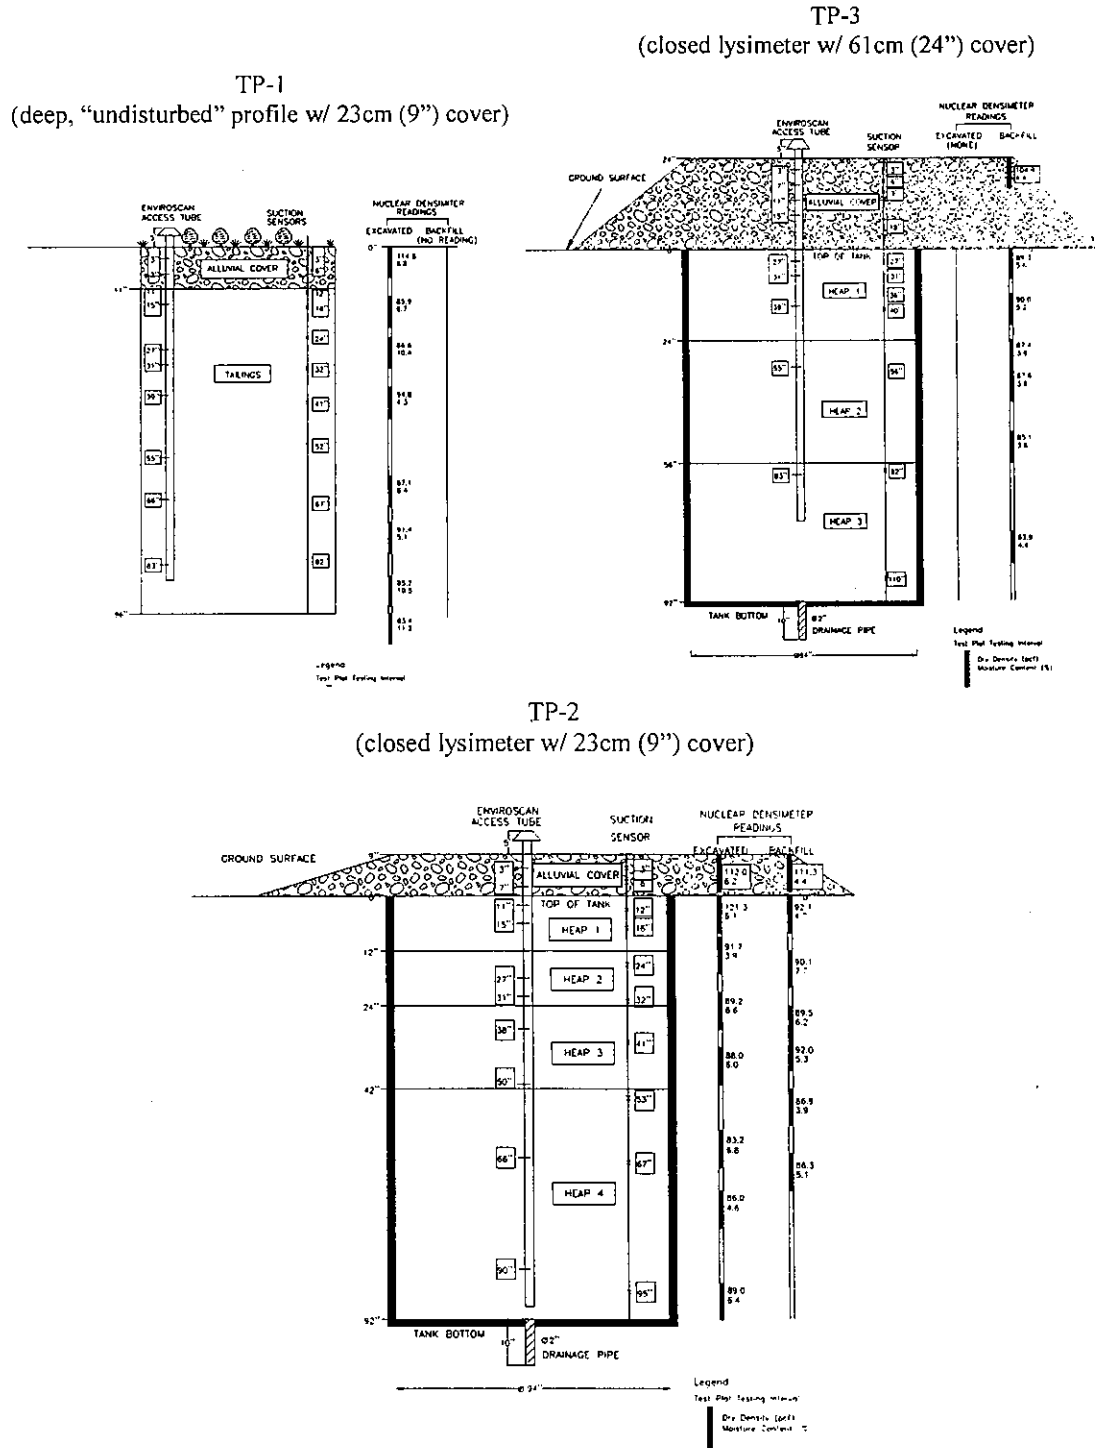
Figure 3. As-built drawings for test plot lysimeters TP-1, 2, 3.

Figure 3 shows the as-built drawings for test plots TP-1, TP-2 and TP-3 illustrating lysimeter dimensions, *in situ* testing results and instrumentation. The figure also shows details of the drain discharge system from the lysimeter to the manhole (for TP-2). At each test plot site, a foot print area of approximately 4.6mx4.6m was staked out and the tailings excavated to a total depth of about 2.4m. The excavated material was then stockpiled for later backfilling (for test plots TP-2 and TP-3 only). The mine rock profile encountered in the excavation was photographed and logged with respect to material type, texture, color, and moisture content. Paste pH and electrical conductivity measurements were taken at representative depths of the soil profile. In addition, representative samples were collected for calibration of the SENTEK moisture content sensors and for further physical and geochemical testing. *In situ* density and moisture contents were measured at representative depths during excavation (typically every 30-90cm and/or where a change in material properties was observed during excavation).

The construction and instrumentation varied between the deep, "undisturbed" profile (test plot TP-1) and the closed lysimeters (test plots TP-2 and TP-3). For test plot TP-1 an access ditch was excavated along one side of the test plot to a depth of approximately 2.7m. The access ditch was used to determine *in-situ* material properties, collect representative samples, and to provide access to the revegetated, undisturbed tailings profile for lateral installation of the suction-temperature sensors (Figure 3). The suction sensors were installed progressively from bottom to top during backfilling of the excavation trench. First, a pilot hole was drilled with a T-bar drill and then the suction sensor was pushed into the slightly undersized drill hole using a specifically designed installation tool to ensure good soil/sensor contact. The volumetric moisture content sensors were installed at the perimeter of test plot TP-1. A 3.5m long PVC access tube (50mm diameter) was pounded into the soil profile using a sledgehammer. Once in place, the soil and tailings present in the access tube were removed using a hand auger and the volumetric water content sensors inserted into the access tube (mounted on a rail).

at representative depths indicated that this backfill method resulted in compaction values very similar to those observed during excavation of the tailings (Figure 3). The resulting moisture content in the backfilled tailings was also very similar to the average moisture conditions observed during excavation (Figure 3).

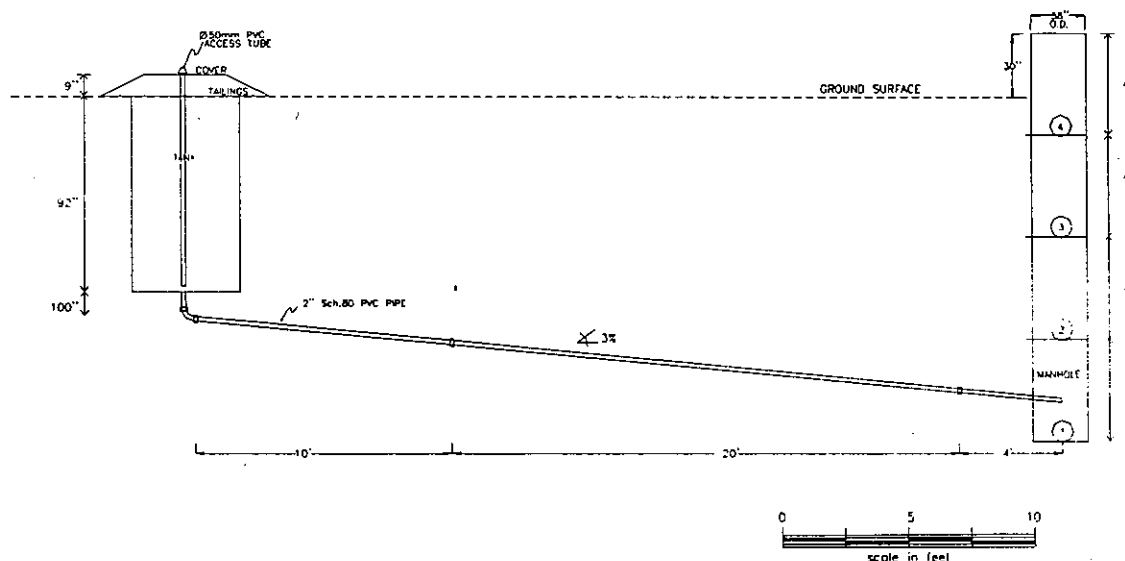
Figure 3 cont'd. As-built drawings of drain discharge system (for TP-2).

Once the lysimeter was backfilled with tailings back to surface a small trench was dug on one side of the excavation holding the lysimeter in order to install the discharge pipe, which connects the drain at the base of the lysimeter to a manhole (Figure 3). The discharge pipe was laid out on a 3% slope to allow easy drainage from the lysimeter. A 50mm  $\varnothing$  elbow at the end of the discharge pipe directs any drain flow downward into a tipping bucket flow gauge and a sampling bucket.

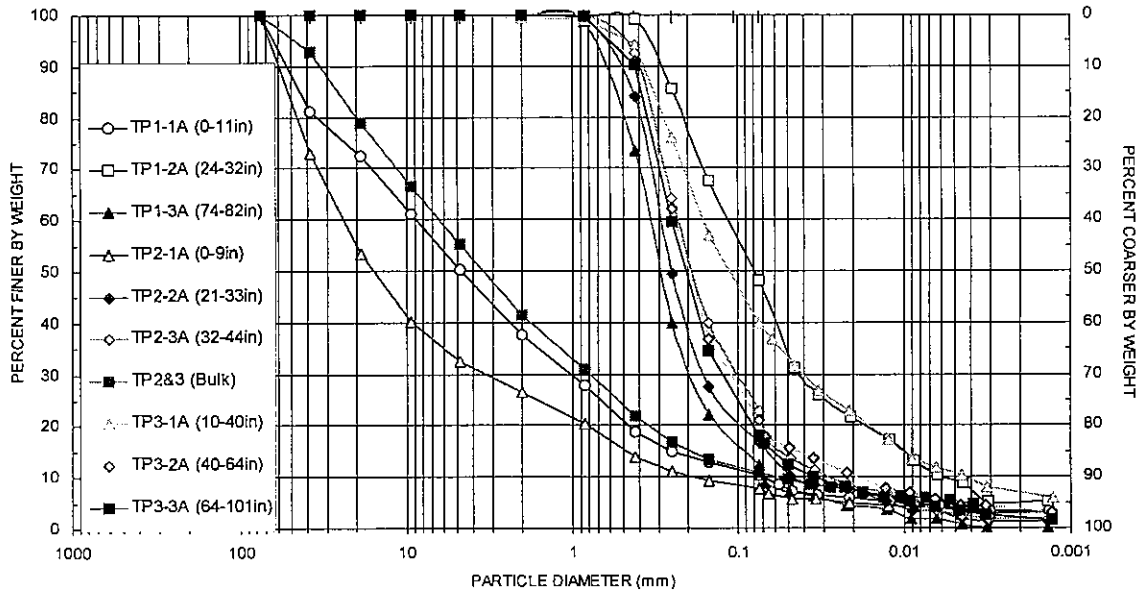
Figure 4. Particle Size Distributions for test plot samples.

Representative samples of tailings and alluvial cover material were taken during construction of the test plots and submitted for laboratory testing to determine hydraulic properties and soil water characteristic curves (see RGC, 2000b for details). The geotechnical characterization includes grain size analysis, moisture content, standard proctor compaction, permeability, and soil water characteristics (i.e. moisture retention). Figure 4 shows the particle size distribution (PSD) of the various tailings and alluvial cover samples taken

from the three test plots. The alluvial cover material represents a fairly well-graded silty/clayey gravel (GM-GC) with a fines content ranging from 7.8 to 10.9%. In contrast, the tailings encountered at the test plots represent a poorly graded silty sand (SM) with a fines content ranging from 12.4% to 48.2%. Hence the cover performance test plot study is most representative for the coarser beach areas that cover about 2/3 of the total tailings area at the Questa tailings facility (Table 1). Based on a review of the PSD data pertinent samples have been selected for standard proctor compaction, permeability, and soil water characteristics testing (RGC, in progress).

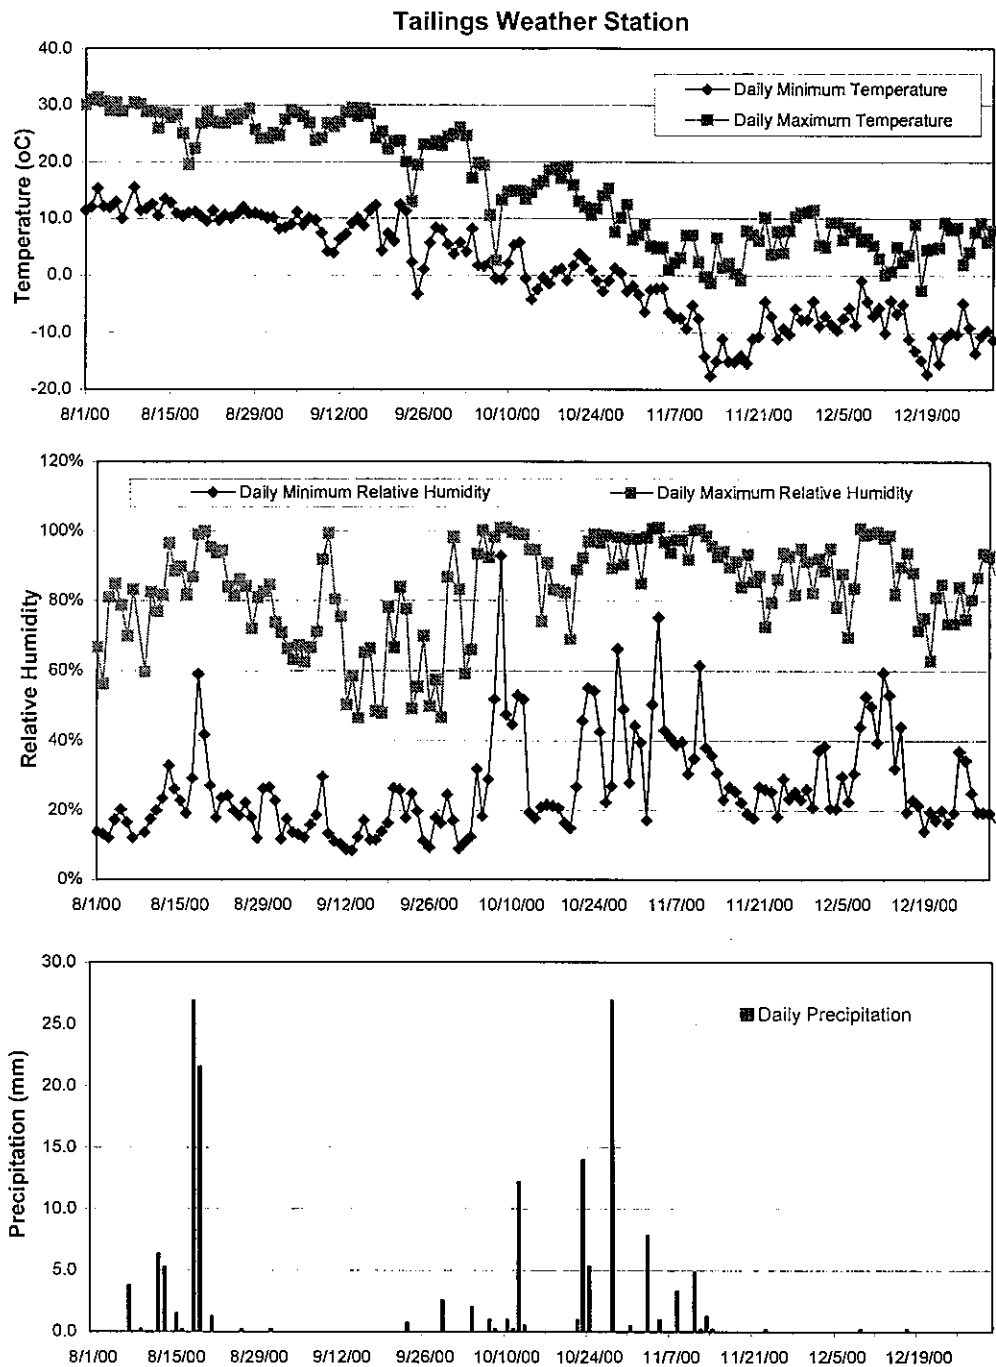
Figure 5 shows time trends of air temperature and relative humidity (daily min/max) as well as daily precipitation for the first five months of monitoring (August 9, 2000 to January 6, 2001). Table 2 provides summary climate statistics for this period. The amount of total precipitation over the 5-month period (155mm) was only slightly above the long-term average for this period (150mm) for the near-by weather station of Cerro (RGC, 1997). The majority of precipitation fell in mid-August and October to mid-November. The air

Figure 5. Time trends of temperature and relative humidity (daily MIN/MAX) and precipitation for the five months monitoring period.

temperature and relative humidity showed significant daily variations characteristic for this semi-arid climate. From mid-October onward, air temperature dropped consistently below the freezing point during the night while rising well above the freezing point during the day.

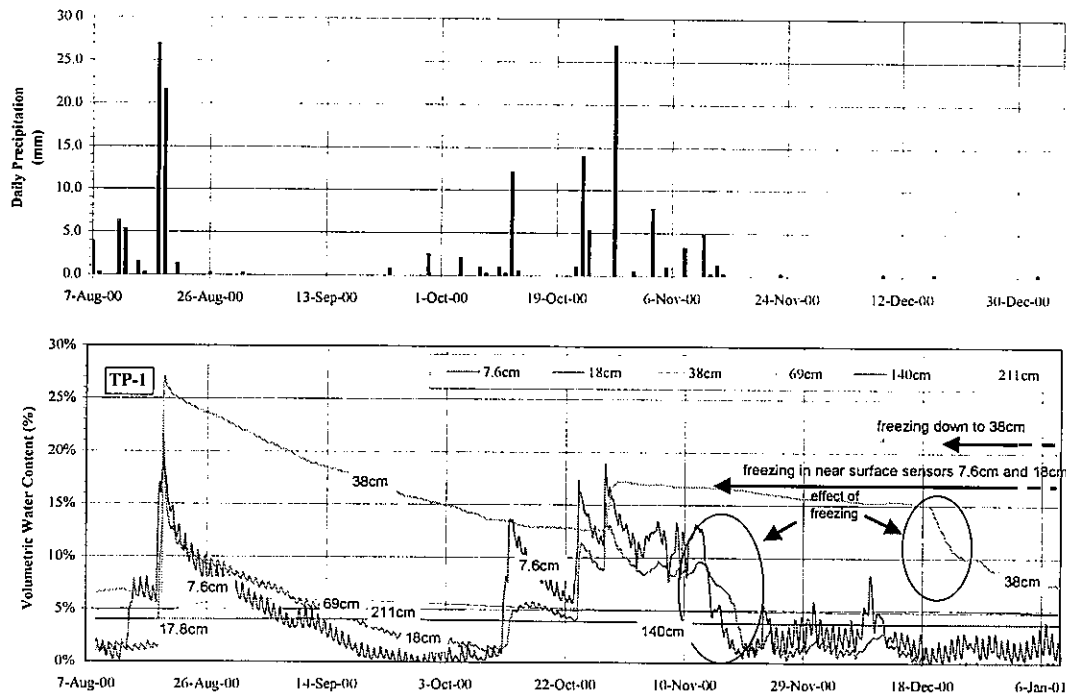
Figure 6 shows the time trends of volumetric water content for the deep, undisturbed test plot profile (TP-1). The daily precipitation is also shown for comparison. The first significant wetting occurred in response to heavy precipitation in mid-

Figure 6. Time trend of Volumetric Water Content for TP-1 and associated precipitation.

August when 48mm fell in 2 days. In the near-surface layers (top 38cm) of the cover/tailings profile the volumetric moisture contents exhibited a very rapid increase (during the rainfall period) followed by a very gradual decline due to subsequent evapotranspiration and drainage. Similar wetting/drying patterns were observed in subsequent precipitation events (Figure 6). Note that infiltration during this five-month period was limited to the near-surface layers. The deepest moisture content sensor recording any appreciable increase in moisture content was located at a depth of 68cm (Figure 6). The deeper tailings profile did not show any change in moisture content throughout this period.

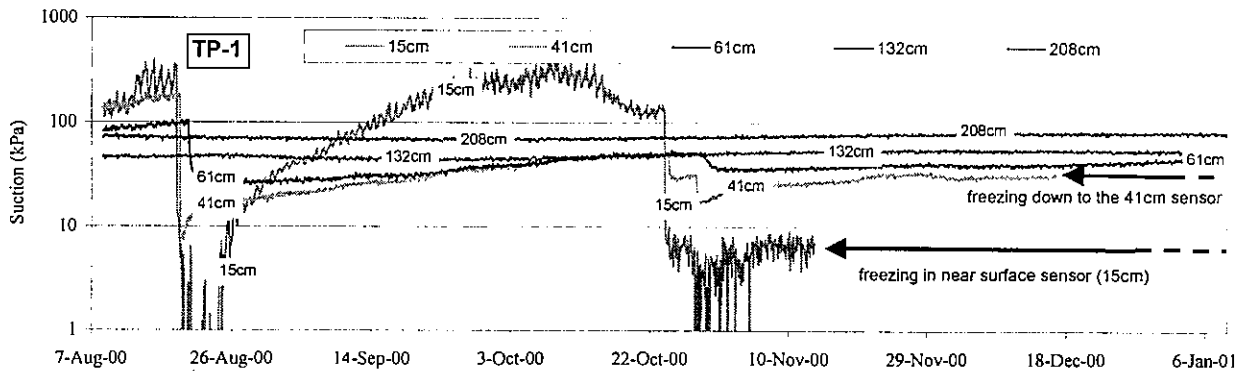
Figure 7. Time trends of soil suction for test plot TP-1.

Figure 7 shows the time trends of soil suction for the deep, undisturbed test plot profile (TP-1). Note that high suction values indicate dry conditions and low suction values indicate wet conditions. As expected the suction values declined sharply in the near-surface layers (up to about 60cm) in response to heavy precipitation and then gradually increased due to subsequent evapotranspiration and drainage. In other words, soil suction is inversely correlated with volumetric moisture content (Figures 6 and 7). Note that the tailings remained unsaturated (suction  $\gg$  1 kPa, e.g. at 41cm depth) whereas the alluvial cover material approaches saturation (suction  $<$  1 kPa, e.g.

at 15cm depth) during the heavy precipitation in August (Figure 7).

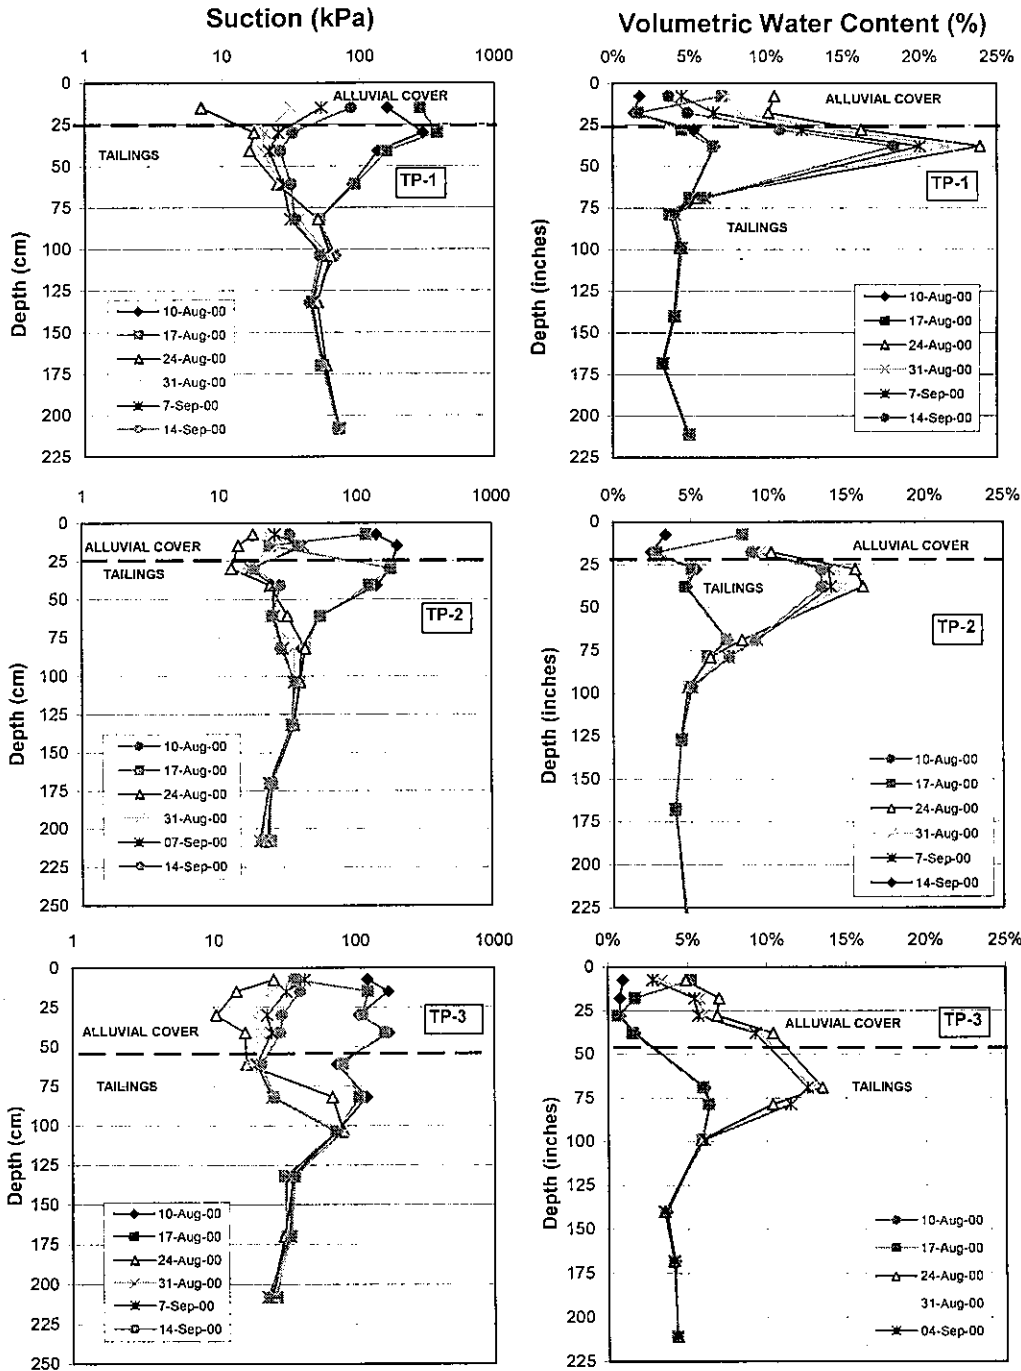
Figure 8. Suction and Volumetric Water Content profiles for TP-1, TP-2 and TP-3.

Figure 8 compares suction and moisture content profiles in all three test plots during the period August 10 – September 14, 2000, i.e. the

period bracketing the first significant infiltration event (Figures 6 and 7). The depth of the alluvial cover is shown in these profiles for comparison. The suction and moisture content profiles are generally very similar in all three test plots. The heavy precipitation on August 18-19 resulted in a

wetting of the cover/tailings profile to a depth of about 75-100cm. The volumetric moisture content in the alluvial cover was generally significantly lower than in the underlying tailings despite similar, if not lower, suction values (Figure 7). This is a result of the much coarser soil texture and hence lower porosity of the cover relative to the tailings (Figure 4). The lower porosity of the alluvial cover also results in a deeper wetting front for the case of a 0.60m thick cover (up to 1m wetting in TP-3) compared to the case of a 0.25m (9") cover (~75cm wetting in TPs 1 & 2). These observations highlight the fact that the tailings have a much better water storage capacity than the alluvial cover.

A comparison of the suction and moisture content responses in test plots TP-1 and TP-2 illustrates the influence of vegetation on cover performance. The presence of a mature grass and brush vegetation in test plot TP-1 resulted in increased drying of the alluvial cover and the underlying tailings compared to the barren test plot TP-2, as illustrated by higher suctions and lower moisture content readings following the rainfall events (Figure 8). These observations support the contention that the upper layers of the tailings are part of the active root zone and can function as an important component of a "store-and-release" cover (RGC, 1998).

The volumetric moisture content and suction values showed very little, if any, variation at depths greater than say 100-125cm below ground surface throughout the first five months of monitoring. These results are consistent with observations in the manholes of the closed lysimeter test plots TP-2 and TP-3, where no discharge was recorded for the first five months of monitoring. Based on the observed rates of net infiltration it may take as much as 1-3 years (or more) before there will be any measurable discharge from the base of the lysimeters (at a depth of ~280-330cm).
