# RECLAMATION AND REVEGETATION IN THE COPPER BASIN: LONDON MILL AREA<sup>1</sup>

**Abstract:** The Copper Basin, located in southeast Tennessee, is the site of extensive copper mining and processing operations dating back to the mid-1800s. The London Mill area within the Copper Basin, which included a mine and a flotation plant to separate metal sulfides from waste rock, was abandoned in 1987. Under a voluntary agreement, Glenn Springs Holdings, Inc., a subsidiary of Occidental Petroleum Company, has developed and implemented a remedial plan for the London Mill area to address safety and human health hazards and conduct environmental restoration activities. The remedial approach for the London Mill area required a combination of reclamation activities including elimination of physical hazards, removal or isolation of waste materials, diversion of clean water, collection and treatment of mine-impacted water, and stabilization of surface conditions.

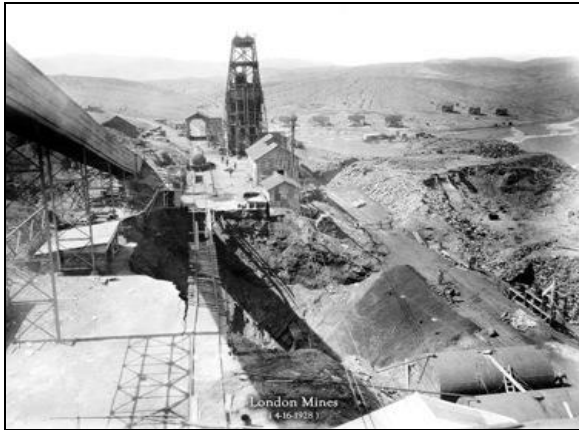
Figure 2. London Mine 1928

The London Mine (Fig. 2) was first operated in 1853 and continued operating until 1926 when the mine was permanently closed. The underground workings extended to approximately 366 meters (1,200 feet) below the ground surface and produced more than 1,451,200 tonnes (1,600,000 tons) of sulfide ore (BWSC, 2000).

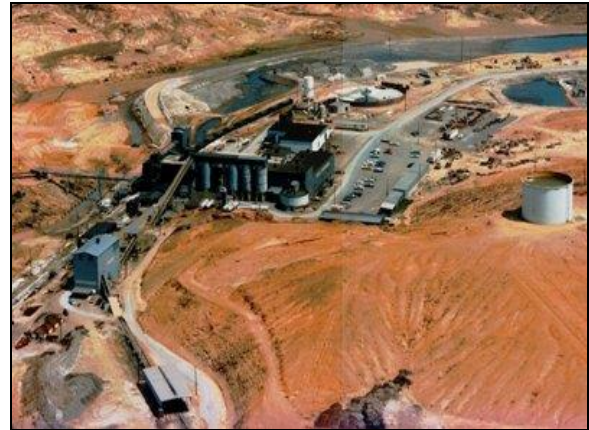
Figure 3. London Mill Plant 1975

Ore from the mine was transported by rail to the primary crushers at London Mill where the mined rock was crushed in a two-stage process to a finely ground ore (see Fig. 3). This finely ground ore then went to the London Mill Flotation Plant, which was built in 1922 to process ore from the Burra-Burra, London, Eureka, and Polk County mines. The London Mill Flotation Plant separated metal sulfides from the gangue, or waste rock, by froth flotation and filtration. This process recovered iron concentrate suitable for making Fe sinter and Cu concentrate for production of Cu and lesser amounts of Zn concentrate. The flotation cells within the London Mill Flotation Plant used lime, creosote, pine oil, nalcolyte, cyanide, sodium silicate, acids, and xanthate as flotation reagents (BWSC, 2006d).

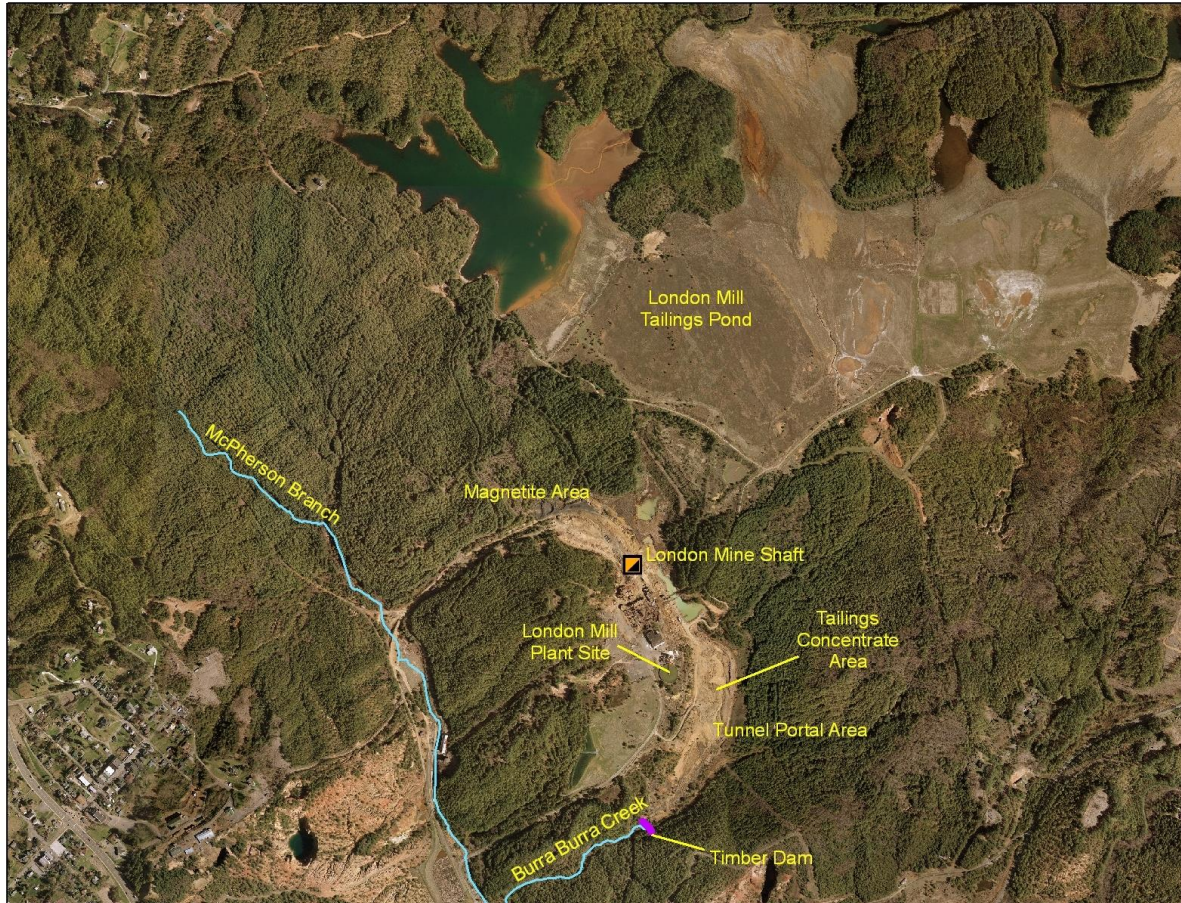
Figure 4. London Mill Operation and Waste Disposal Areas

All flotation operations within the Basin were consolidated to London Mill in 1958. In 1987, the London Mill Flotation Plant was abandoned and partially dismantled by salvage companies. Waste materials and excess product remained stockpiled or temporarily disposed at several locations within the London Mill area: London Mill Tailings Pond; Upper Burra-Burra Creek; Magnetite area; London Mine Shaft; London Mill Plant Site; Tailings/Concentrate area; and the Isabella Tunnel Portal area (see Fig. 4).

GSH undertook the task of reclaiming the London Mill area in 2001. Since then they have removed and isolated acid-generating material; properly disposed of hazardous wastes, PCBs and asbestos; filled voids with clean fill to address physical hazards; routed clean water away from contaminated areas; collected impacted water for treatment; and graded, covered with soil material and revegetated in each of the operation and waste disposal areas shown in Fig. 4. The following describes the reclamation and remedial actions taken in the areas impacted by mining

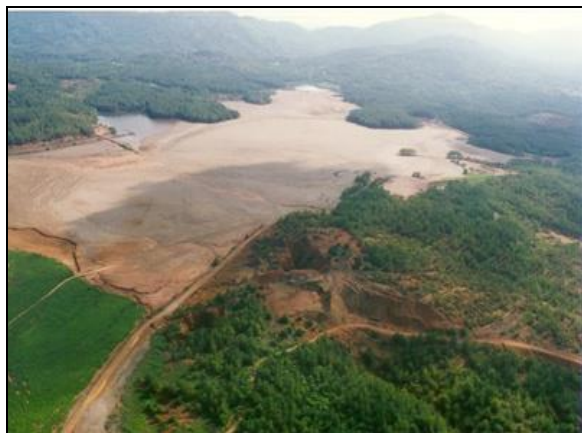
Figure 5. London Mill Tailings Pond 1993

The London Mill Tailings Pond is the northern-most operating unit in the Lower North Potato Creek Watershed. From 1946 until 1987, tailings from the London Mill Flotation Plant were disposed in the Tailings Pond. The Tailings Pond forms a broad, mostly barren, and nearly flat plain covering approximately 1.5 square kilometers (370 acres) (Fig. 5). The tailings are a slightly silty, fine to medium sand with minor amounts of metal sulfides in localized areas. In 1998, the University of Tennessee established revegetation test plots on a portion of the tailings to determine which plants and soil amendments were most likely to grow successfully on the tailings material (Cook, 2000). Several native grass mixtures were tested with various

In 2002, GSH, as a means of controlling fugitive dust from the tailings, revegetated the Tailings Pond by applying agriculture lime at the rate of 6.7 Mg/ha (3 tons/Ac) and 318 kg (700 lbs) of 5/20/10 fertilizer (N-slow release sulfur coated urea) per 0.41 hectare (1 acre) to the tailings, incorporating these amendments by discing, and then seeding the tailings. Seeding rates and mixtures applied are described in the Revegetation Section. Hay mulch was then applied at the rate of about 6.7 Mg/ha (3 tons/Ac). In addition to the hay, compost mushroom was spread over a 12.2 hectare (30 acre) area and tilled into tailings. These seeding efforts were highly successful (see Fig. 6).

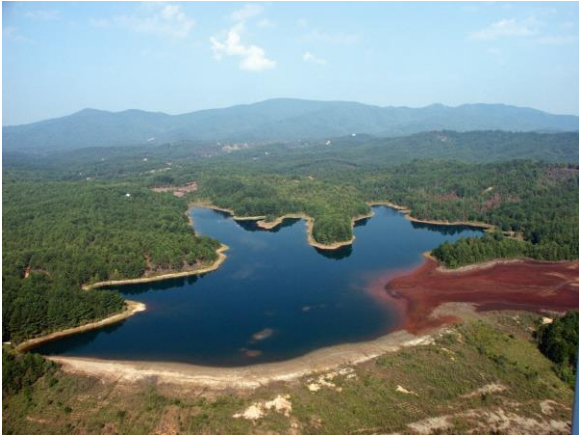
Figure 7. Tailings Pond Water Body 2007

The starter dike for the Tailings Pond was constructed in the mid 1940s. The outfall of the surface water retained by the Tailings Pond is a spillway that was relocated in 1962 (see Fig. 7). Additional modifications were made to the spillway in 1976 and 1996 to include a concrete weir and then a system to regulate flow from the Tailings Pond to Burra-Burra Creek after the previously installed sluice gate became inoperable. Water from the Tailings Pond outfall and upper portion of Burra-Burra Creek is of relatively good quality; however, as the surface water entered the London Mill area there was a significant decrease in water quality (BWSC, 2006b). The base flow and storm flow, up to and including the 10-year/24-hr storm, from the Tailings Pond outfall and the upper portion of Burra-Burra Creek has been diverted to McPherson Branch of Lower North Potato Creek. Diversion of this water prevents commingling of good quality water with poor quality water and reduces the volume of water in the London Mill area requiring treatment. Completion of this diversion required modification of the existing Tailings Pond spillway, construction of a low-head dam on Upper Burra-Burra Creek, and installation of a diversion pipeline (see Fig. 8). Construction of this diversion began in mid-October 2006 and was completed in March of 2007.

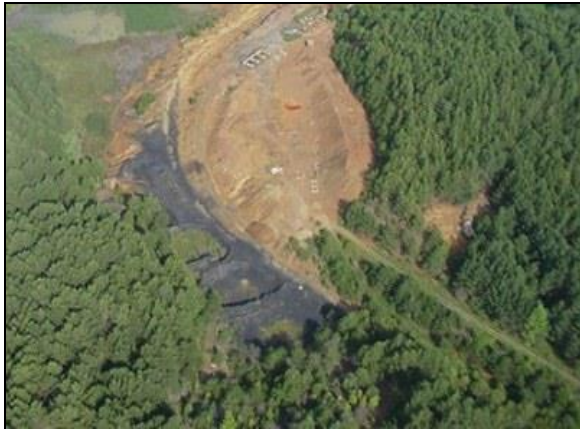
Figure 9. London Mill Magnetite Area - Before

The London Mill Magnetite Area was located at the northern end of the London Mill area. The pile was approximately 30.5 m (100 ft) by 45.7 m (150 ft) and contained an estimated volume of 1,758 m<sup>3</sup> (62,100 cu-ft) of magnetite (see Fig. 9). Neither sulfides nor oxidation salts were visible in the field. The magnetite contained elevated levels of Cd, Cu, Fe, Pb, Se, and Zn.

In 2007, GSH hauled the magnetite to the Isabella Pit for sub-aqueous disposal, graded the remaining material, established drainage control, covered the graded area with 0.46 m (18 in) of soil material, and revegetated the area consistent with the revegetation methods described later in the Revegetation Section (see Fig. 10). The Isabella Pit is located east of the London Mill Area and is the result of several planned collapses of stopes in the Isabella Mine that occurred in 1960 through 1974. After several years of study of the pit and associated groundwater conditions, the sub-aqueous disposal of materials was determined to be an efficient, environmentally safe, and permanent method of disposal of acid-generating, non-hazardous materials and was approved by the TDEC (TDEC, 2005).

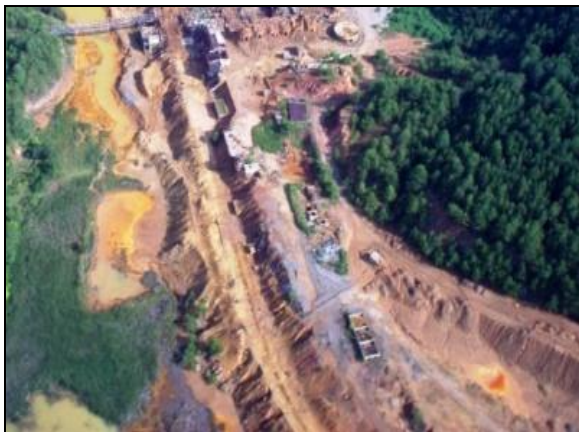
Figure 11. London Mill Shaft Area - Before

The London Mine Shaft Area is located immediately north of the plant site extending to the magnetite area to the north, to the flotation plant to the south and includes the London Shaft, ore pockets, calcine bins, former location of a cyanide tank, and railroad grades (see Fig. 11). The mine shaft, calcine bins and other underground voids presented a physical hazard to humans. Approximately 2,770 m<sup>3</sup> (97,875 cu-ft) of clean fill was placed into these voids in 2002 before other reclamation activities began in the area.

Most of the surface materials present within the London Mine Shaft Area were acid-generating and some had high concentrations of Fe, Pb, Zn and Cu. The acid-generating materials were hauled to the Isabella Pit for sub-aqueous disposal. Cyanide, polycyclic aromatic hydrocarbons (PAHs), and Hg were also identified in the surface materials in concentrations below action levels for protection of human health. Materials containing these constituents were segregated from other materials in the area, consolidated within the footprint of the London Mill Flotation Plant, and placed under an engineered cap.

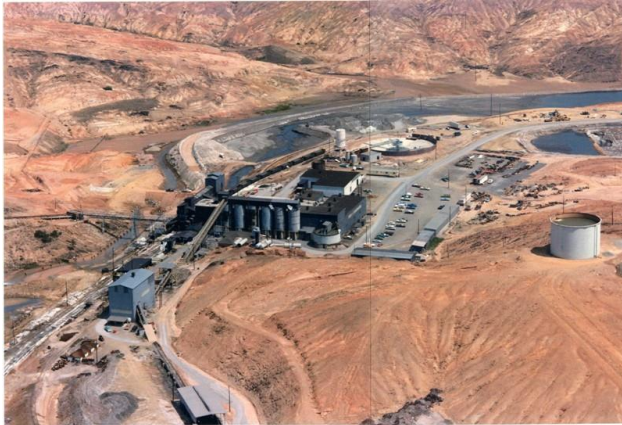
Figure 13. London Mill Plant 1976 - Before

The London Mill Plant site is located south of the London Mine Shaft. During the late 1800s and early to mid 1900s, the London Mill Plant site included a flotation plant, crushers, fine ore storage bins, warehouse, laboratory and site office (see Fig. 13). Portions of these structures remained after the site was abandoned and partially dismantled in 1987 (see Fig. 14). Significant volumes of mining wastes, processing wastes, processing chemicals, stockpiles of products including Cu, Fe and Zn concentrates, construction debris, and demolition waste also remained on the site (BWSC, 2004). The mining wastes, processing wastes, and concentrates were acid-generating materials.

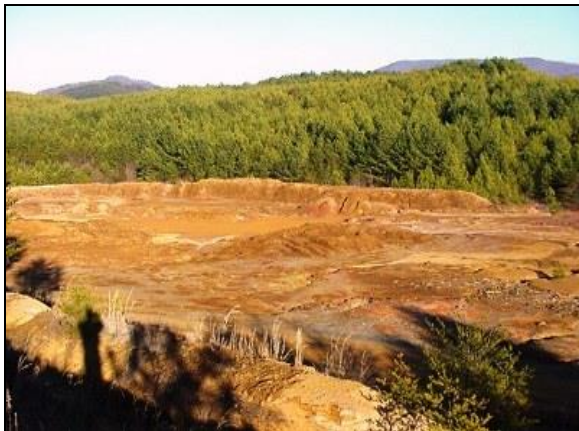
Figure 17. Tailings/Concentrate Area - Before

From 1922 until 1946, tailings were disposed in the London Mill area behind a rock and timber dam creating the tailings/concentrate area (see Fig. 17). The tailings/concentrate area is located east of the London Mill Flotation Plant within the former flood plain of Burra-Burra

During the operation of the London Mill Flotation Plant, occasionally the production of Fe and Cu concentrates exceeded the capacity of the other mineral beneficiation plants in the Basin for the concentrates. In the 1970s, the excess production of the concentrates was temporarily stored within bermed areas of the former tailings collection area. These storage practices lead to the mixing of the tailings with Fe and Cu concentrate when portions of the concentrate were reclaimed for processing in the mid 1980s. Two types of concentrate have been reported in the tailings/concentrate area, Cu concentrate and Fe concentrate. The Fe and Cu concentrates are a dark gray to black silt sized material.

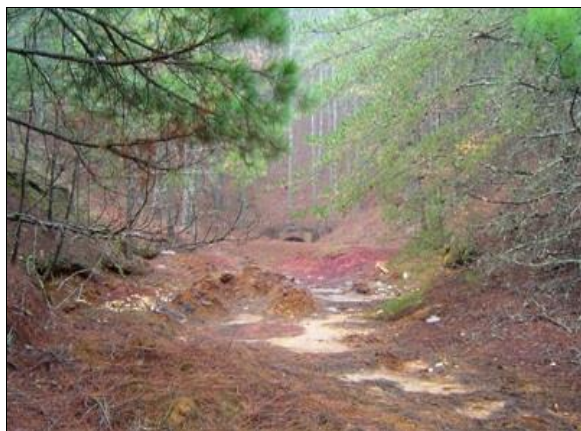
Figure 19. Tunnel Portal Area - Before

Starting in the 1950's, Fe concentrate was transported from the London Mill Flotation Plant to the Fe roasters via a pipeline passing through a tunnel in the ridge between the London Mill and Isabella processing areas. The pipeline, which had a clean out at the inlet to the tunnel, was occasionally drained. Iron concentrates accumulated in and around the portal and in the adjacent tributary to Burra-Burra Creek. The cut bank at the entrance to the tunnel covers an area 45.7 m (150 ft) by 12.2 m (40 ft). The entrance area had weathered iron concentrate and oxidation salts. Sulfide minerals comprised > 25 percent of the material (see Fig. 19). Samples of surface water collected from the tributary above and below the Tunnel Portal area indicated that water quality in the tributary deteriorated immediately downstream of the Tunnel Portal.

In 2006, remedial actions were implemented to help isolate poor quality water from the Tunnel Portal area from good quality water to decrease the overall amount of water in the London Mill area requiring treatment. This diversion generally consists of collecting the base flow and storm flow, up to and including the 10-year/24-hour storm, from the tributary and diverting the flow to Burra-Burra Creek. This project included construction of an earthen dam to detain the surface water from the tributary upstream of the Tunnel Portal and installation of a pipeline to direct the discharge to Burra-Burra Creek downstream of the Tunnel Portal area. The diversion also prevented the surface water from entering the Tunnel Portal area so that excavation of Fe concentrate and other waste mining materials could be performed in dry
